TECHNICAL | MEMORANDUM

TO: Dan Hudson, Director of Engineering, Town of Salem
FROM: Laura Diemer & Christine Bunyon, FB Environmental Associates
SUBJECT: **Task 2: 2018 MS4 Catchment Investigation**
DATE: July 23, 2018
CC: James Danis, Town of Salem; Forrest Bell, FB Environmental Associates

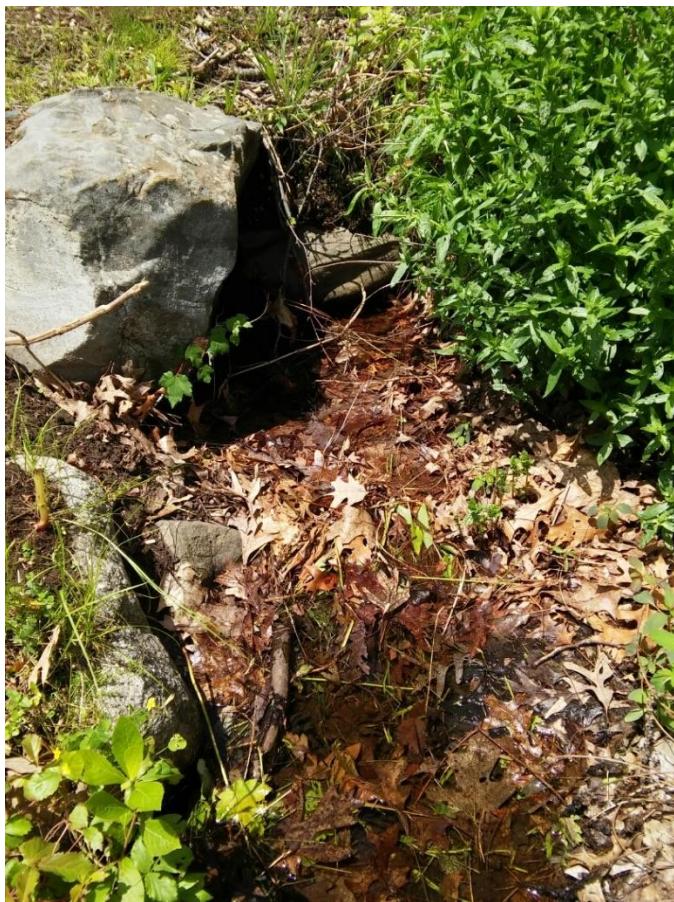
ARL-0425-OF on 6/25/18 (left) and ARL-0879-OF on 4/24/18 (right). Photo Credit: FBE.

Several possible contamination sources were noted in the catchment area to **ARL-0425-OF**. Residential lawns were large and well-manicured, suggesting that several properties likely fertilize their lawns regularly. Fertilizers can contribute to nutrient runoff. Although there was no visible pet waste, James Danis estimated that about 30% of residents in the area own a pet. Waterfowl have also been known to congregate on the lawn adjacent to the shoreline at map-lot 28-5506, where there are no barriers to the water's edge. Waterfowl waste, as well as pet waste, are likely

contributing nutrients and fecal indicator bacteria to areas at or near the catch basins or outfall. A dead and decomposing animal odor was noted between catch basins 3 and 5 (moving upstream from the outfall); a decaying animal in the storm drain may be causing the elevated total ammonia and fecal indicator bacteria levels. No evidence of household detergents (greywater) were found in the catchment during the dry weather investigation; however, during wet weather, an observation was made by a homeowner at 26 Marys Lane (map-lot 28-5604) regarding suds at the water's edge that were traveling from the south along his property. Sampled water at the outfall was also clearer during dry weather than wet weather, which appeared brown, and may be from washed-out organic matter in the sumps following the heavy rain storm.

The catchment area to **ARL-0425-OF** was investigated because of elevated fecal indicator bacteria, as well as elevated total chlorine and total ammonia, suggesting possible greywater and fecal sources of contamination. The investigation showed that the outfall may be impacted by fecal sources from pets and geese, as well as possible fertilizers and improper disposal of household detergents (suds were observed along shoreline near outfall).

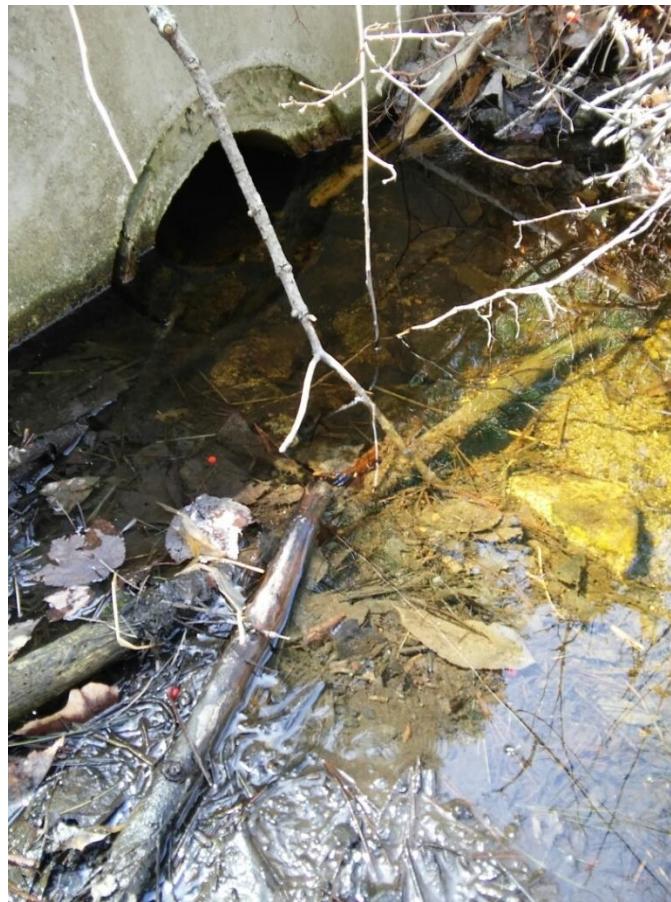
Several possible contamination sources were noted in the catchment area to **ARL-0879-OF**. Roughly 70% of the catchment area was vegetated with a mix of deciduous and non-deciduous trees, leaving 30% of the catchment impacted by residential development and roads. Lawns west of the outfall were well-manicured and possibly fertilized. James Danis stated that there is less irrigation and chemical use further up in the catchment and roughly 10-20% of homeowners in this area have pets. A bag of pet waste was also spotted in the flow path downstream of ARL-0879-OF at the initial screening on 5/24/18 (but not during the investigation on 6/21/18), indicating that pet waste may be a significant contributor of elevated fecal indicator bacteria to the area. Twelve Canada geese were spotted swimming at the water's edge at map-lot 40-5257 where there was minimal to no buffer separating a well-manicured lawn with the Arlington Mill Reservoir. Although this area was outside of the ARL-0879-OF catchment, the newer homes on the water's edge (map-lot 40-5255, 40-5235, and 40-5252) have their backyard lawns leading directly to the water's edge, where waterfowl can easily access and defecate. No visual evidence of household detergents (greywater) were found during the site investigation.

The catchment area to **ARL-0879-OF** was investigated because of elevated fecal indicator bacteria, as well as elevated total chlorine and specific conductivity, suggesting possible greywater, fecal, and road salt/water softener sources of contamination. The investigation showed that the outfall may be impacted by fecal sources from pets and geese, as well as possible fertilizers.

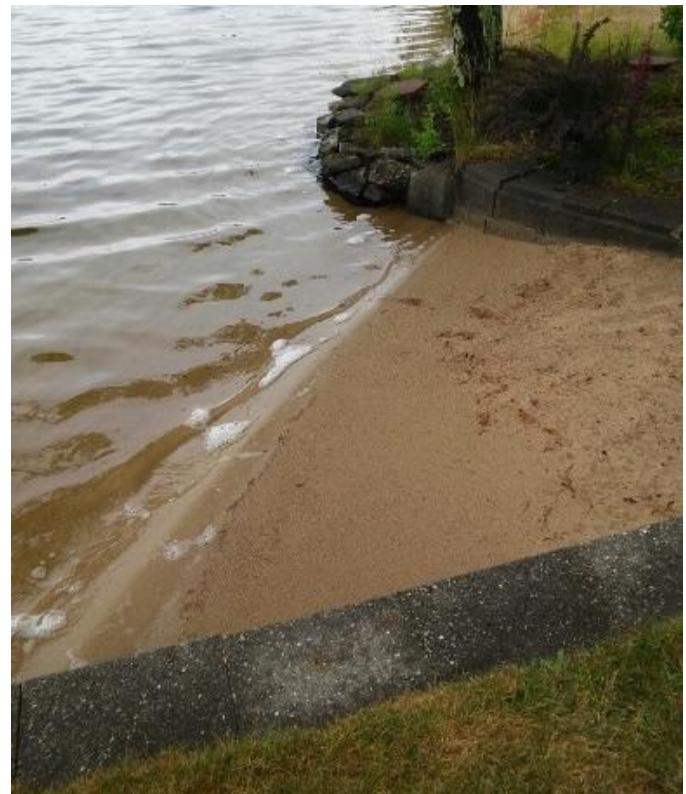
Homeowner observation and comment regarding suds at water's edge at 26 Marys Lane (map-lot 28-5604).

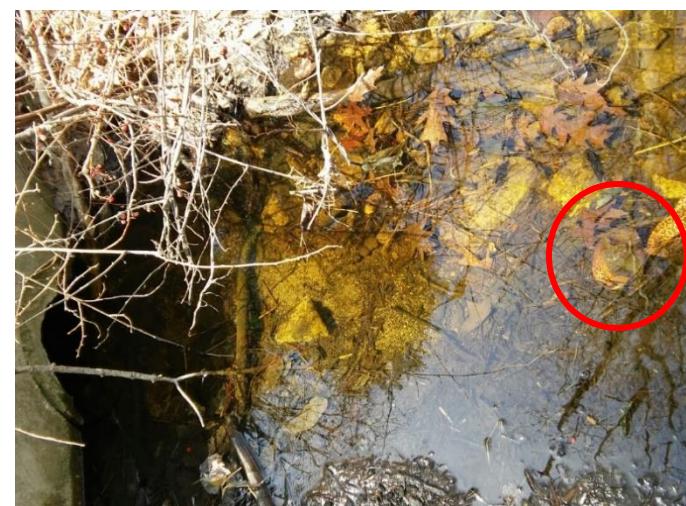
A bagged pet waste specimen (circled in red) was found a few feet downstream of ARL-0879-OF.

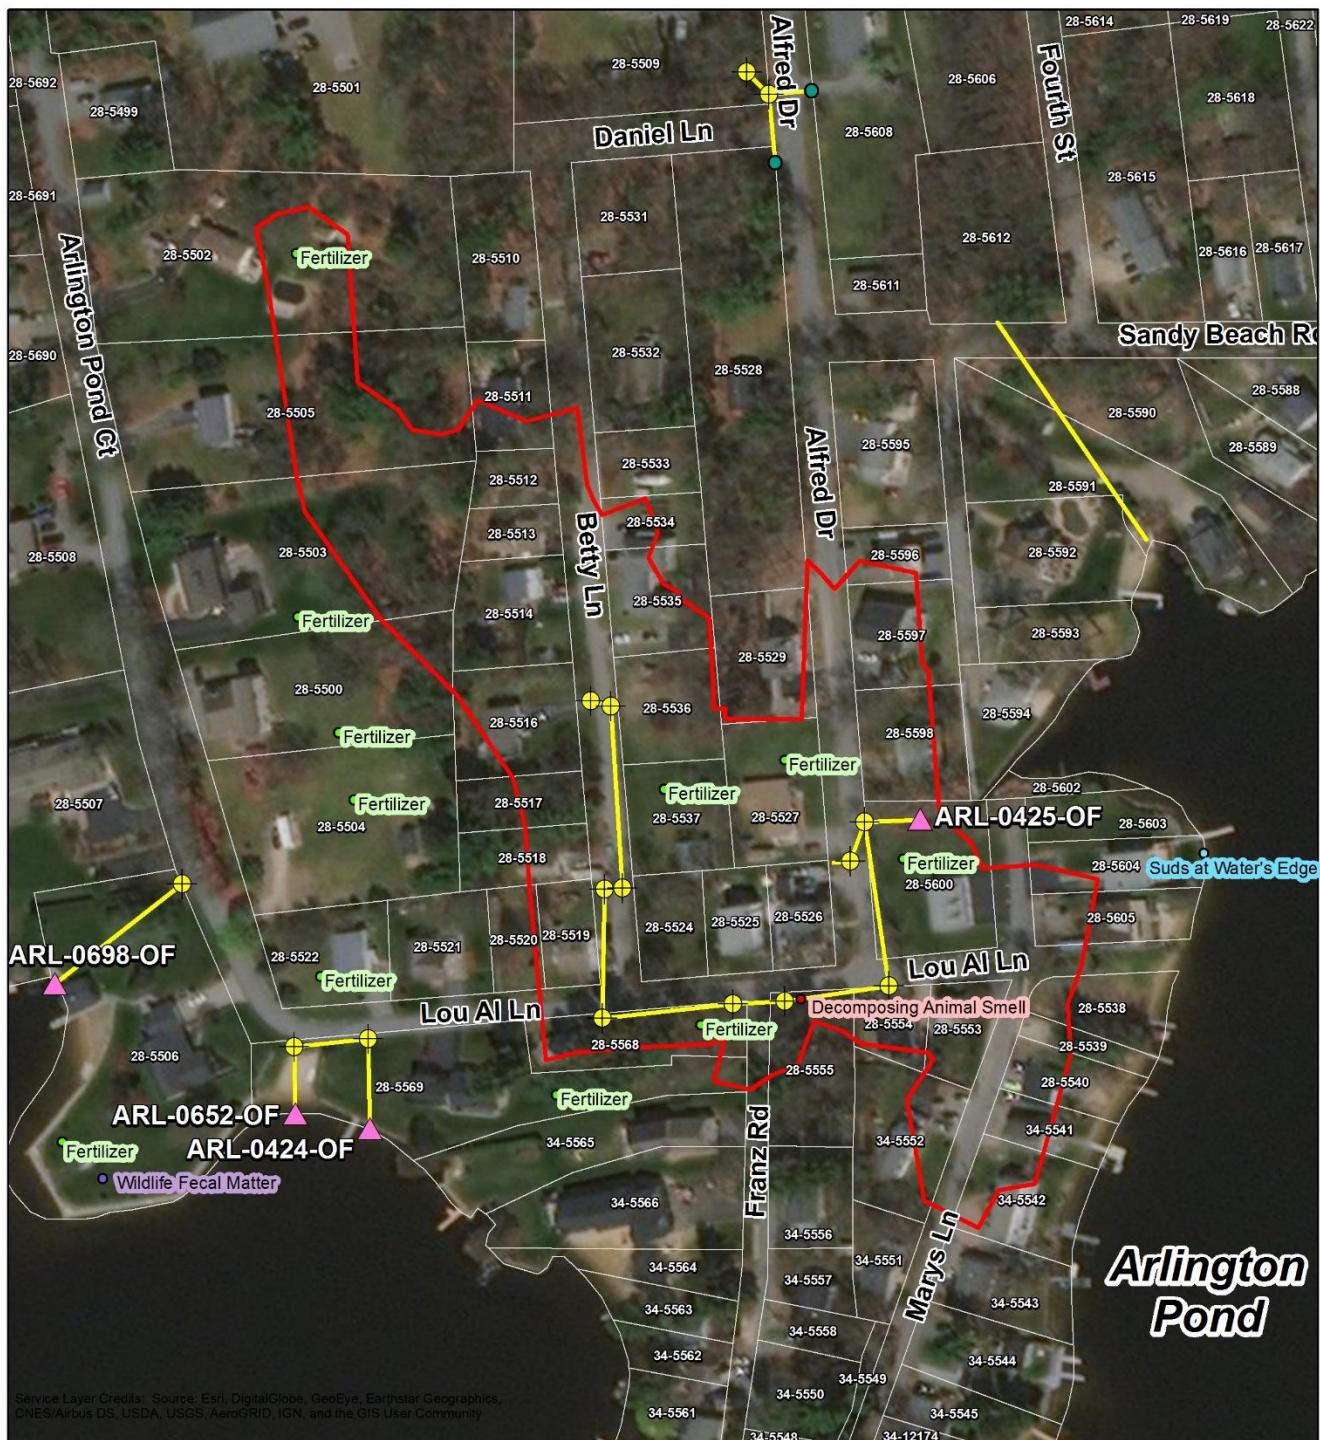
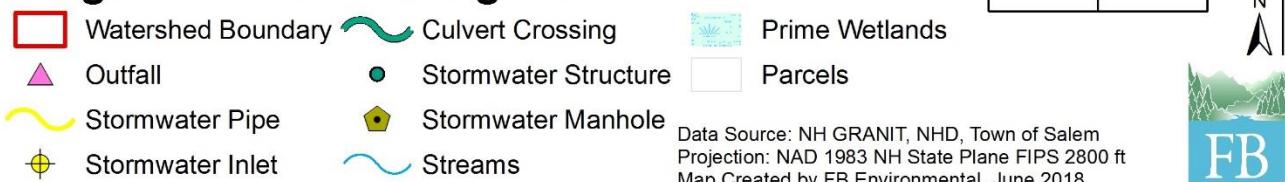
Arlington Pond - Drainage to ARL-0425-OF

FIGURE 1. Stormwater catchment area to ARL-0425-OF at Arlington Mill Reservoir. Potential pollutant sources noted.

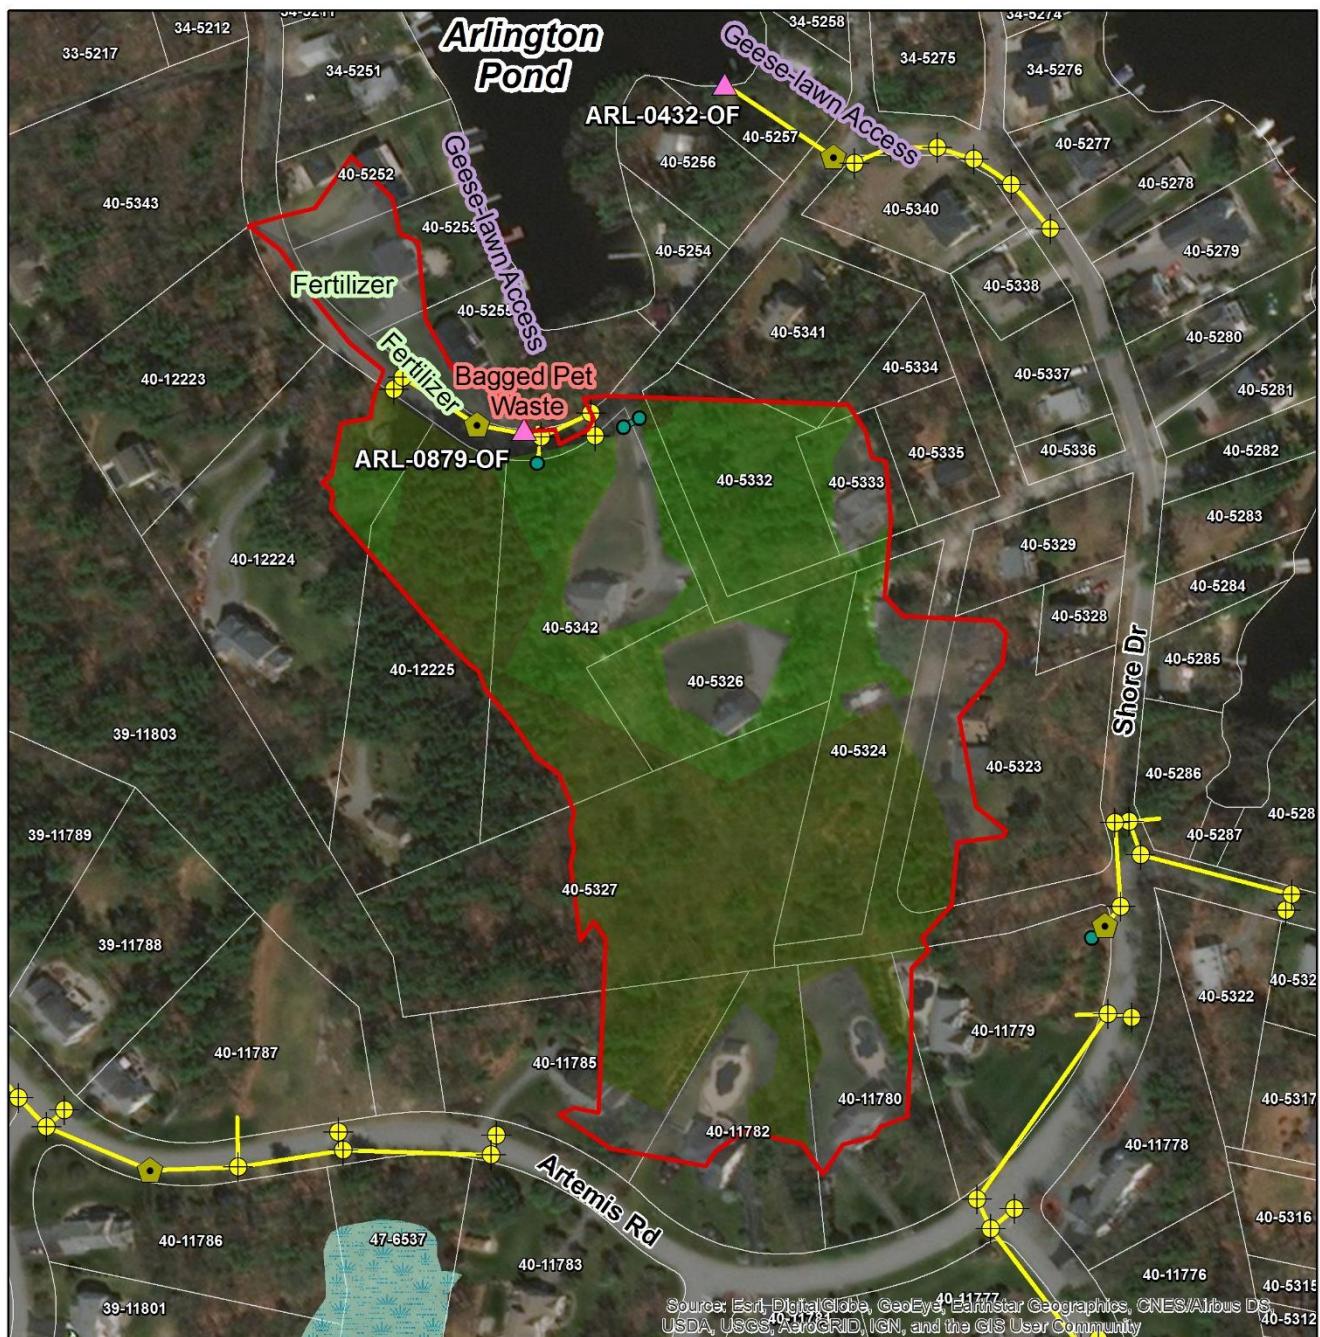
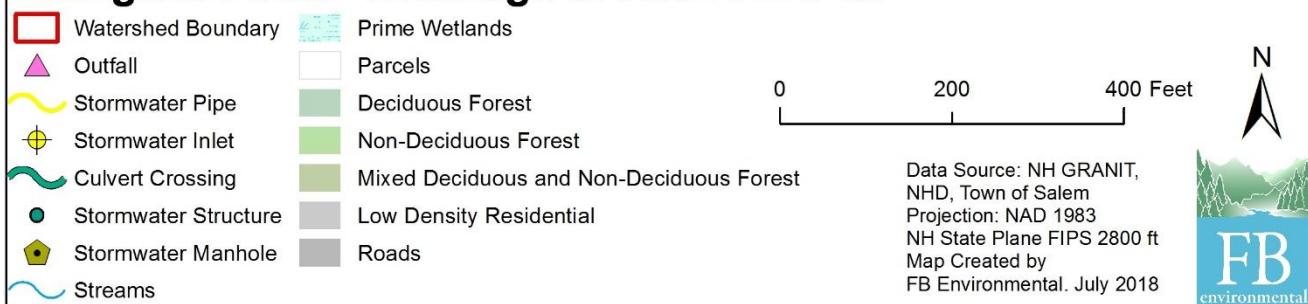
Arlington Pond - Drainage to ARL-0879-OF

FIGURE 2. Stormwater catchment area to ARL-0879-OF at Arlington Mill Reservoir. Potential pollutant sources noted.
