EVALUATION AND ASSESSMENT  
SALEM TOWN OFFICES  
33 GEREMONTY DRIVE  
SALEM, NEW HAMPSHIRE

OCTOBER 11, 2017

The H.L. Turner Group Inc.

Facility Assessment Report  
Salem Town Office Building

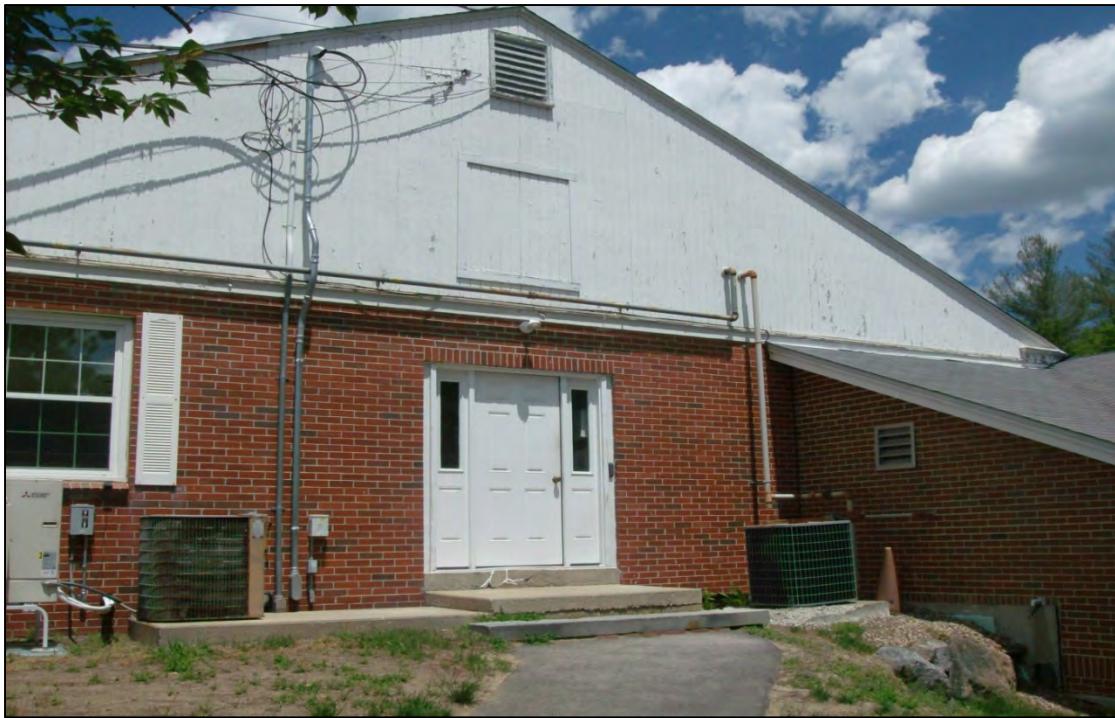
Peeling paint on gable end. Also note deteriorated compressor pad and cracked door sill.

- The wood on the gable end is peeling and needs scraping and repainting.
- At the east entry from the lower parking lot, repair the roof fascia, beam enclosure, and soffit. Repaint the entire canopy. Provide adequate support for the roof columns on the foundation wall and upgrade the handrails.

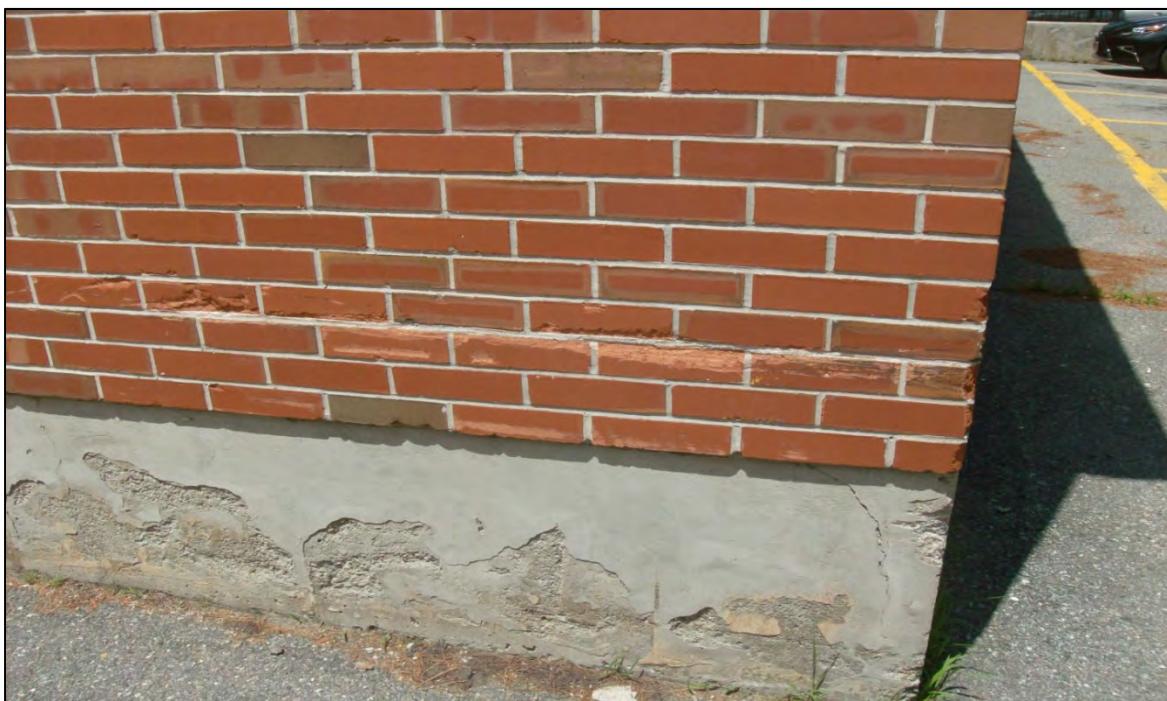
The brick veneer is in good condition. The veneer has been damaged at the southeast corner adjacent to the accessible parking space, presumably from snow plows. The exposed portion of the concrete foundation at the southeast corner of the first addition is cracking and is in need of repair. Similar cracking was observed at the southwest corner of the DMV addition. It should also be repaired.

Damaged and cracked concrete and damaged brick at southeast corner.

- Repair the cracked concrete foundation at the southeast corner of the building, as well as the southwest corner of the DMV addition. The cracks may lead to large areas of concrete spalling off the foundation wall if left unattended.

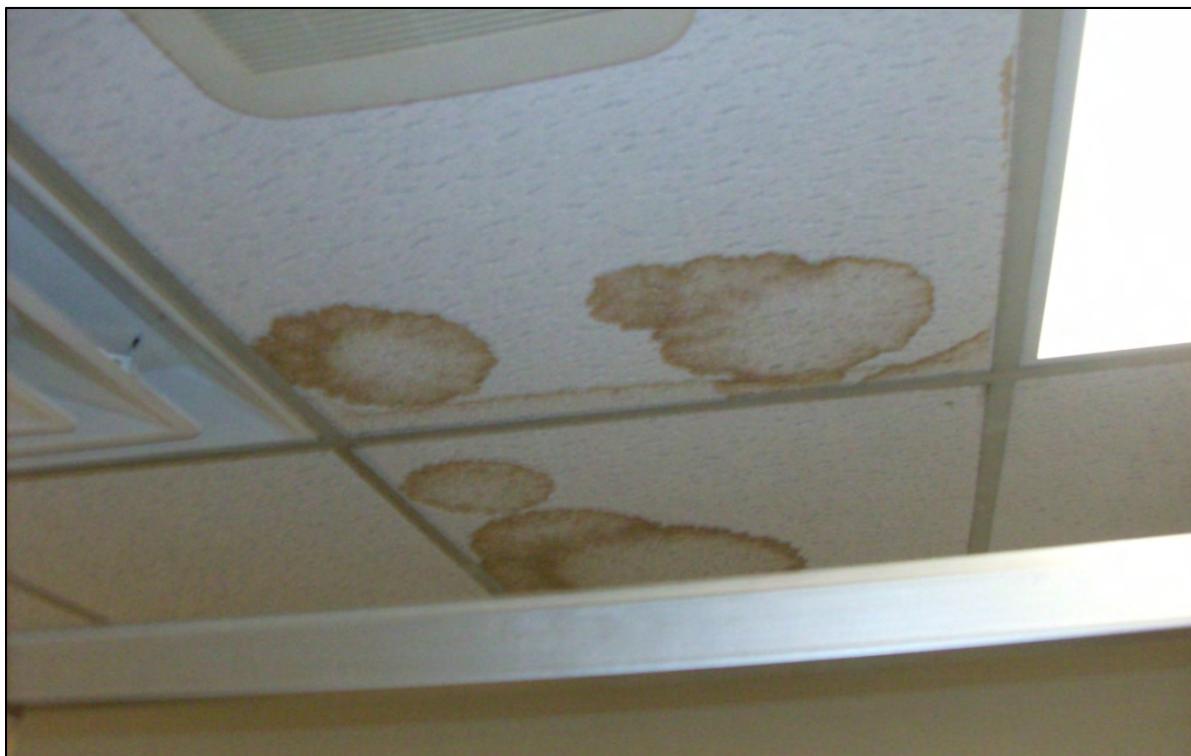
The ceiling throughout the building has significant staining and discoloration from a variety of causes, from roof leaks to pipe leaks to condensation.

Stained ceiling tiles typical throughout building from pipe and/or roof leaks.

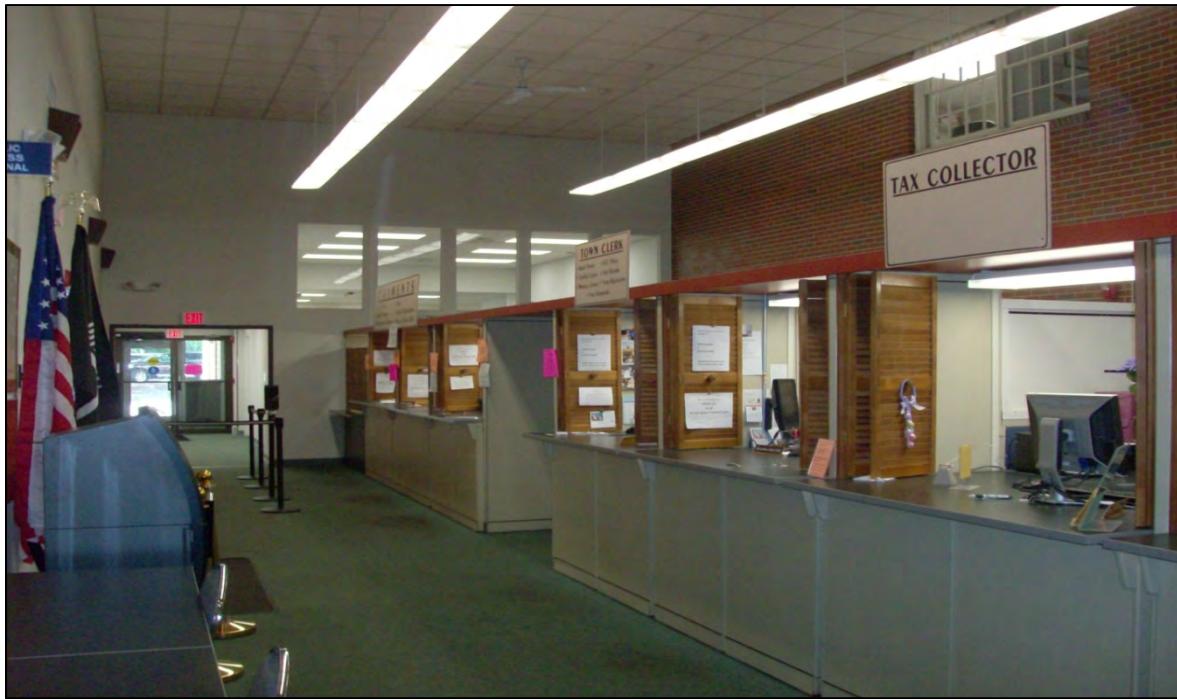
Counter area for serving the local residents. Note worn out carpet.

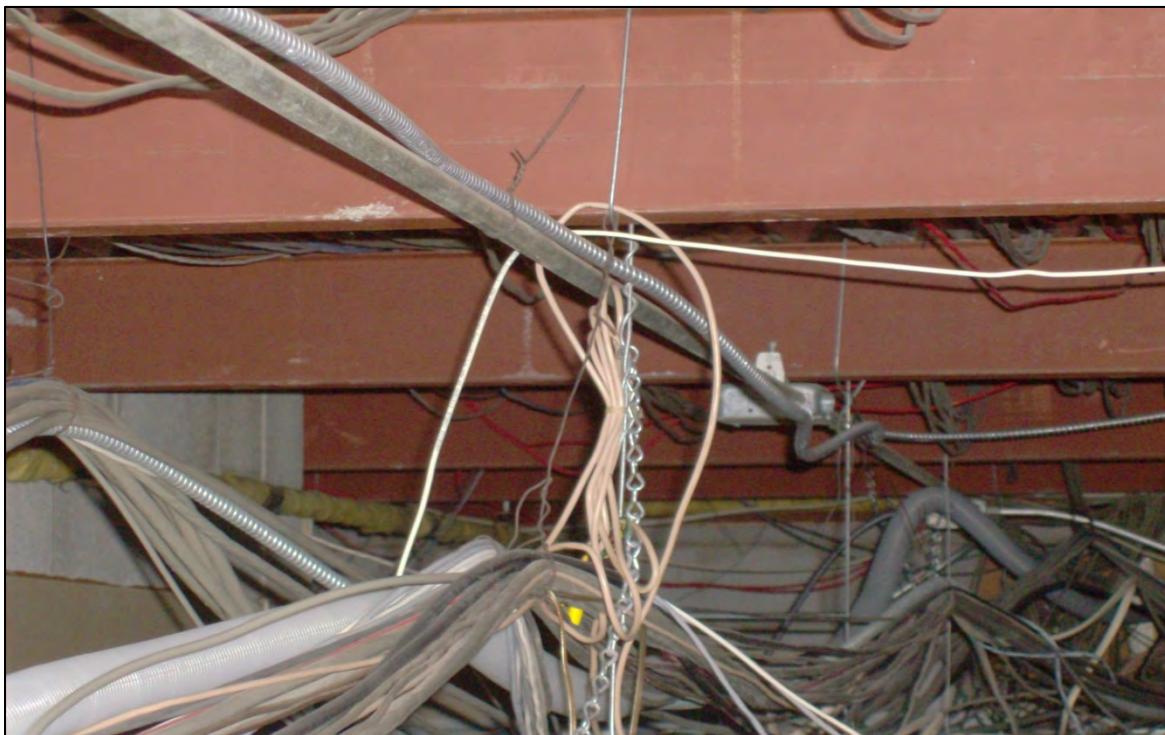
Tangle of wiring and communication cables over corridor ceiling. Many cables are no longer used.

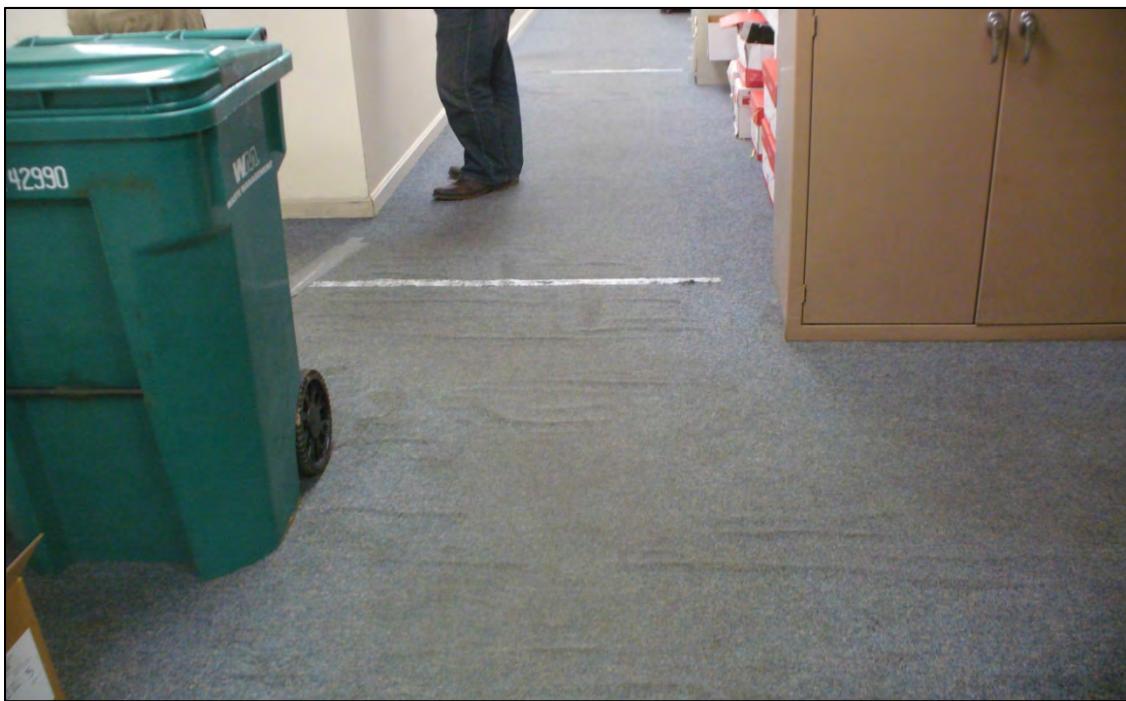
Tears, bulges, and wear on carpets.

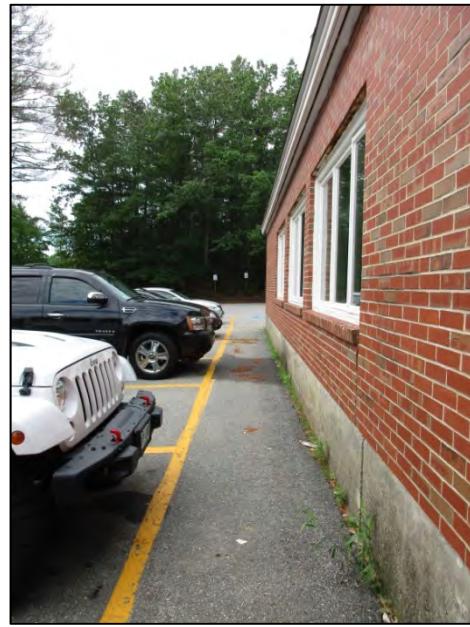
Pavement at face of foundation on east side. Note absence of roof gutter. Potential location for stone drip edge with underdrain. Installation of a guardrail or parking bumpers can help protect the building from vehicle impacts.

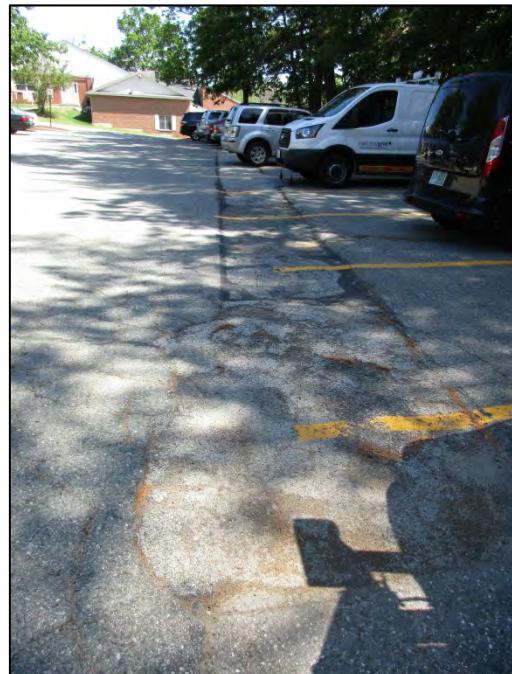
Pavement deterioration at south side parking lot.

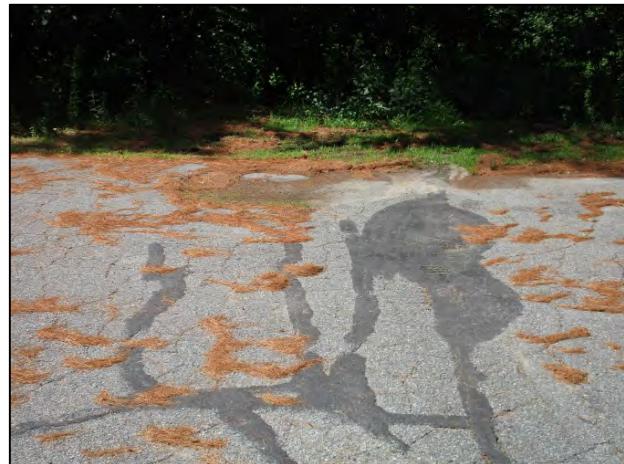
Pavement deterioration and evidence of past repairs where south side parking lot drainage runs off the asphalt and into the wooded area between Town Hall and the Courthouse site.

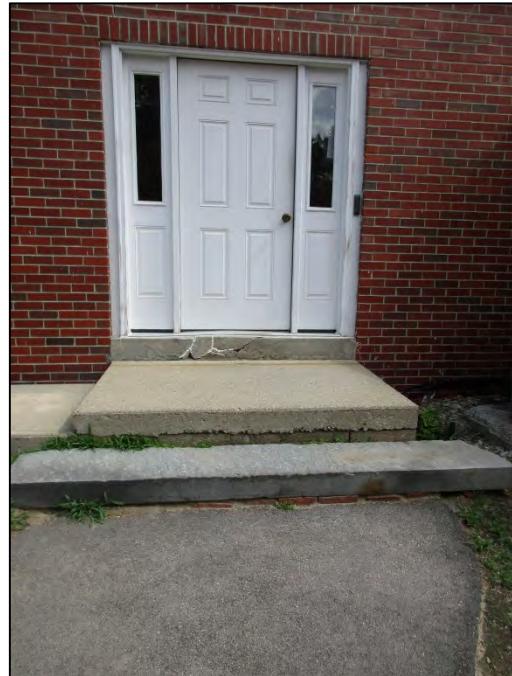
Stairs at southwest entrance. Replacement required for compliance with ADA. Note absence of handrails.

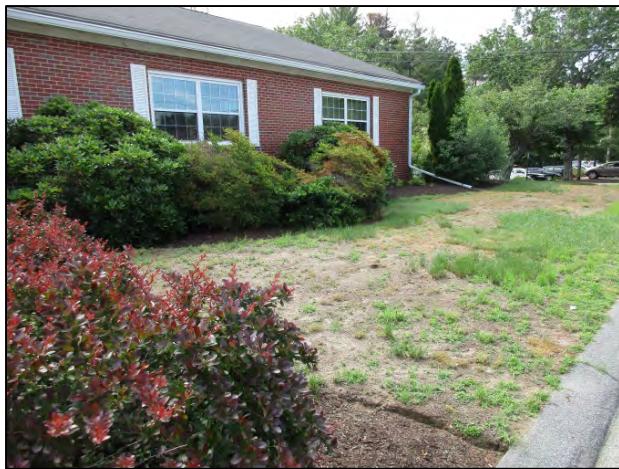
Prune landscaping along west face of building.  
Note sparse vegetation (typical of several locations sitewide).

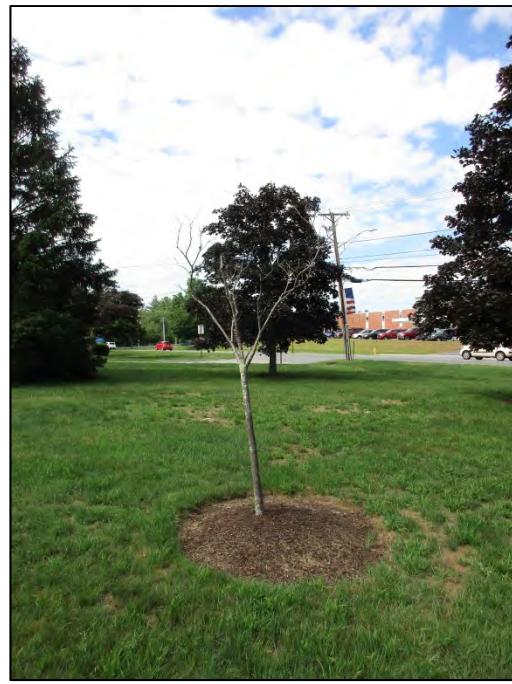
Replace the dead tree on the north side.

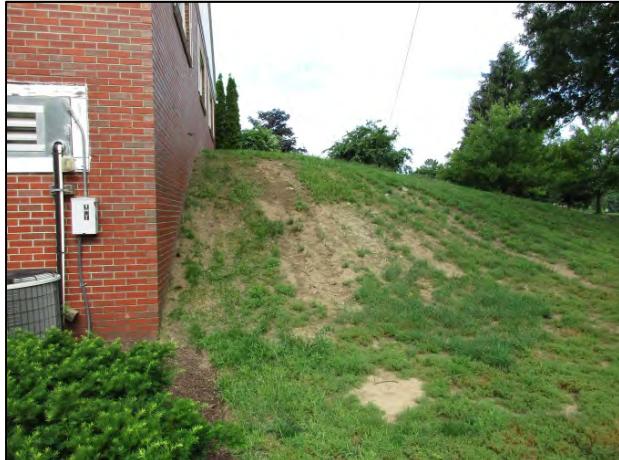
Sparse grass-cover on north side slope.
