ADDENDUM NO. 1
DATED AUGUST 28, 2018
CROSS COUNTRY SEWER INTERCEPTOR REHABILITATION
SALEM, NEW HAMPSHIRE

SMH INSPECTION REPORT

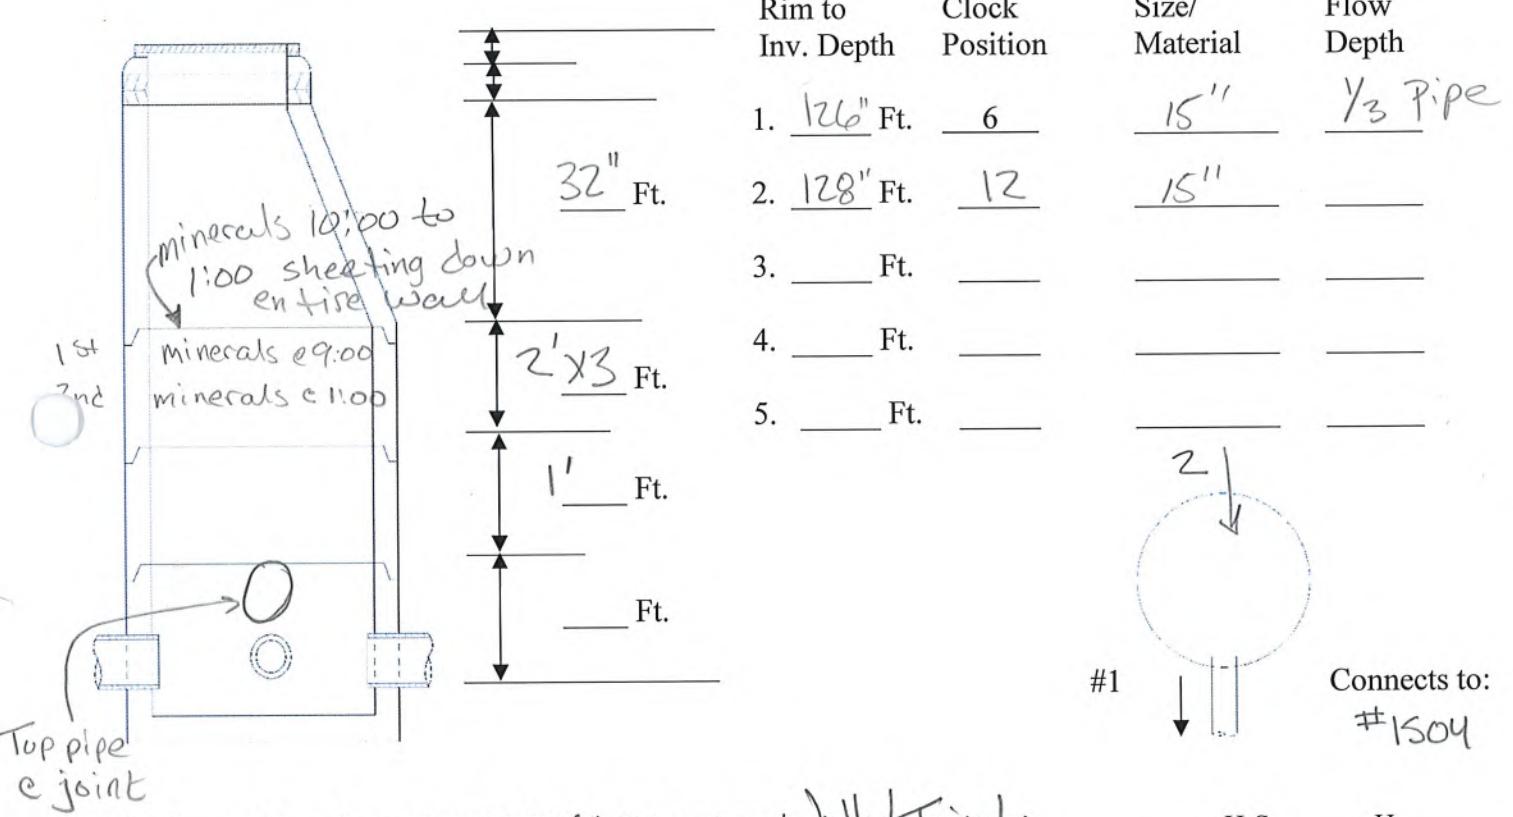
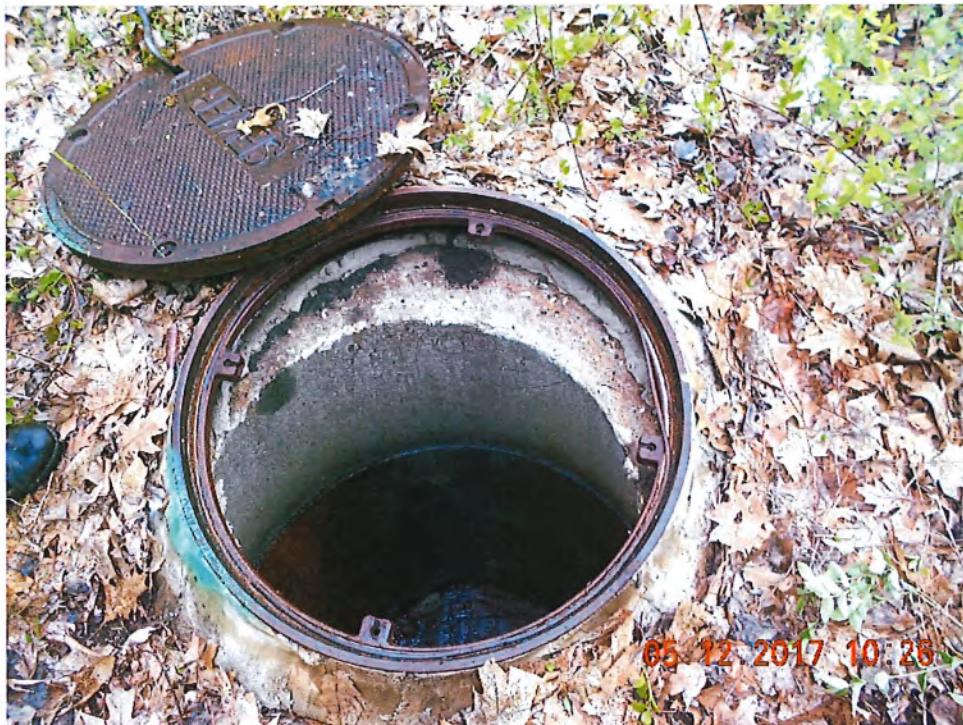
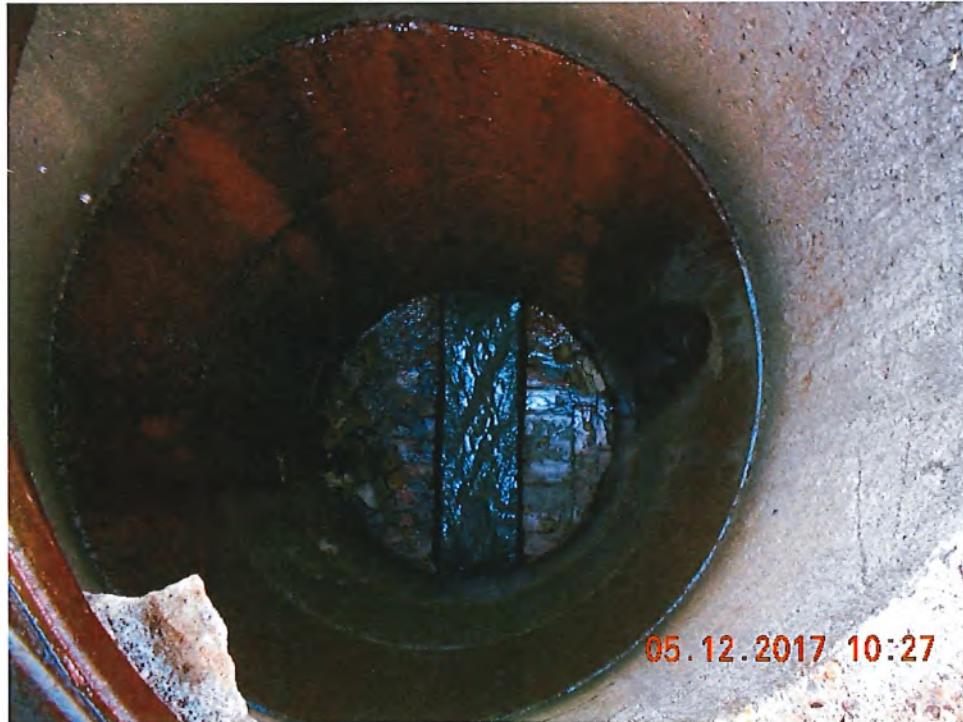
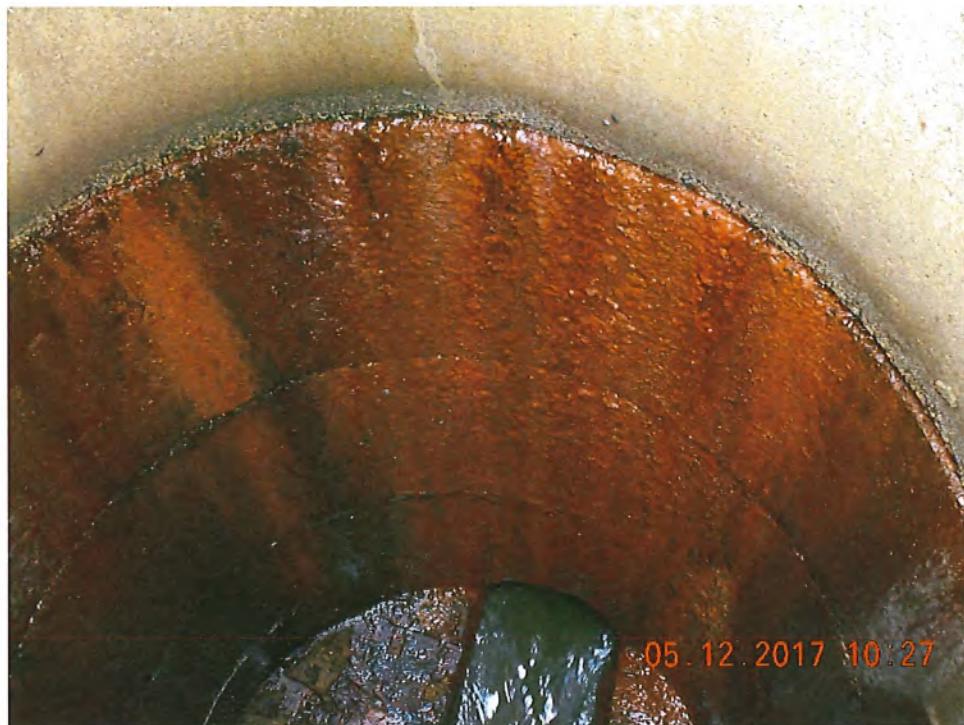
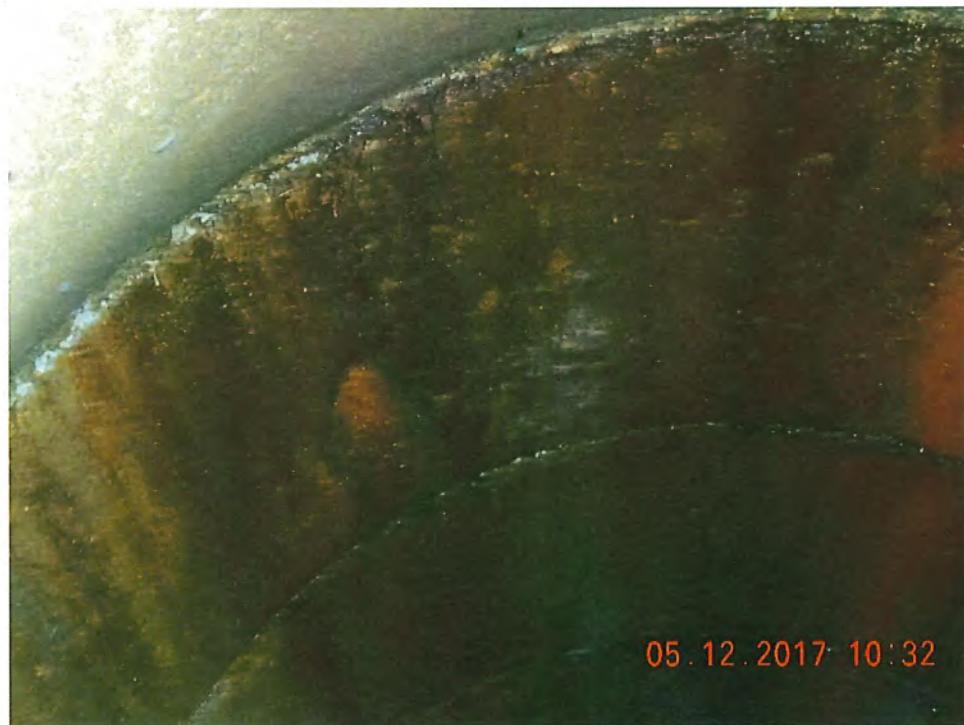
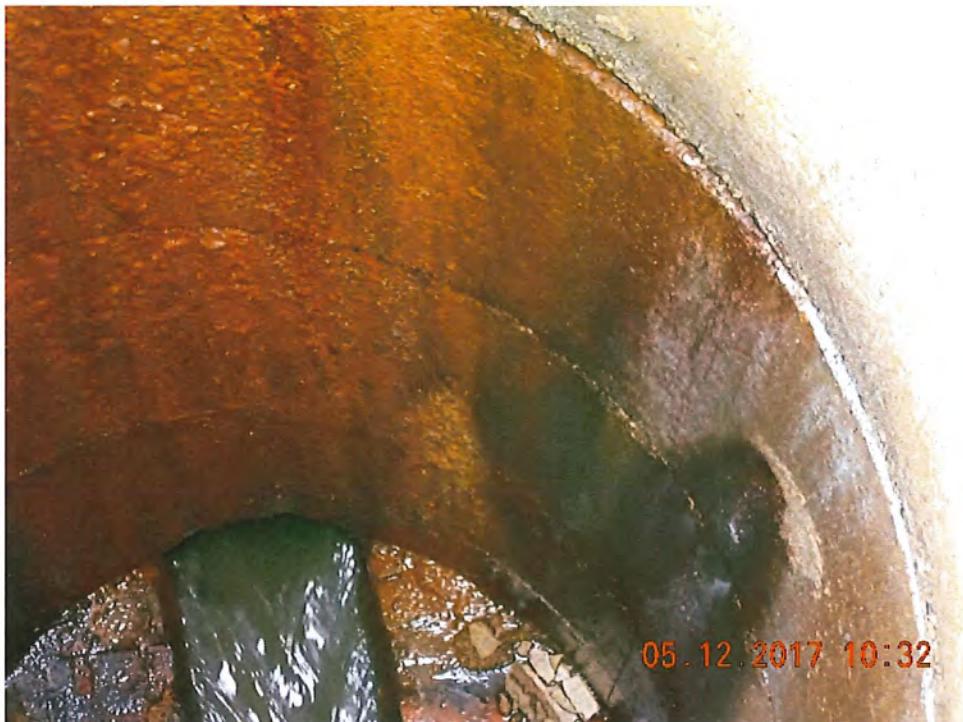
ID No. 1503

Infiltration: None observed Est. GPM <0.01 Location: Walls/Joints H₂S _____ pH _____

Observations	Material	Condition Rating	Notes
Frame/Cover:	<u>Bolted</u>	<u>2</u>	<u>8" offset</u>
Corbel:	<u>N/A</u>		
Cone/Slab Top		<u>1</u>	
Walls		<u>3</u>	<u>Joint @ cone, Dripping <0.01 gpm</u>
Invert/Shelf		<u>2</u>	<u>Concrete debris on shelf</u>

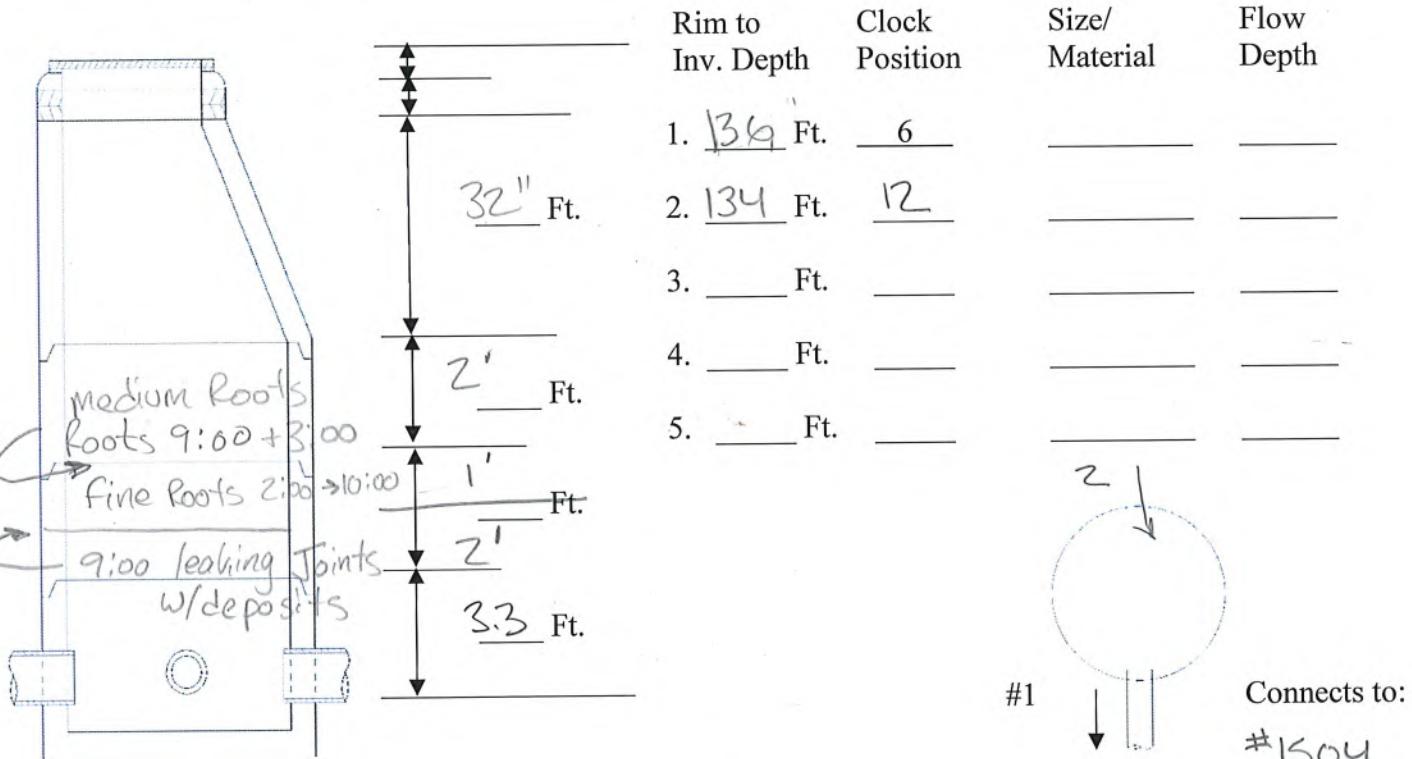
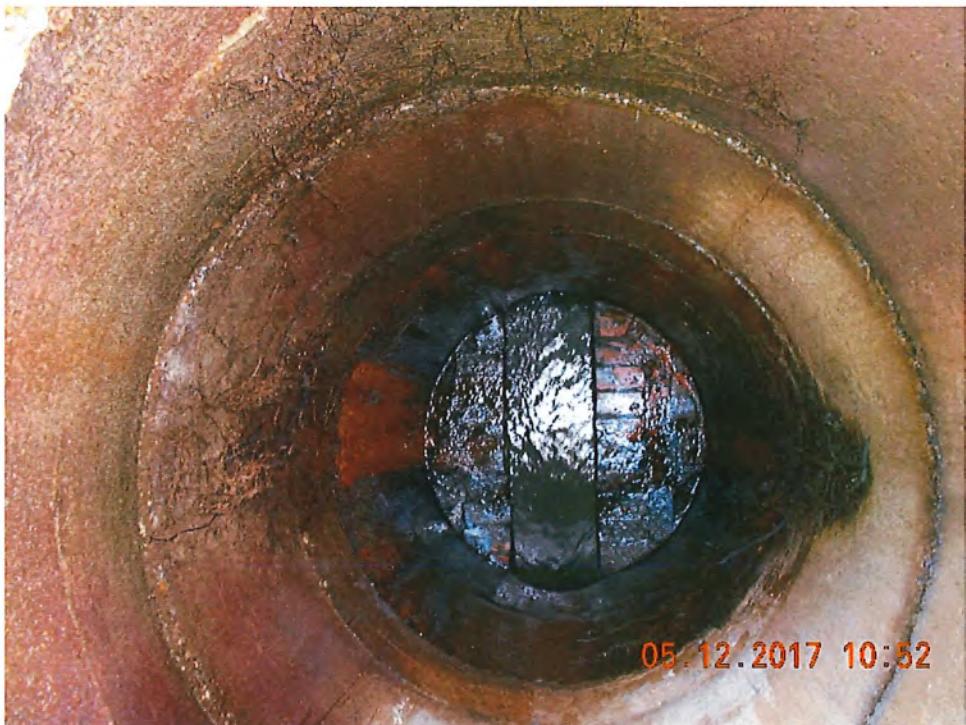
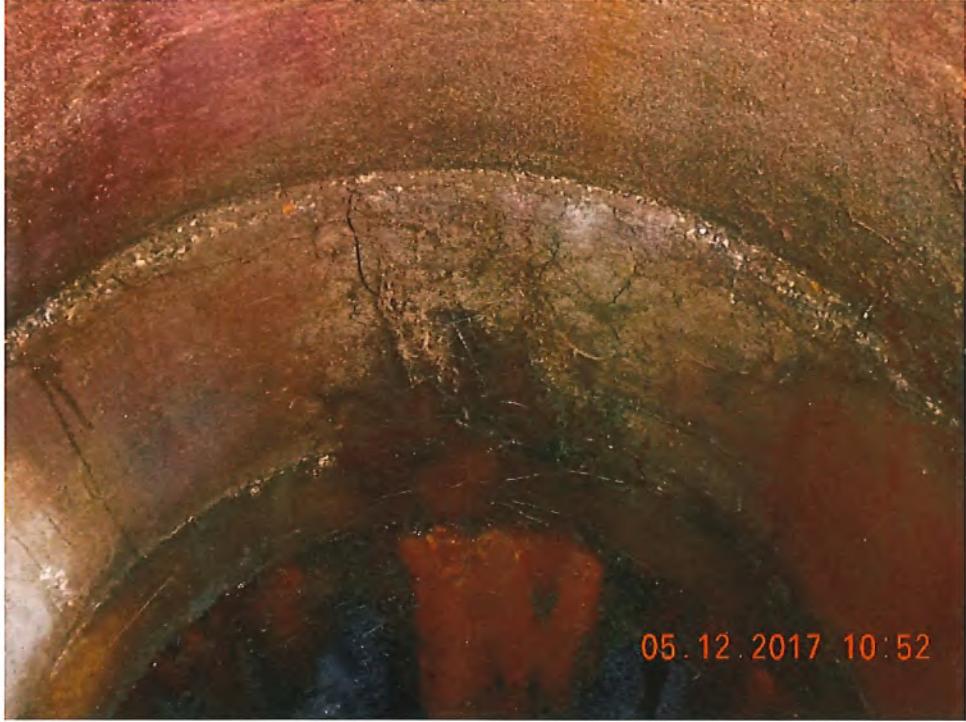
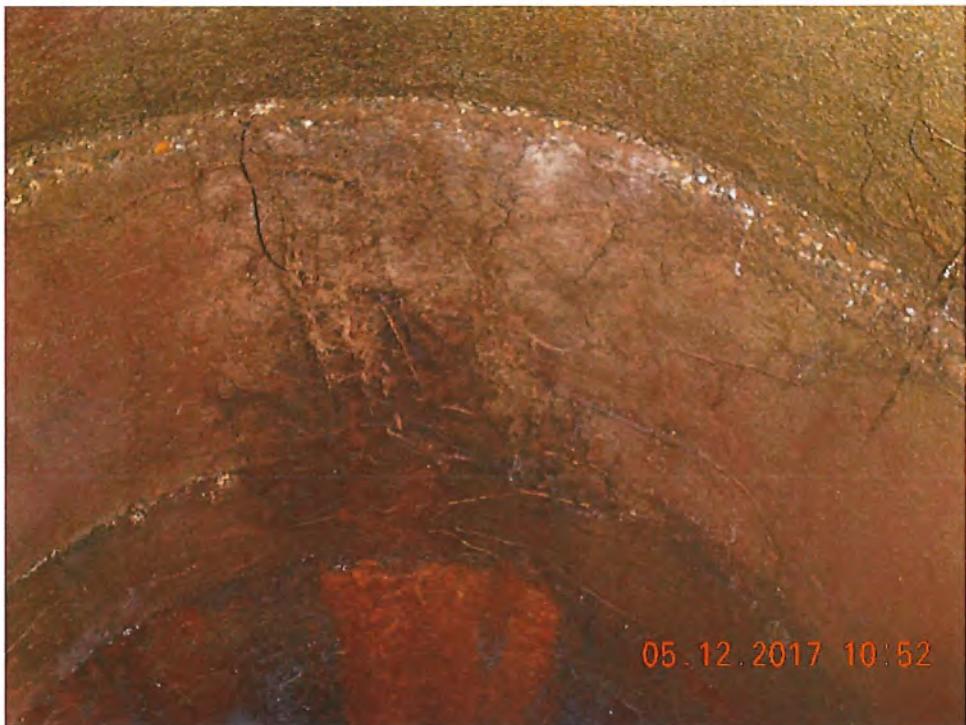
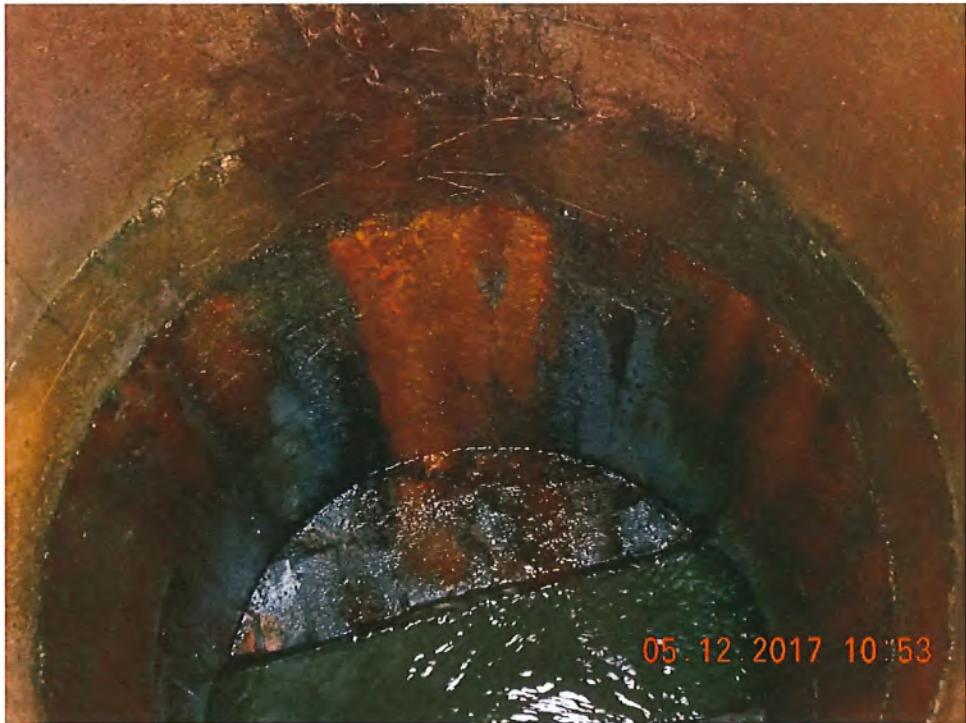
Location: X-country Rail trail ID No. 1504
 Dia. 4' Ft. Material: Pre-cast By: CSM DJR Date: 5/12/17
 Clear Opening: 30" In. Corbel: N/A In. Frame 6" In. Potential: N/A S.F.

Notes: Recommended removal of trees, Tap Root @ 3:00
Bolted cover

Infiltration: None observed Est. GPM <0.01 Location: Wells H₂S pH

Observations	Material	Condition Rating	Notes
Frame/Cover:		<u>1</u>	<u>New Bolted cover</u>
Corbel:	<u>N/A</u>	<u>N/A</u>	
Cone/Slab Top		<u>2</u>	
Walls		<u>3</u>	<u>Med+fine Roots, leaking Joint</u>
Invert/Shelf	<u>Brick</u>	<u>2</u>

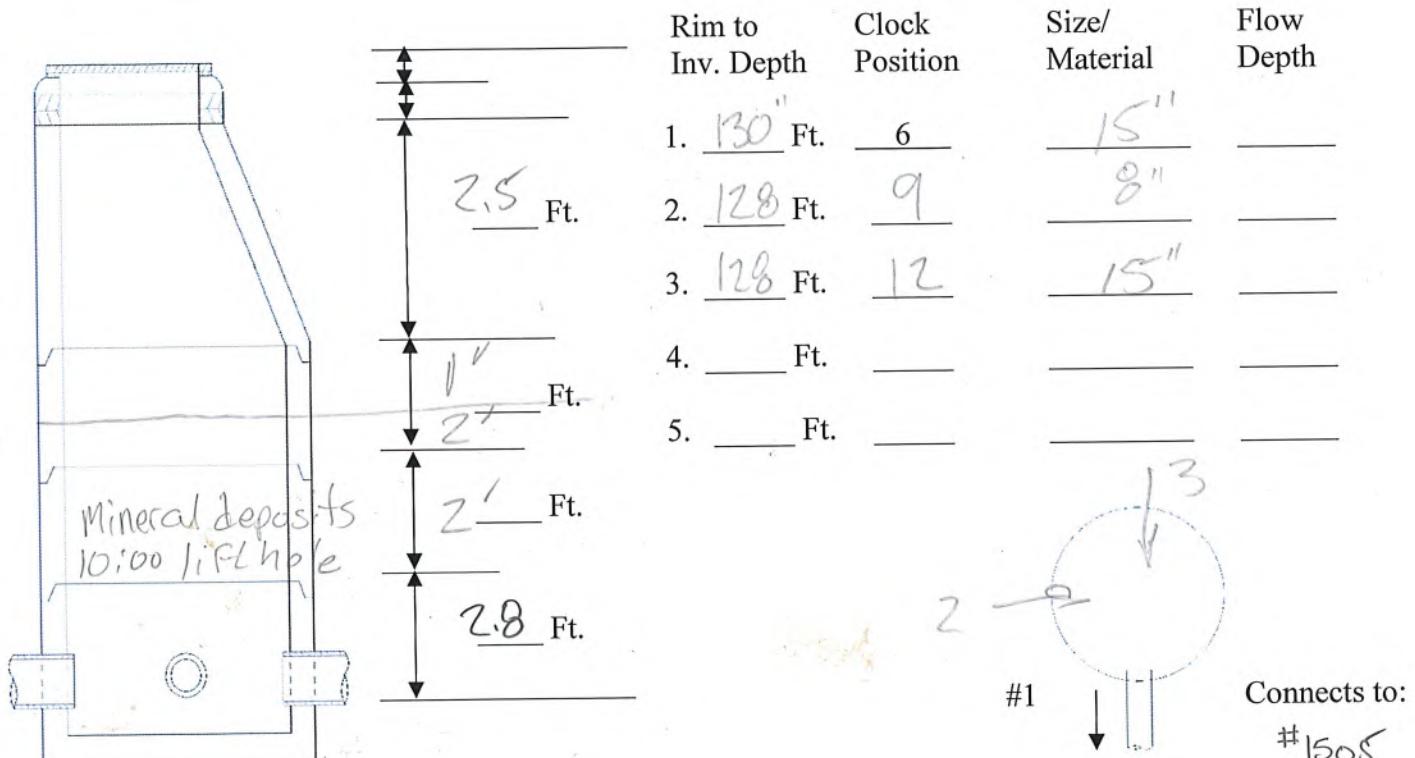
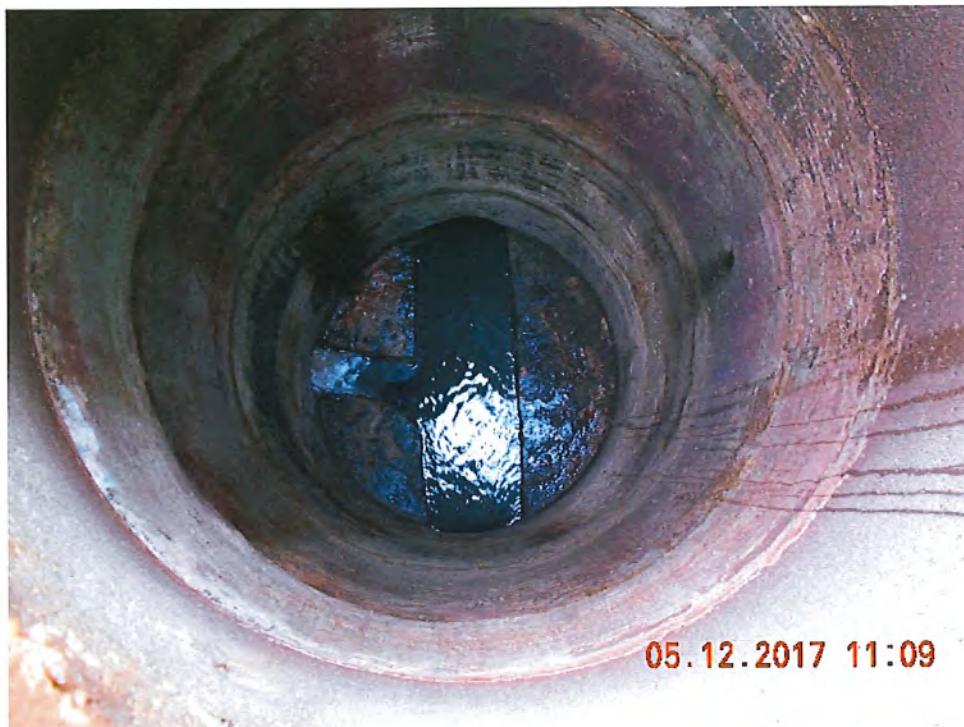
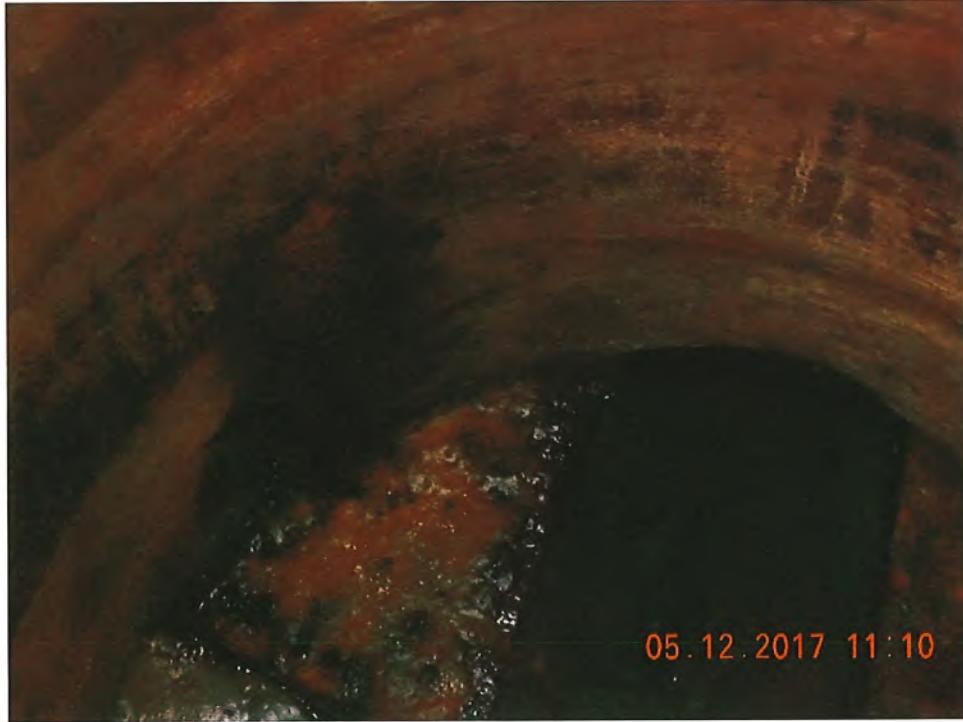
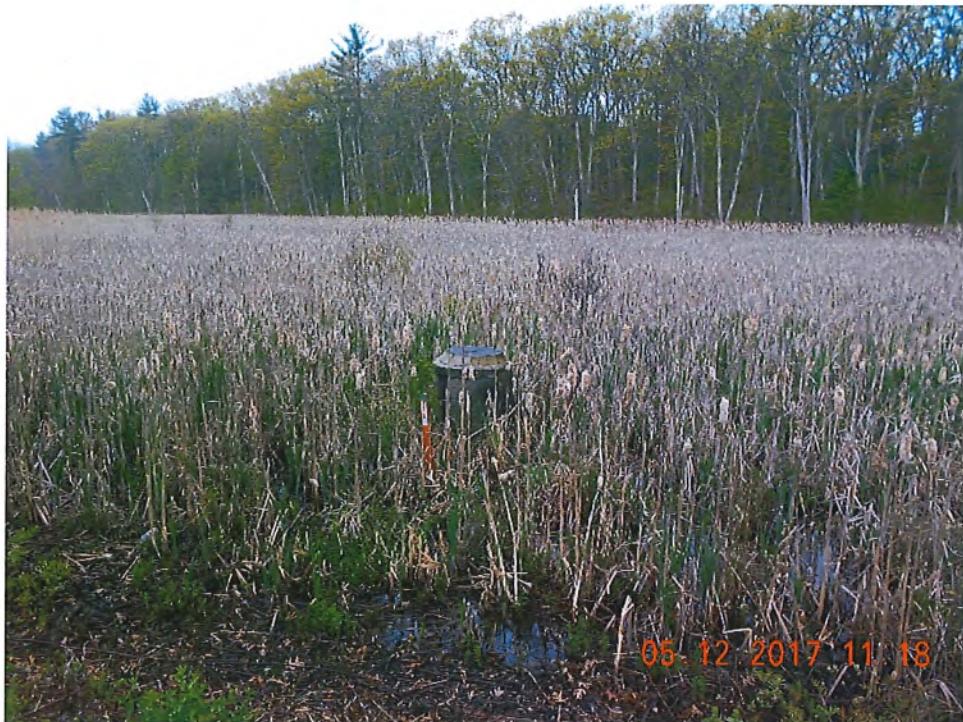
ID No. 1505

Infiltration: None observed Est. GPM < 0.01 Location: Walls H₂S pH

Observations	Material	Condition Rating	Notes
Frame/Cover:		1	Bolted
Corbel:		N/A	
Cone/Slab Top		2	
Walls		3	
Invert/Shelf		2

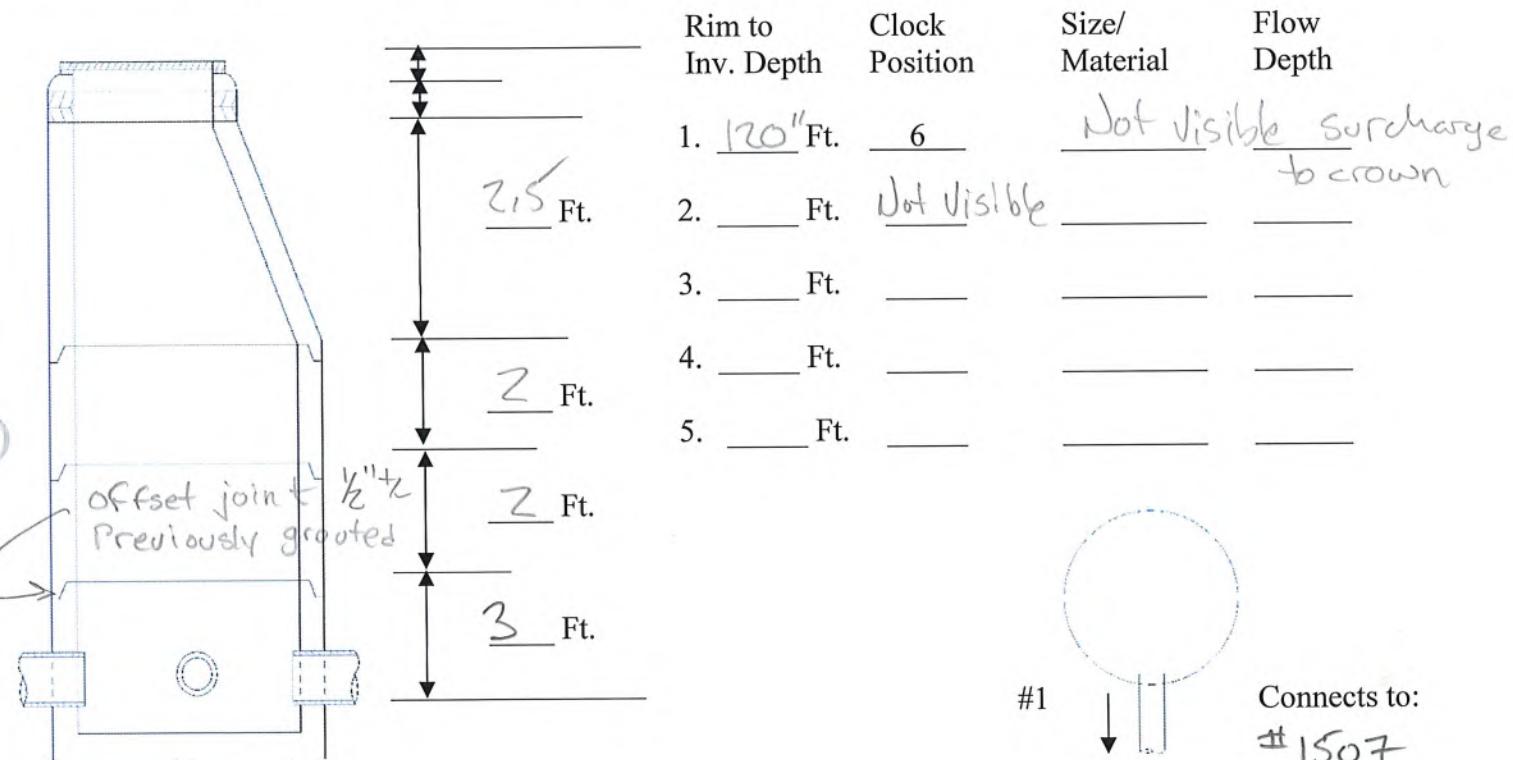
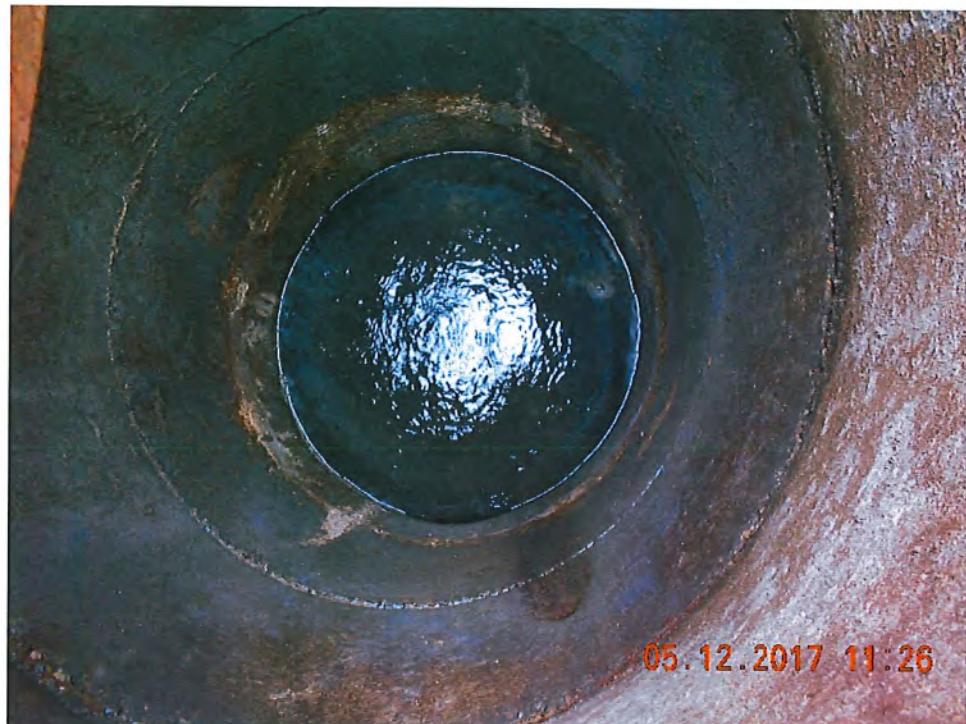
Location: X-country Rail trail ID No. 1506
 Dia. 4' Ft. Material: PreCast By: DTR CSm Date: 5/12/17
 Inflow Area
 Clear Opening: 30" In. Corbel: 0 In. Frame 6" In. Potential: N/A S.F.

Notes: Manhole surcharged to crown
Inlet possibly lower than outlet based on H₂O level

Observations	Material	Condition Rating	Notes
Frame/Cover:		1	Bolted New
Corbel:		N/A	
Cone/Slab Top		2	
Walls		2	Previous grouting/grout @ bottom, seam
Invert/Shelf		N/A	Not visible

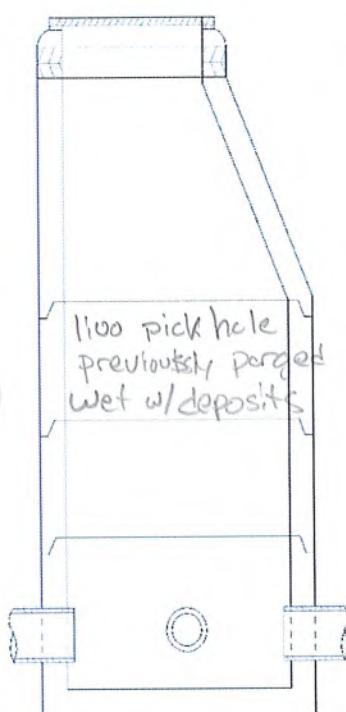
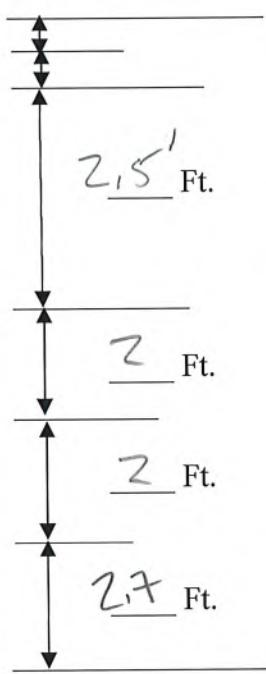
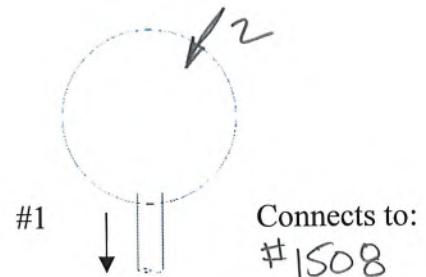
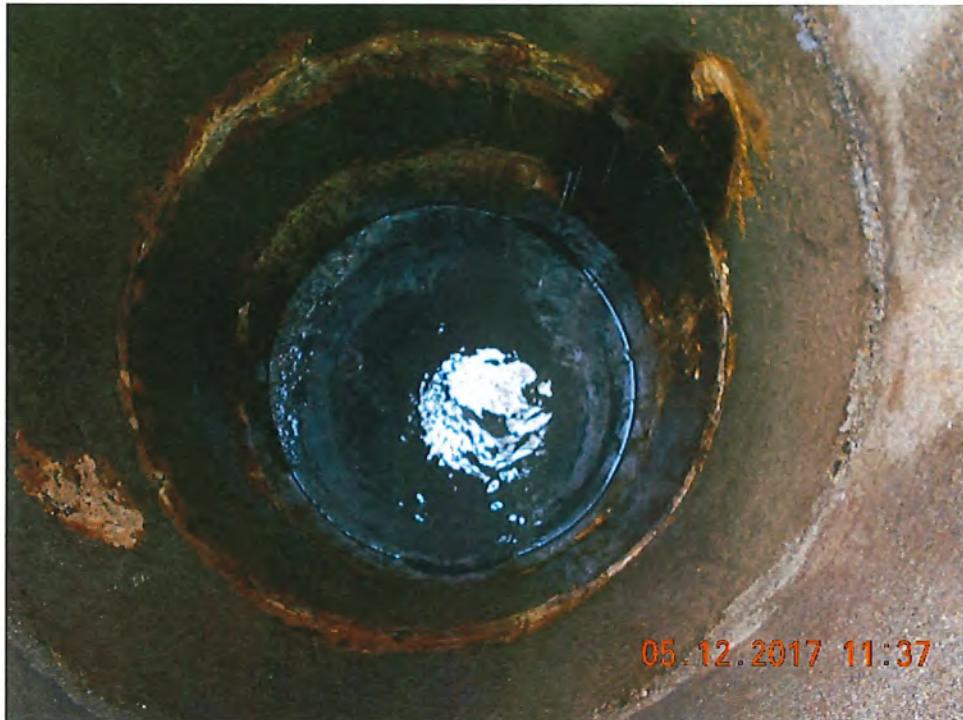
Location: X-Country Rail trail ID No. 1507

Notes: Surcharged to top of Invert shelf

Infiltration: None observed Est. GPM 50,01 Location: Walls H₂S pH

Observations	Material	Condition Rating	Notes
Frame/Cover:		<u>1</u>	<u>Botted New</u>
Corbel:		<u>N/A</u>	
Cone/Slab Top		<u>2</u>	
Walls		<u>3</u>	<u>all Joints previously perged</u>
Invert/Shelf		<u>N/A</u>	<u>Not visible</u>

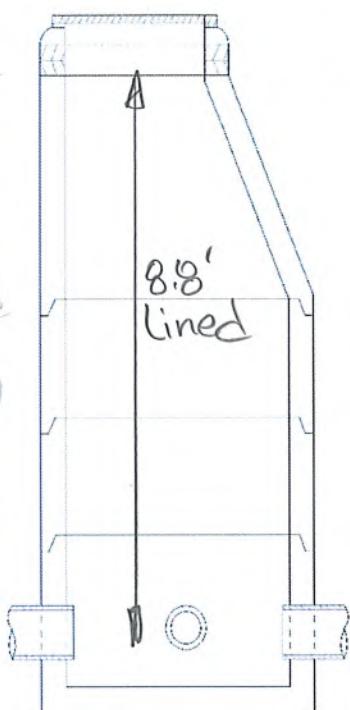
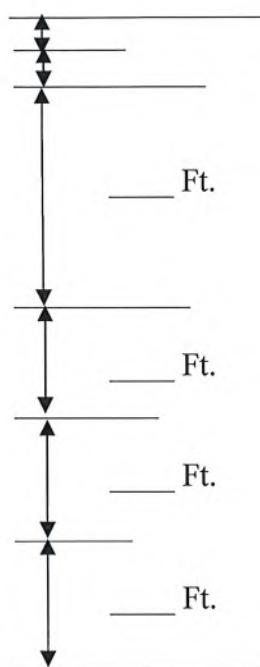
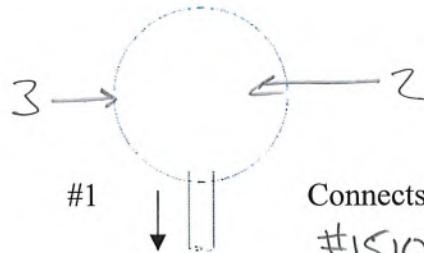
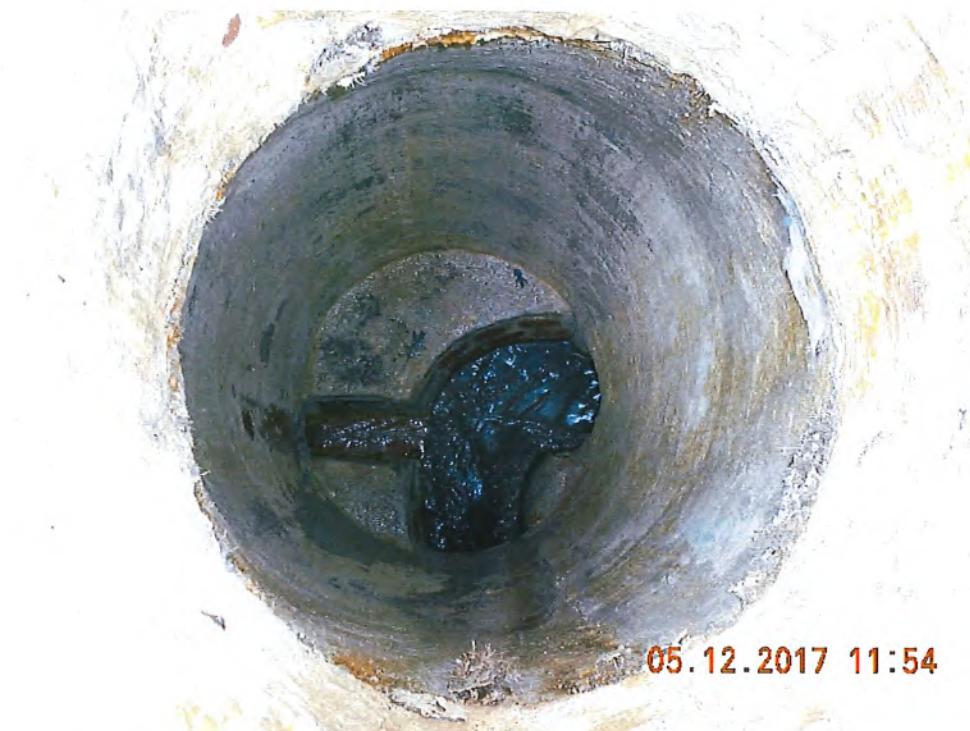
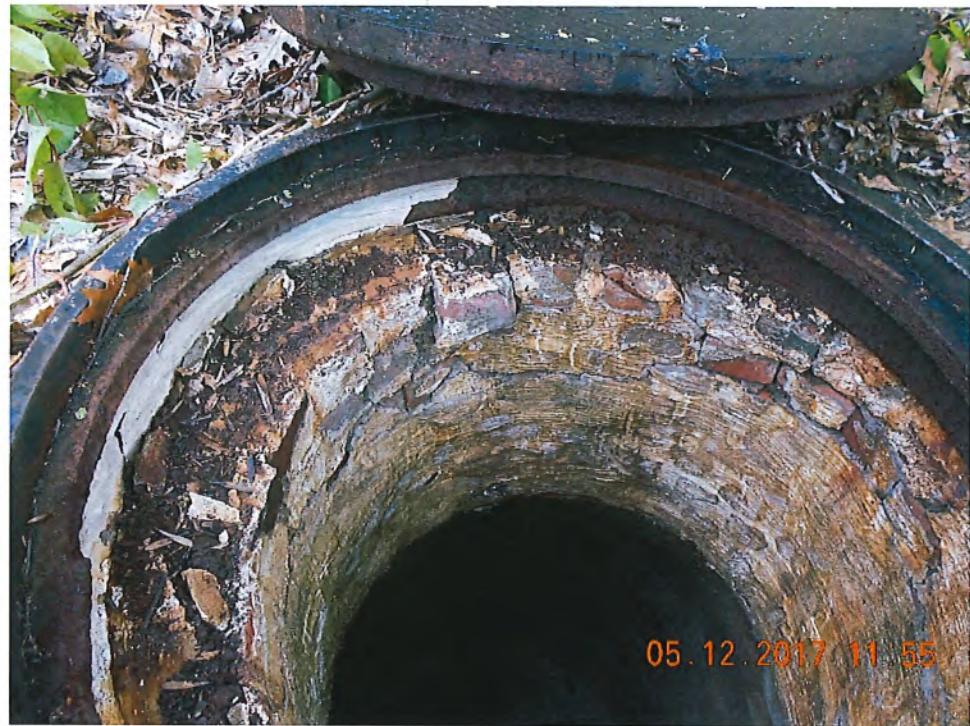
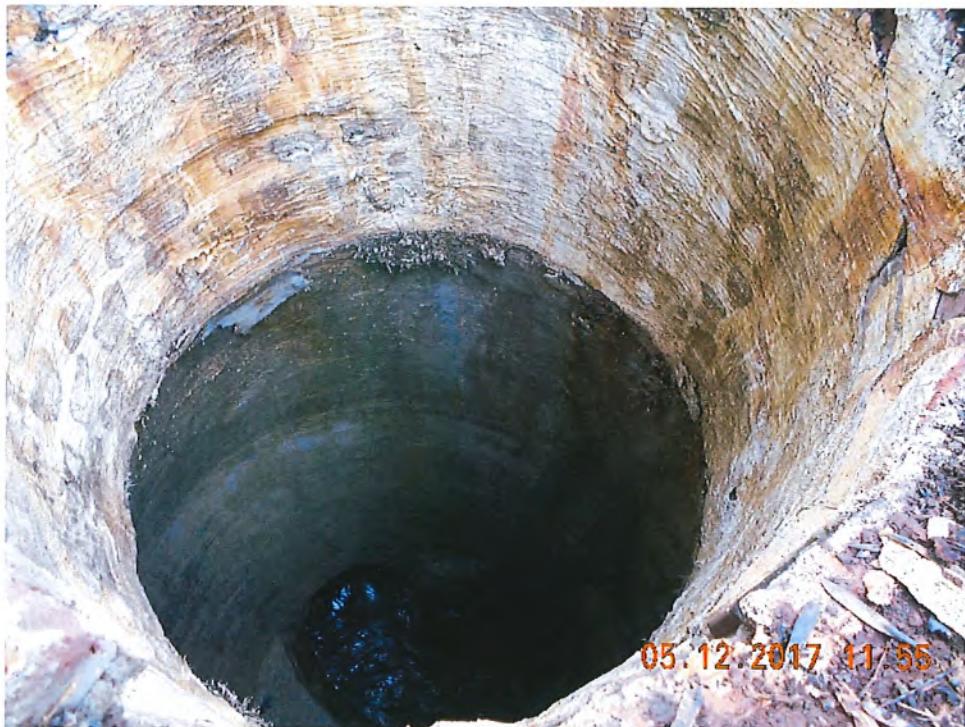
Location: X-country Rail trail ID No. 1508 1509

Observations	Material	Condition Rating	Notes
Frame/Cover:		2	Frame is cracked.
Corbel:		2	lined, peeling away
Cone/Slab Top		2	roots through liner at corbel joint
Walls		2	Previously lined
Invert/Shelf		2	Previously lined.
