**HAZARDOUS MATERIALS SURVEY  
COMMERCIAL BUILDING  
4 SOUTH BROADWAY  
SALEM, NEW HAMPSHIRE**

**January 2020**

**Project 19039**

January 9, 2020

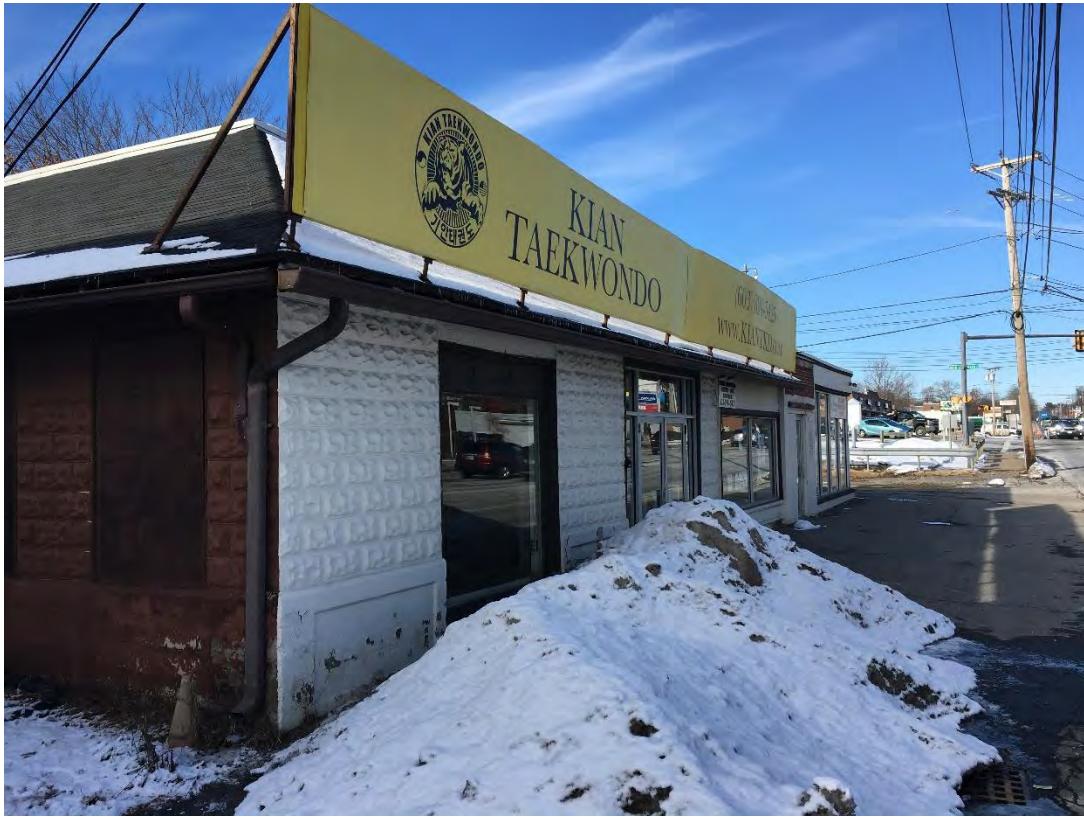
A view of the east side of the building facing northwest

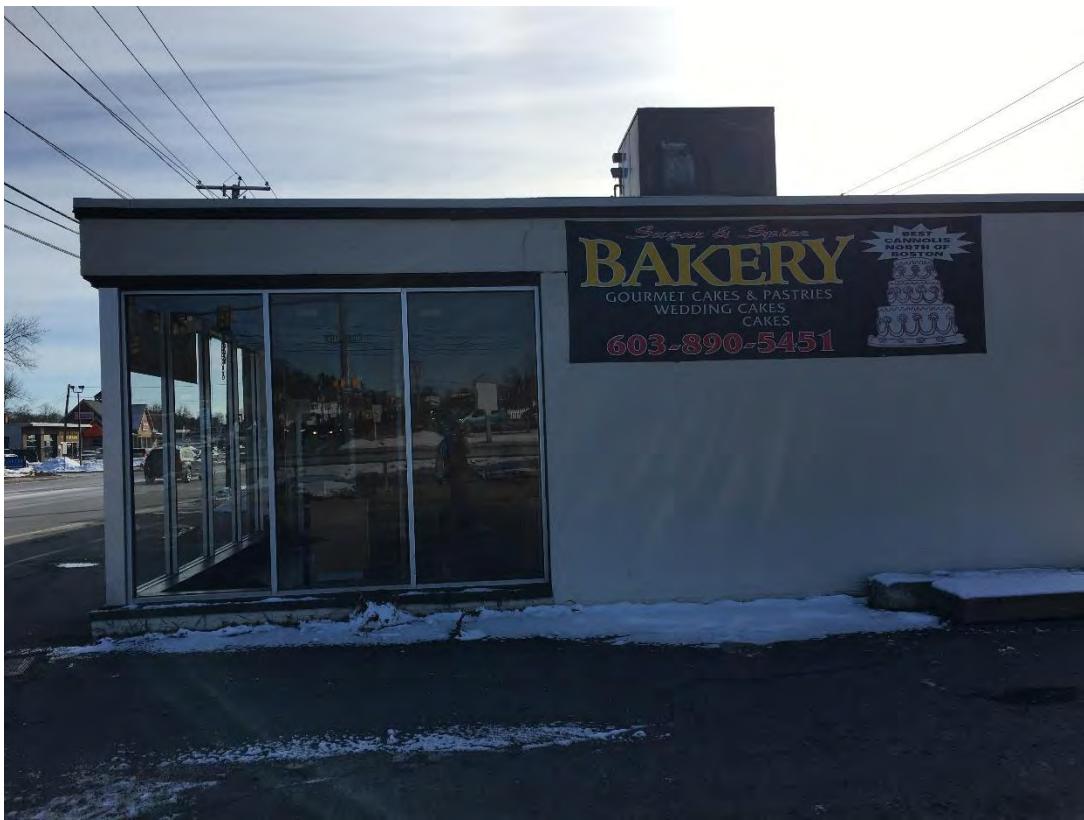
A view of the north side of the building, facing south.

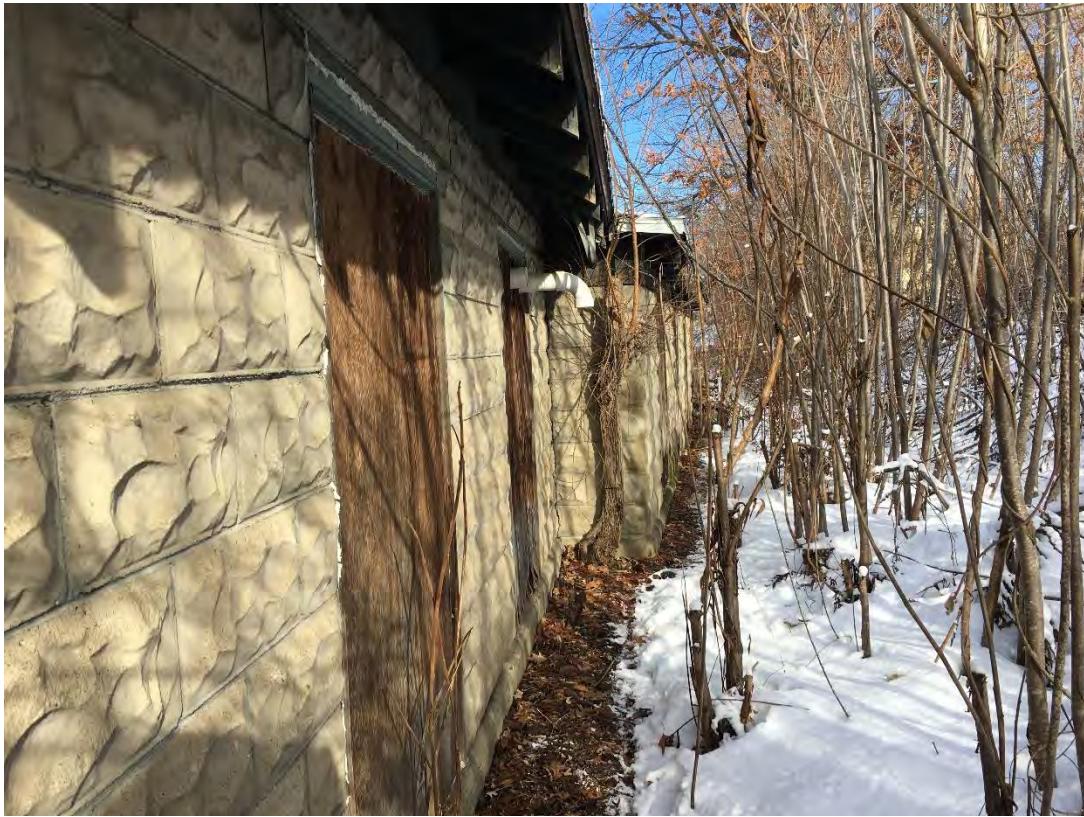
A view of the west side of the building, facing south

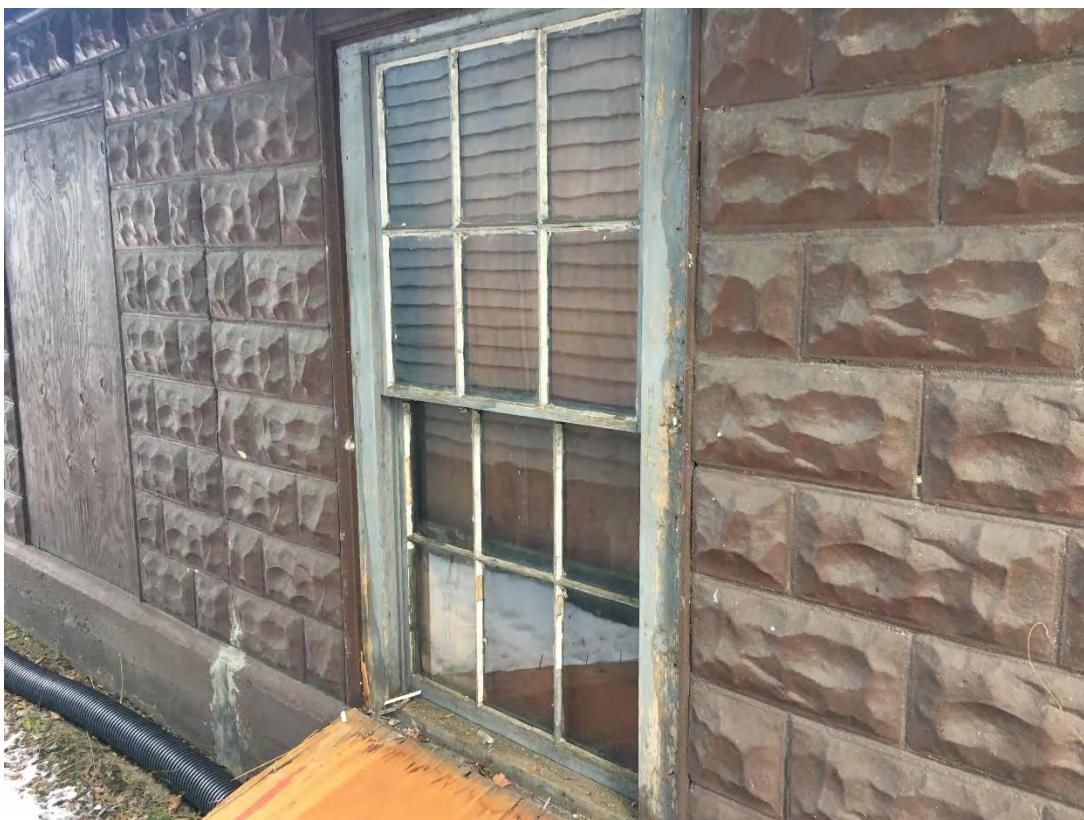
A view of the exterior windows, behind plywood

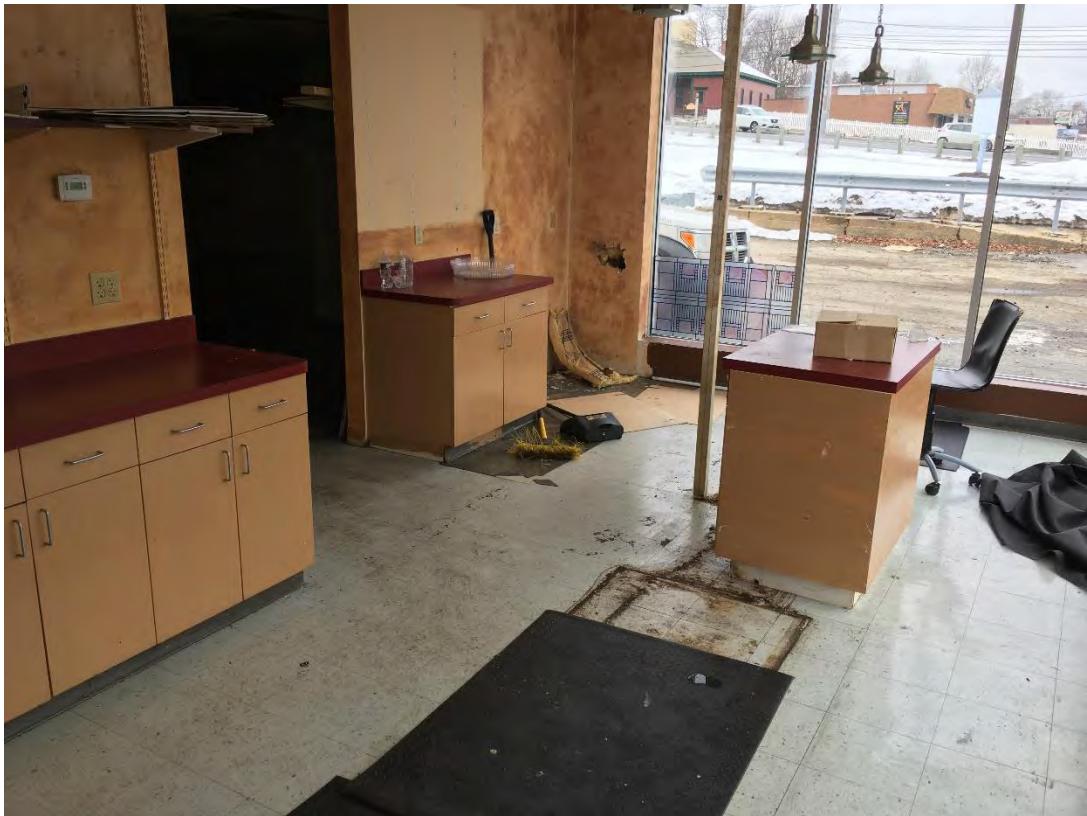
A view of the front area of Unit 4

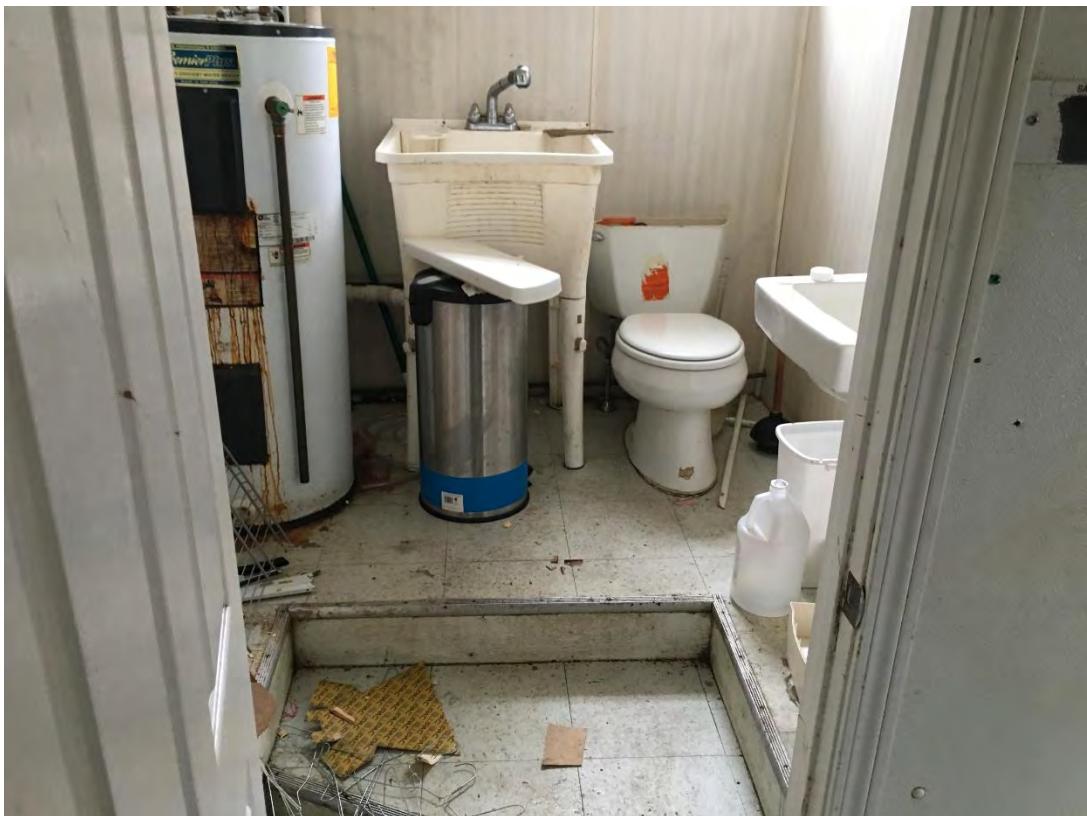
A view of the bath of Unit 4

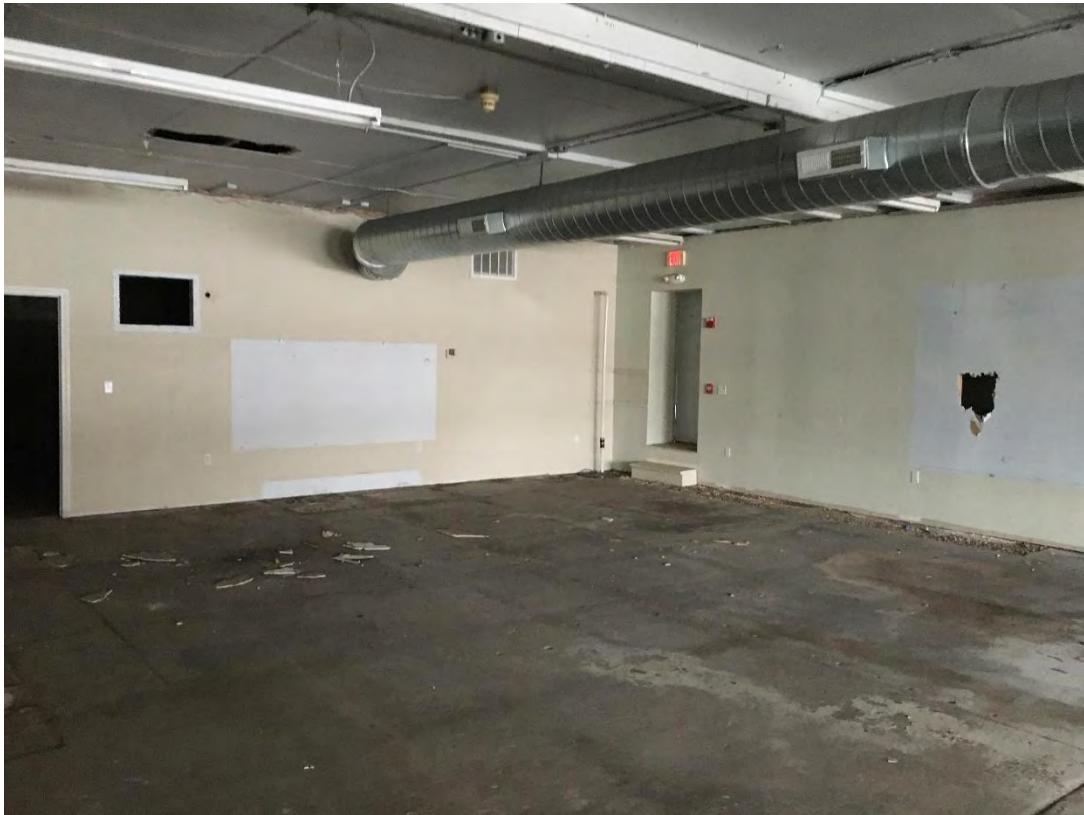
A view of the main area of Unit 6

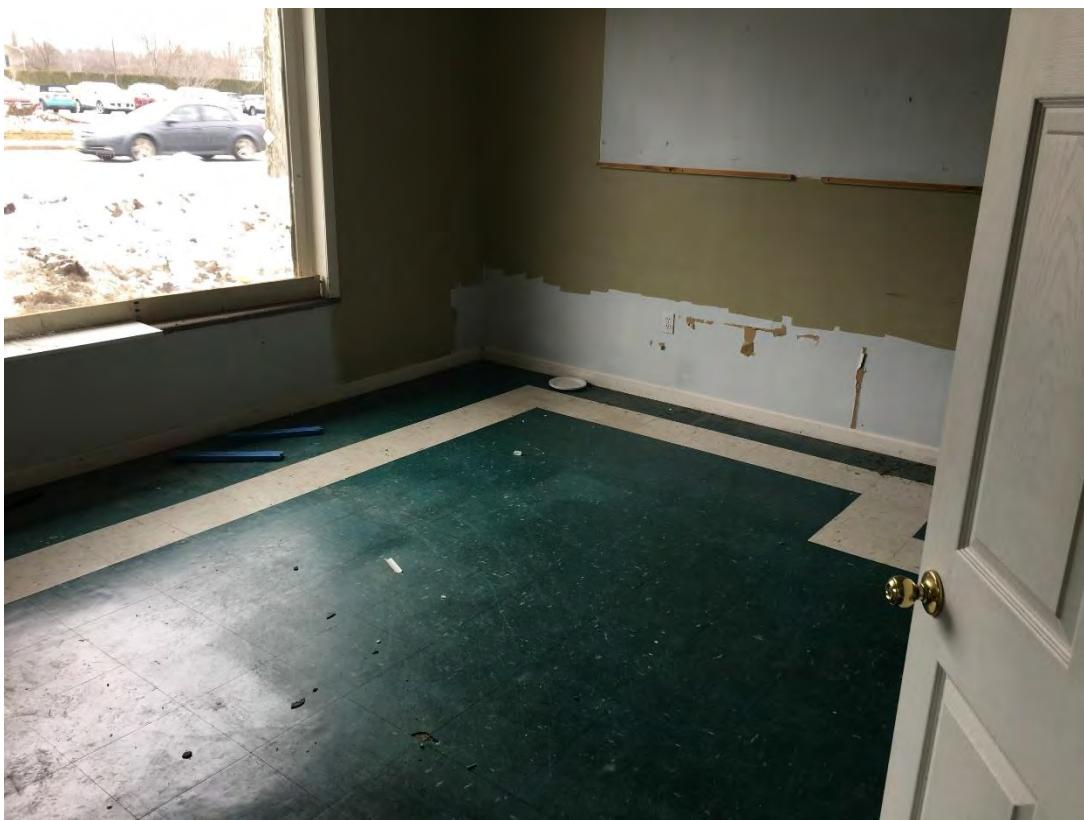
A view of Room 1 within Unit 6

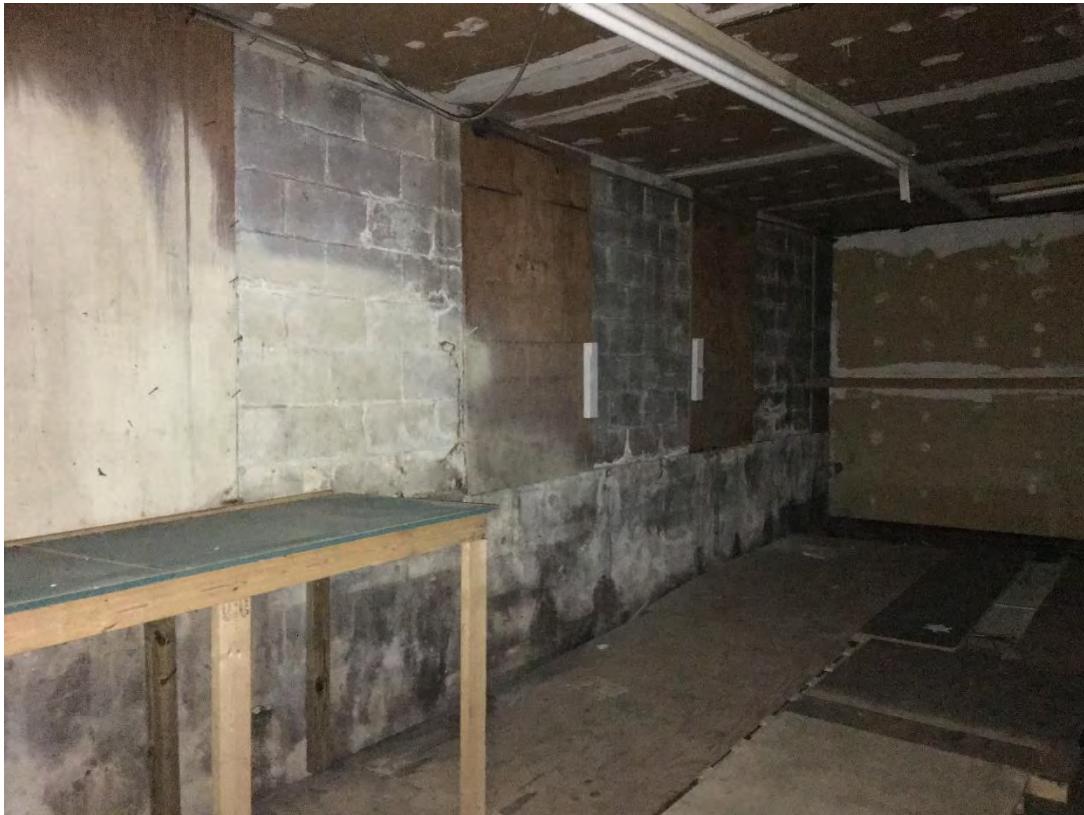
A view of the back area of Unit 6
