**HAZARDOUS MATERIALS SURVEY
COMMERCIAL BUILDING
14 SOUTH BROADWAY
SALEM, NEW HAMPSHIRE**

January 2020

Project 19039

January 9, 2020

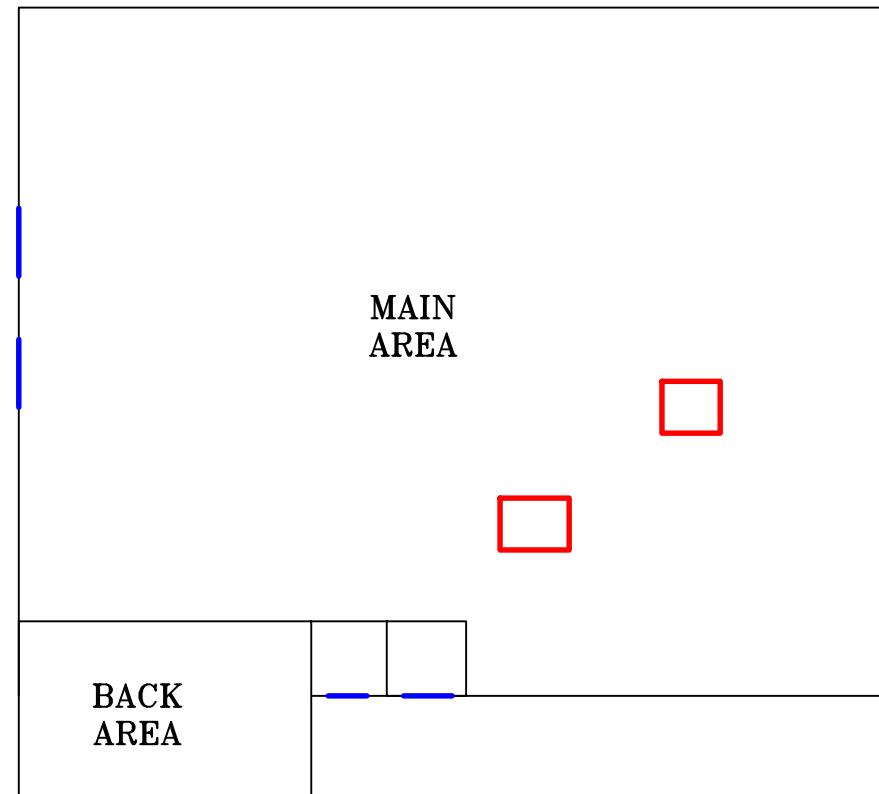
FIGURE: 1
PROJECT NO.: 19039
DATE: JANUARY 2020

APPROXIMATE LOCATION OF
ASBESTOS CONTAINING 9" TAN
FLOOR TILE

APPROXIMATE LOCATION OF
ASBESTOS CONTAINING
EXTERIOR WINDOW GLAZE

Asbestos was positively identified at the 14 South Broadway building, as summarized in **Section 2** and **Appendix E**. In accordance with NESHAP and NHDES regulations, all friable ACM, or materials made friable by demolition or renovation activities, must be removed from the building by a licensed asbestos abatement contractor, prior to demolition or renovation. Removal of ACM is regulated by NHDES. GREEN recommends the identified ACMs be removed from the buildings in accordance with applicable asbestos abatement regulations prior to the start of planned demolition activities. Asbestos abatement must be done by a New Hampshire licensed Asbestos Abatement Contractor and be properly disposed of offsite at an appropriate receiving facility in compliance with all applicable state and federal regulations. The New Hampshire asbestos regulations require visual inspection and clearance air monitoring at the completion of an asbestos abatement project. Additionally, full-time monitoring of asbestos abatement procedures in compliance with design specifications and regulations is recommended during major asbestos abatement projects.
