**Owner's Project Manager
Request for Qualifications (RFQ 2021-011)
Town of Salem**

RFQ 2021-011 OWNER'S PROJECT MANAGER

On Wednesday, June 21, 2017, The H.L. Turner Group Inc. (TTG) visited the site of the Salem Town Offices at 33 Geremonty Drive in Salem, NH, to perform a facility assessment of the building and surrounding site. The purpose of this assessment was to identify any existing deficiencies in the building or site that the Town should plan to address. The report is divided into four main sections. The first section gives an overview of the architectural features of the building including the exterior façade, roof, and interior finishes. The second and third sections address the major electrical and mechanical equipment, and associated deficiencies respectively. The final section is an in-depth discussion of the surrounding site, including drainage issues.

PROJECT NO. 4529 ~ SALEM TOWN OFFICE BUILDING - FACILITY ASSESSMENT

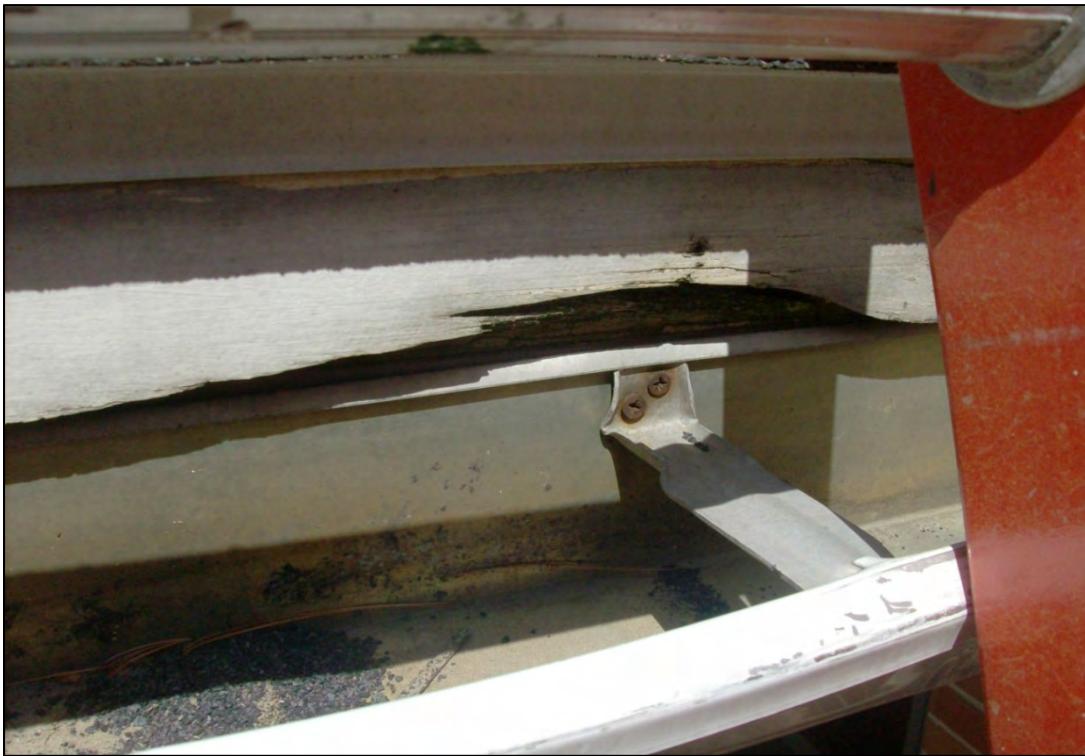
Rotted fascia board on east side.

- Scrape and paint the wood fascia, rake board, cornice, trim and soffits. Replace wood that has rotted.
- Remove the old abandoned air handling units in the attic space. Properly insulate the area occupied by the units.

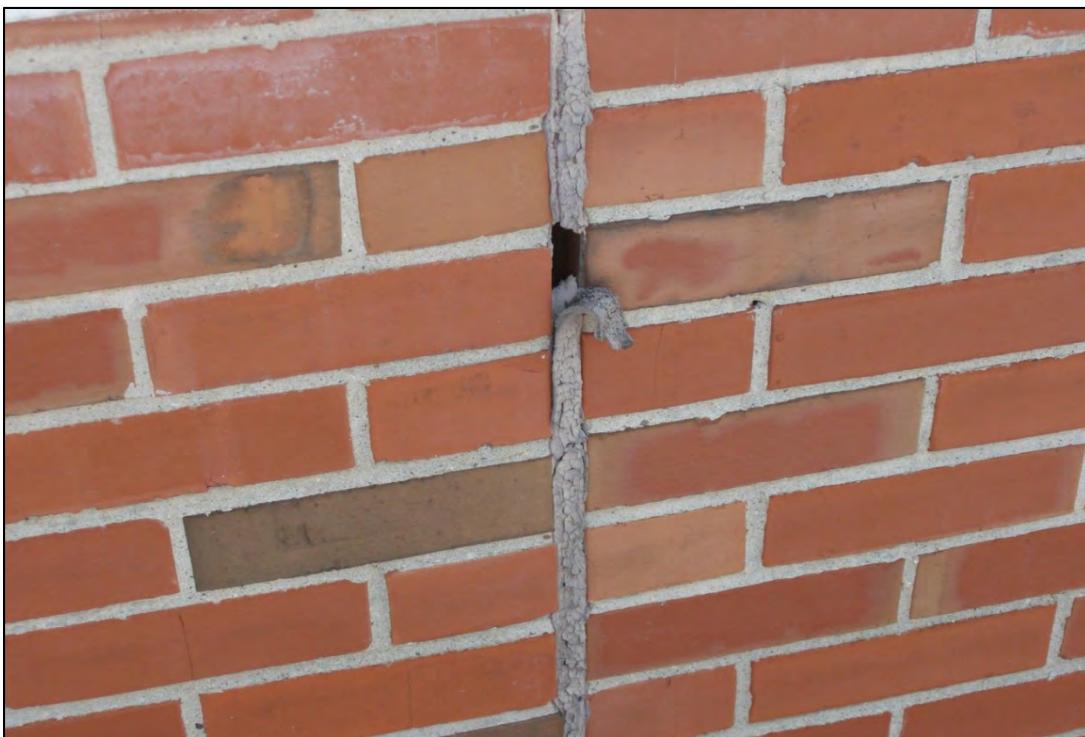
Deteriorated and failed control joint sealant.

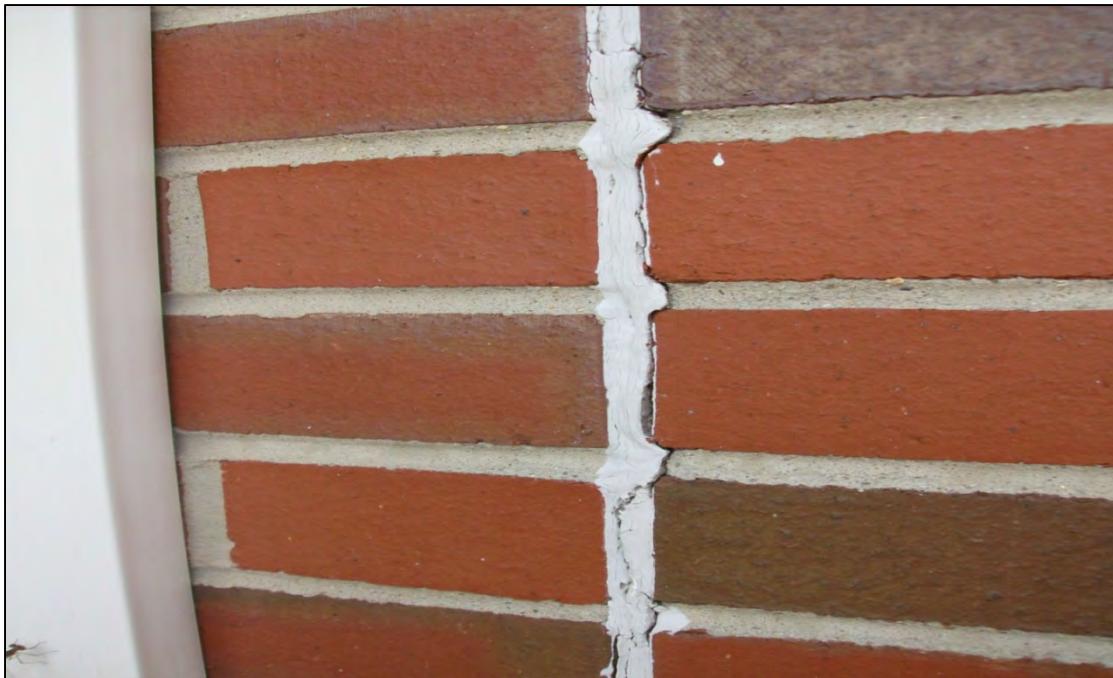
Failed control joint sealant.

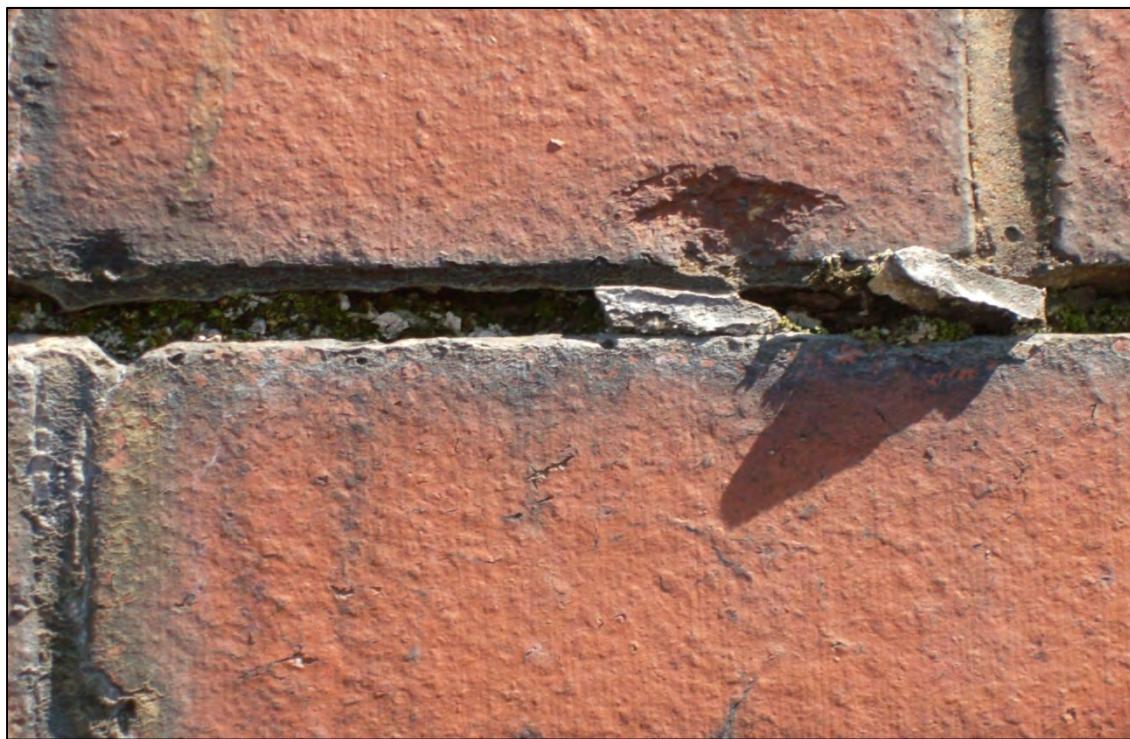
The cupola has some rotted sections of wood trim, and in general, the entire cupola needs scraping and painting. The brick chimney which extends up through the roof has loose mortar joints and needs repointing in several areas.

Repointing needed at brick chimney.

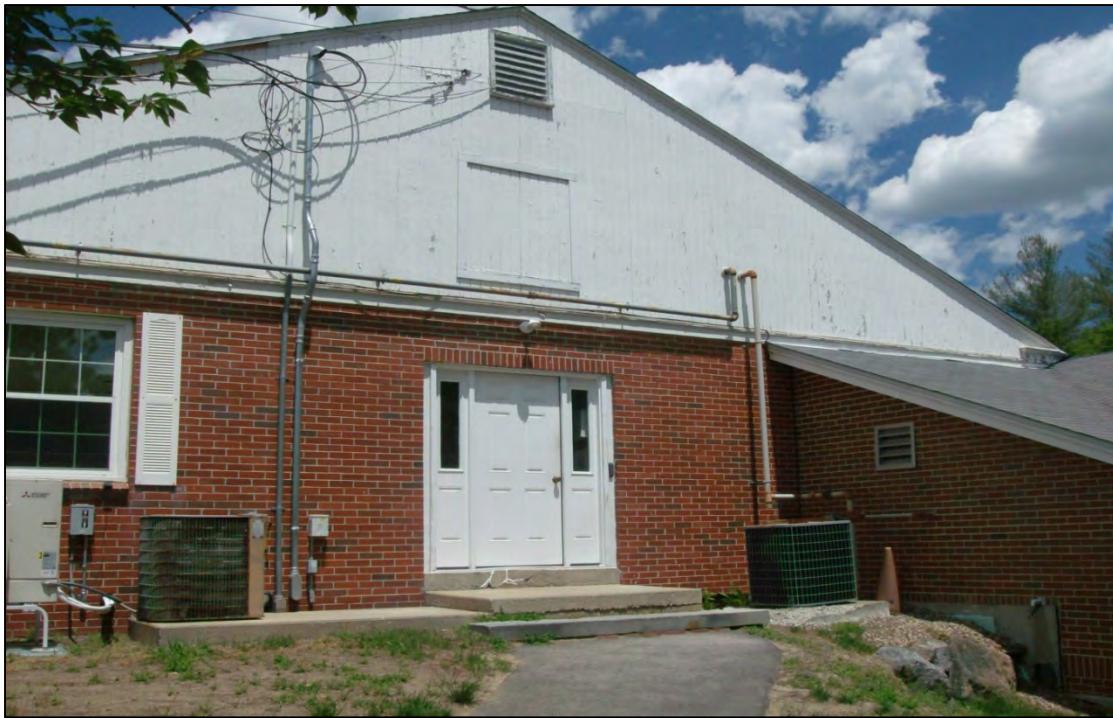
Peeling paint on gable end. Also note deteriorated compressor pad and cracked door sill.

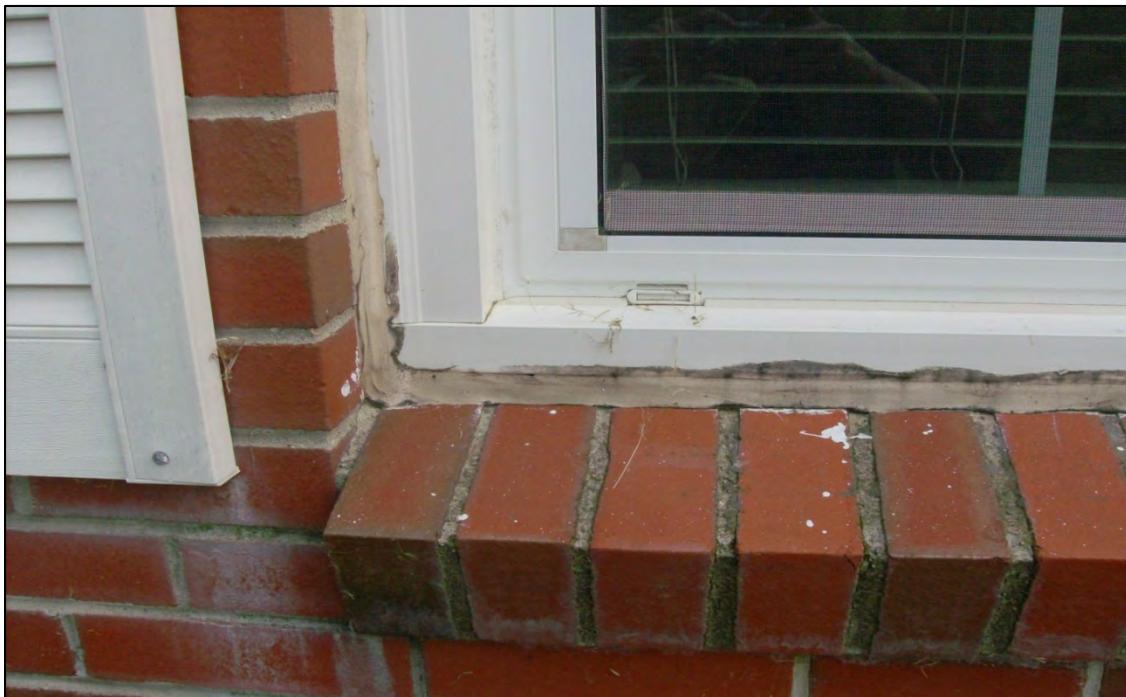
Sealant around window needs replacement.

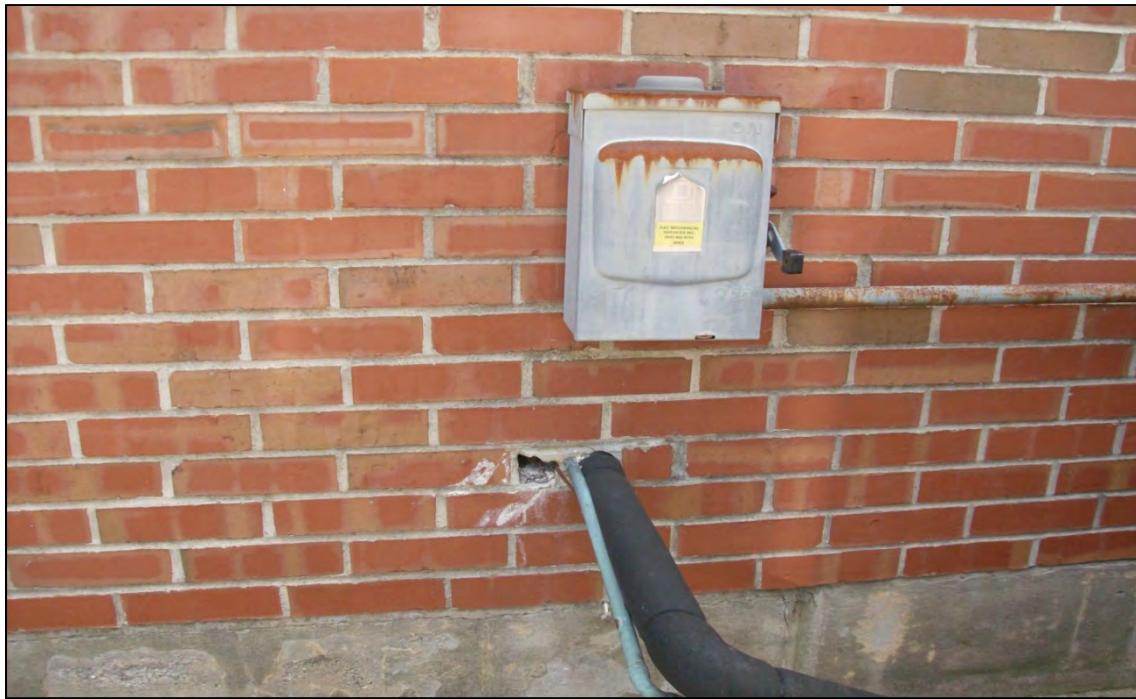
Open hole in brick face allows air and moisture infiltration, as well as access for insects and rodents.

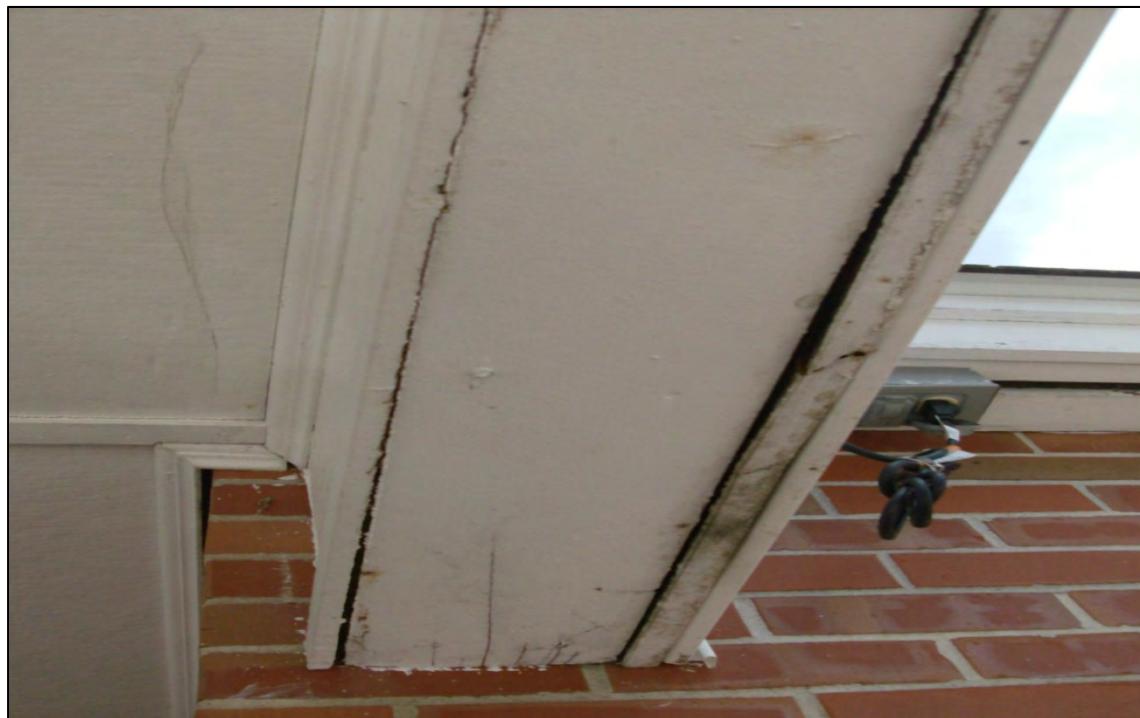
There are four canopy roofs over most of the entry doors around the building. At the east entry from the parking lot to the lower level, the canopy roof fascia, beam enclosure, and soffit are separating, and need repair and or replacement, and the entire canopy needs repainting.

East side beam enclosure is separating at canopy and there is some rot starting.

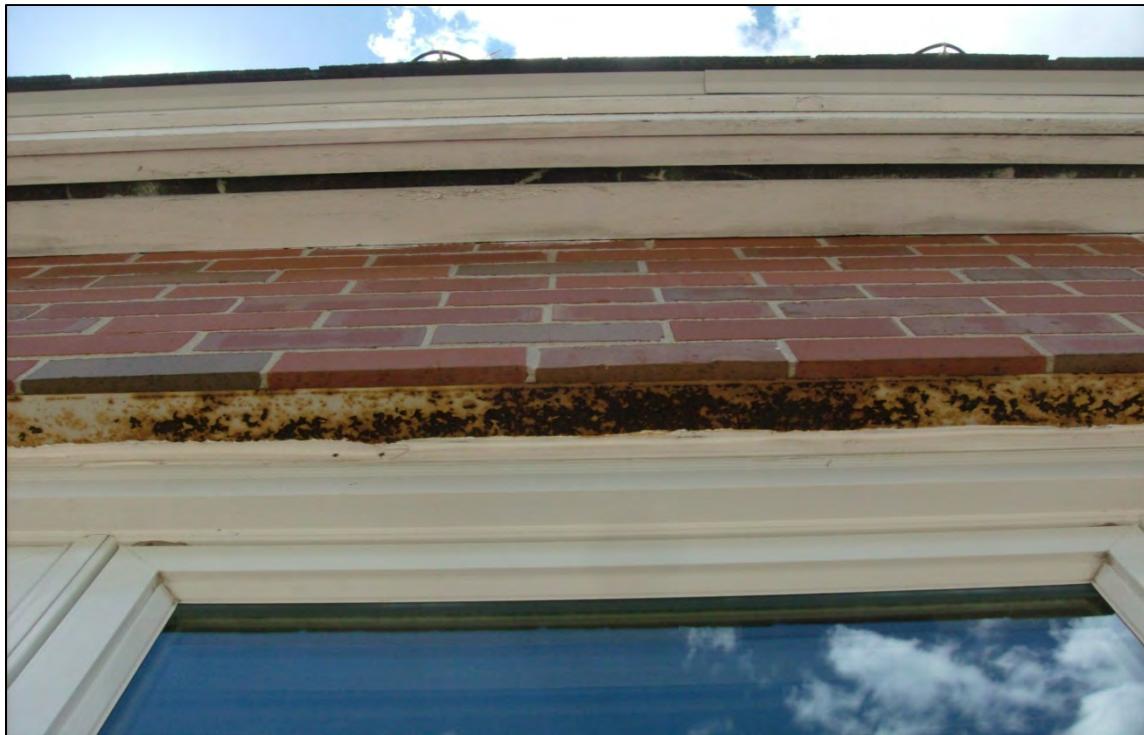
Typical condition of rust on lintels over windows.

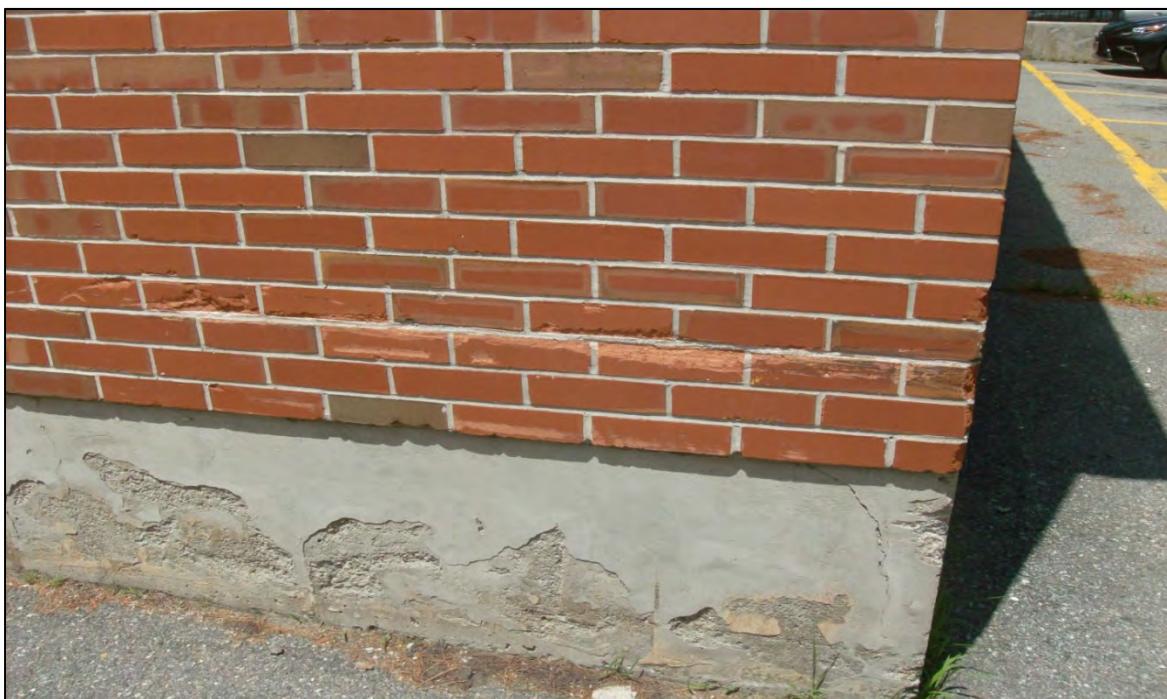
The brick veneer is in good condition. The veneer has been damaged at the southeast corner adjacent to the accessible parking space, presumably from snow plows. The exposed portion of the concrete foundation at the southeast corner of the first addition is cracking and is in need of repair. Similar cracking was observed at the southwest corner of the DMV addition. It should also be repaired.

Damaged and cracked concrete and damaged brick at southeast corner.

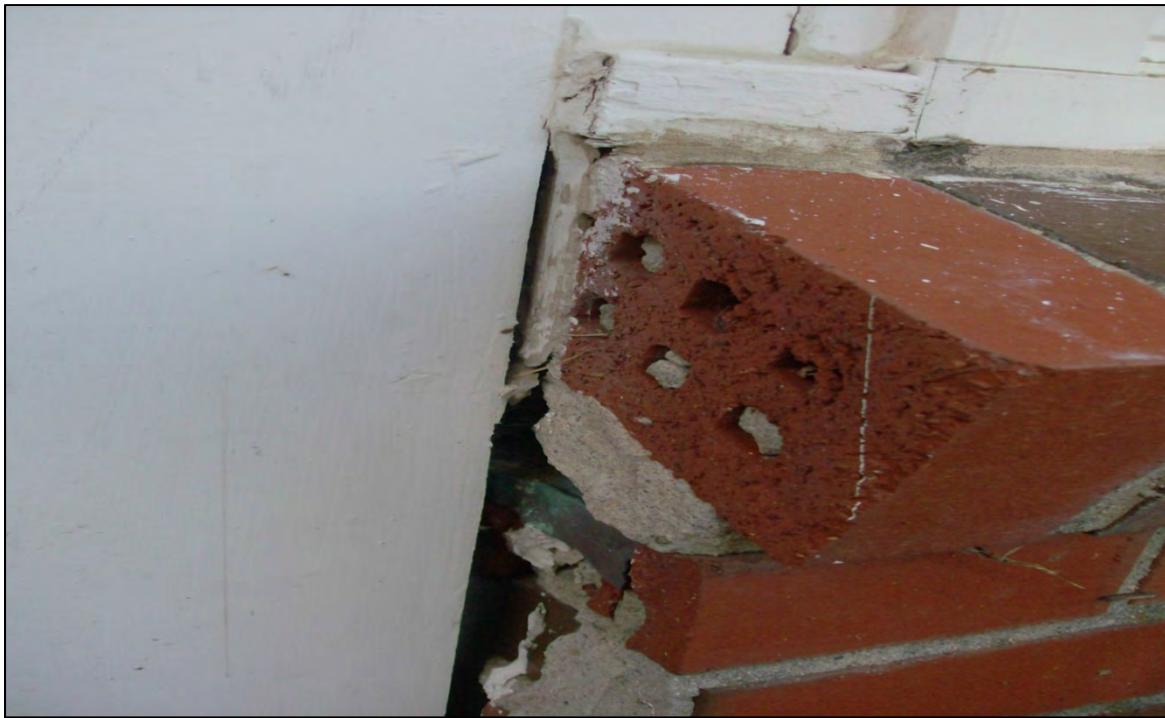
On the east side of the building at the exterior door that exits from the finance department, we observed exposed brick cores at the cut end. In addition, we noted the brick veneer below the sloped brick sill where the window was removed for a new door is unfinished on both sides of the door, and thus the inner wall cavity is exposed.

Doorway cut into wall at finance department left large gaps between trim and brick façade.

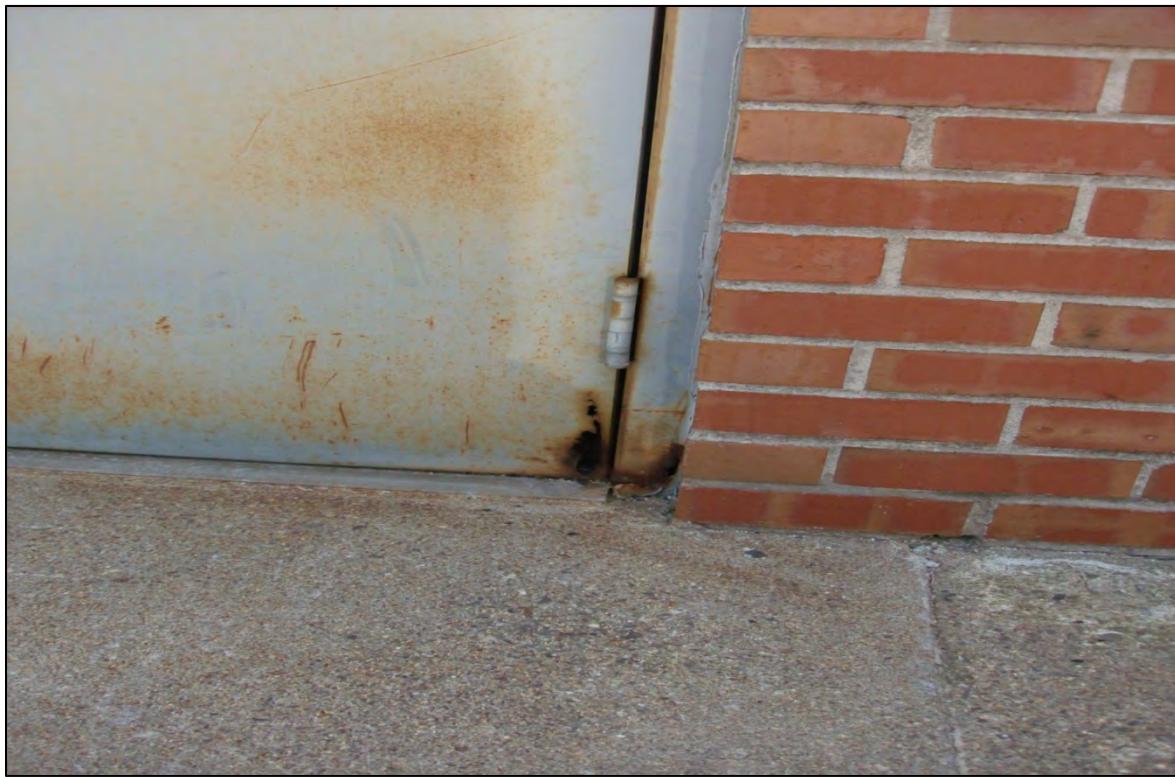
The exterior doors on the original 1967 building are insulated, hollow metal doors, with insulated vision panels. At the east and south entrances, the exterior doors are made of aluminum. These doors appear to be in good condition. The door into the mechanical room at the northeast corner (at the stair tower) is rusted and should be replaced.

Rusted door and frame at mechanical room at northeast corner.

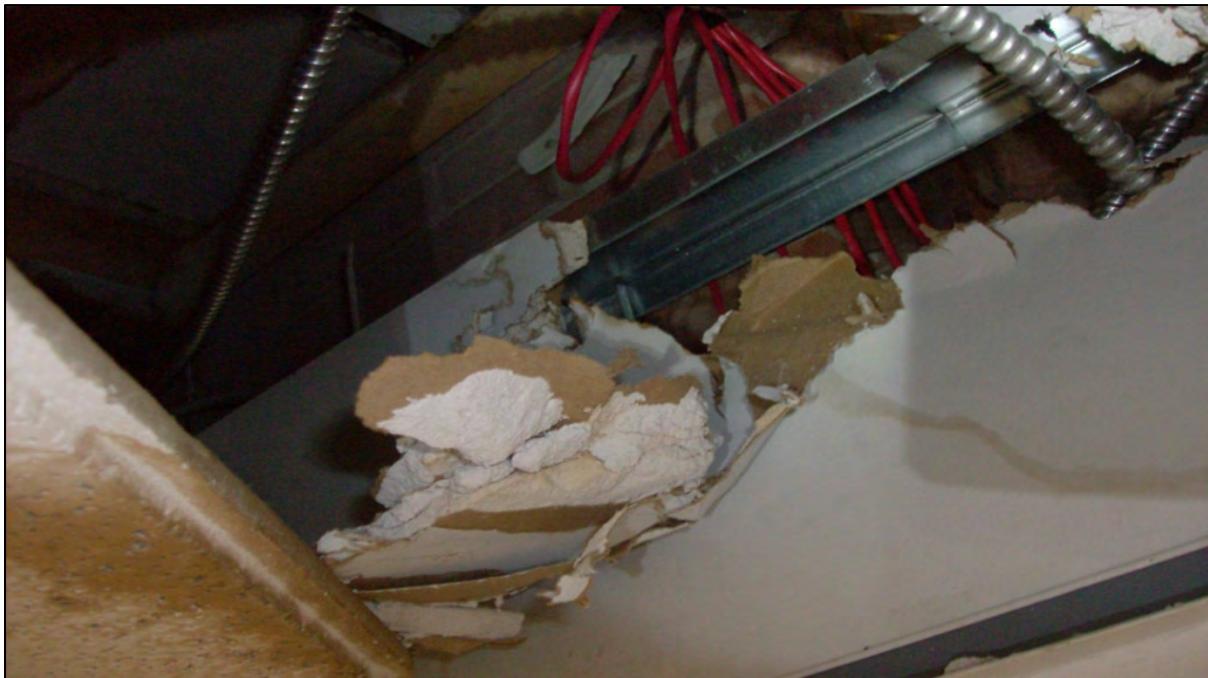
Damage to gypsum above suspended ceiling in community development area from water damage.

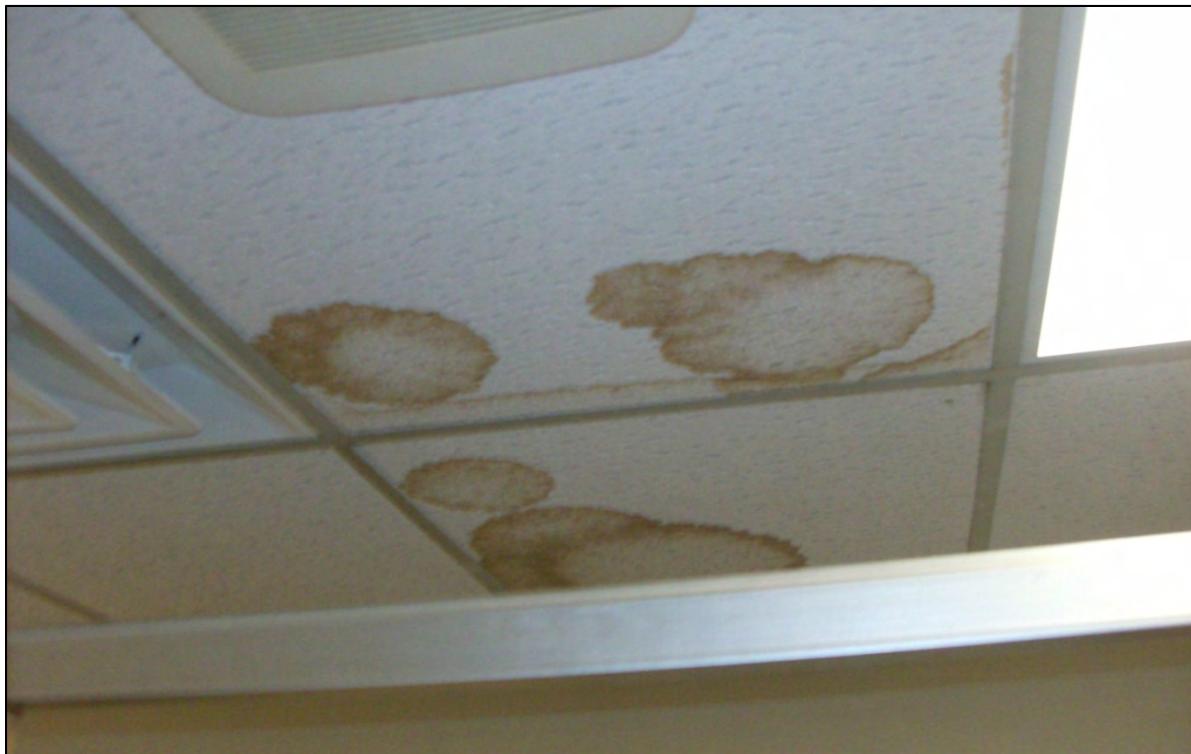
Stained ceiling tiles typical throughout building from pipe and/or roof leaks.

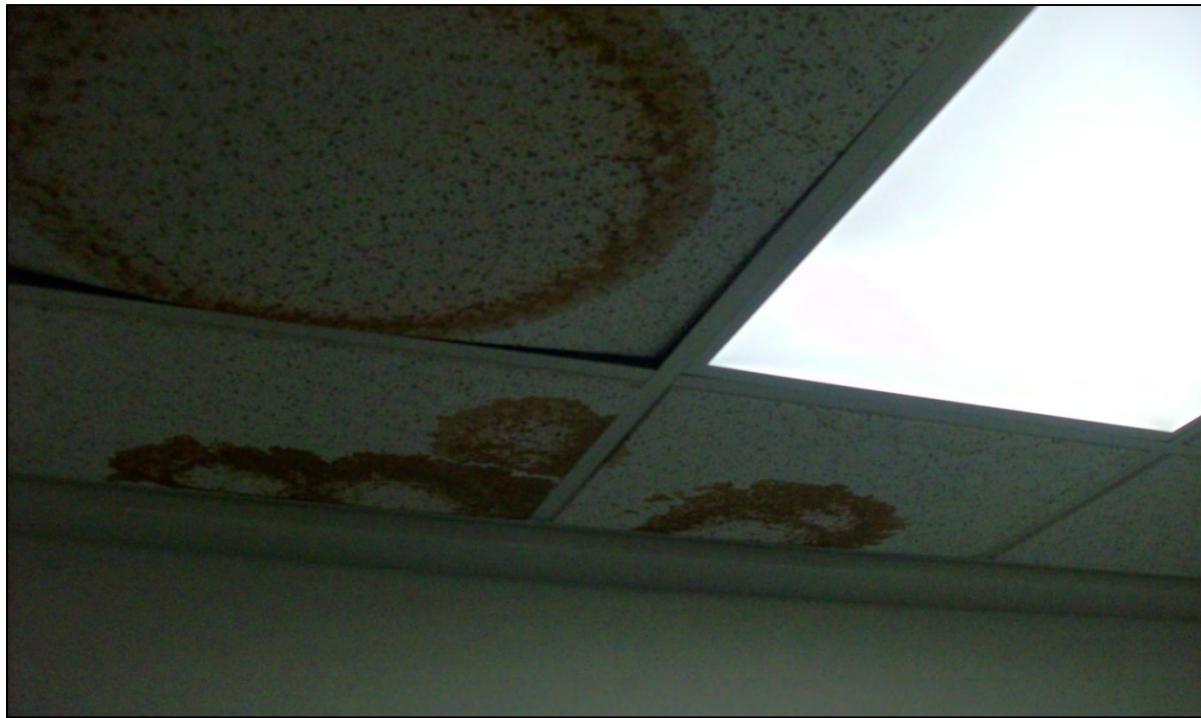
Stained ceiling tiles in bathroom from roof leaks.

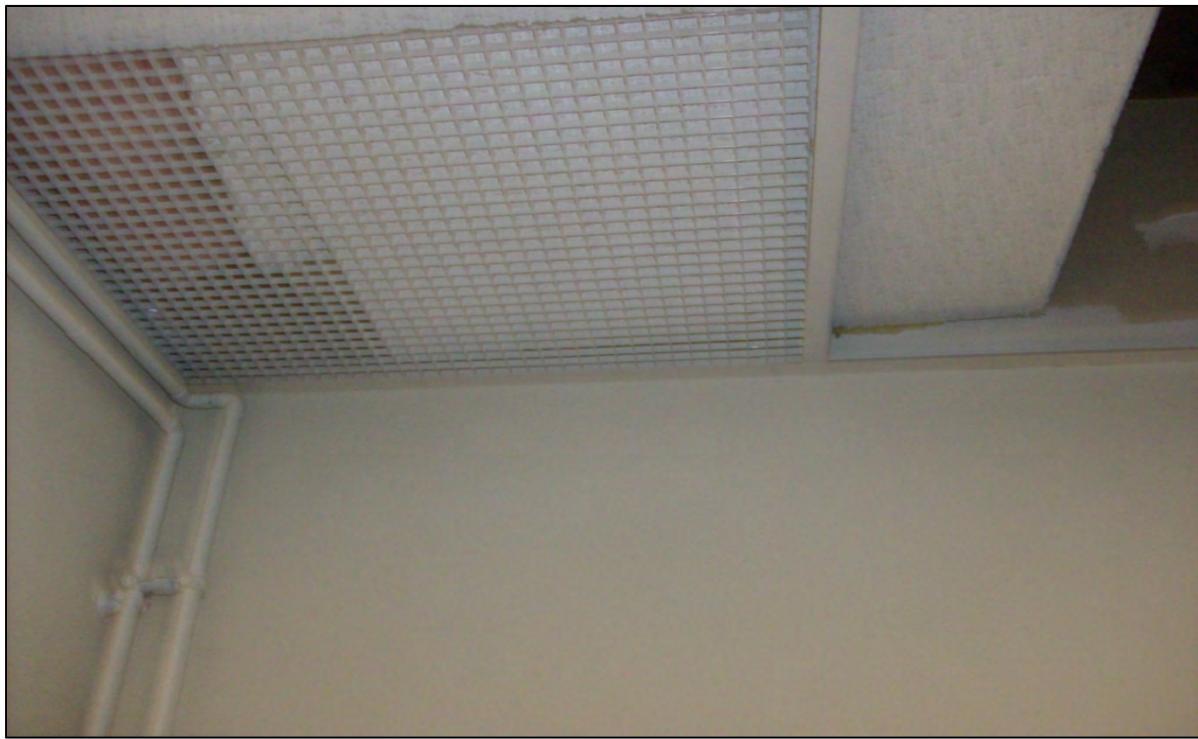
Open ceiling grate in east side bathroom to let warm air above ceiling so pipes don't freeze.

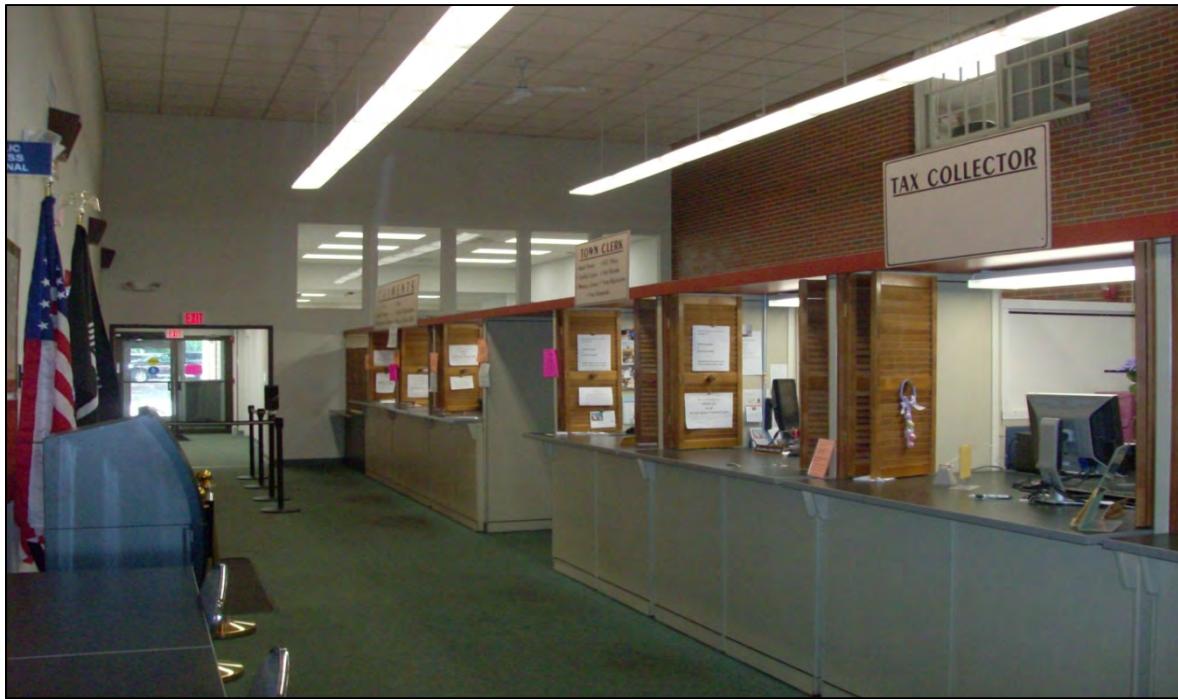
Counter area for serving the local residents. Note worn out carpet.

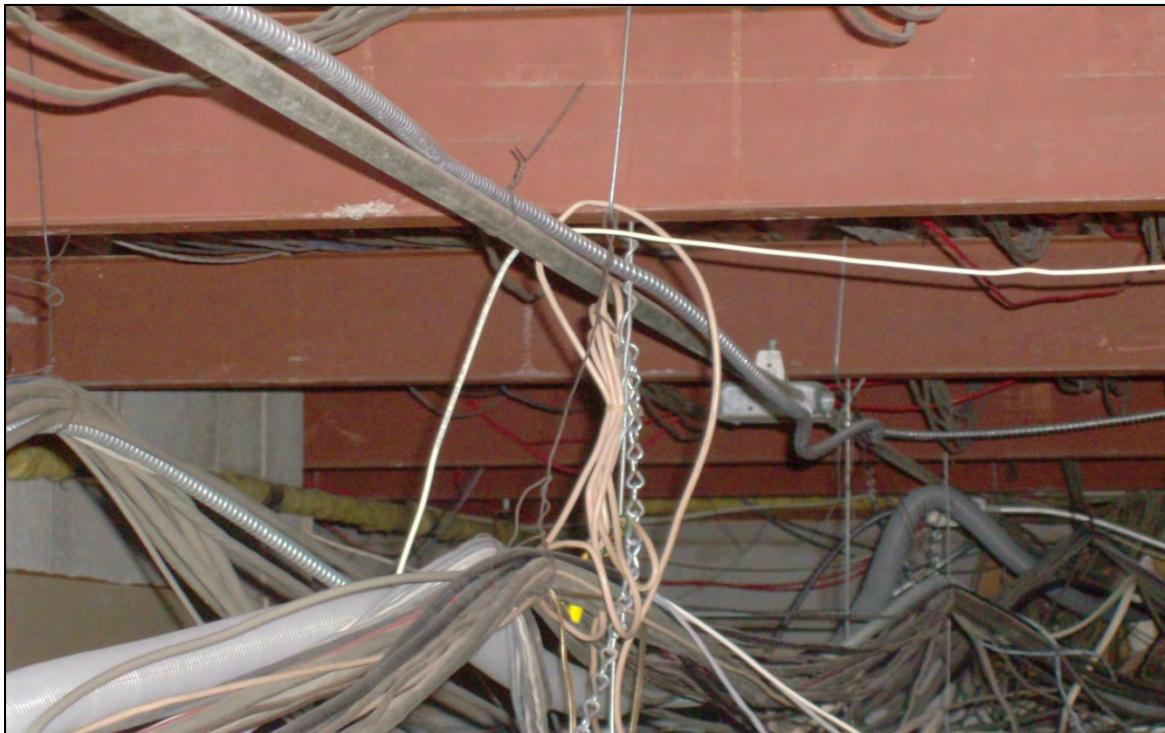
Tangle of wiring and communication cables over corridor ceiling. Many cables are no longer used.

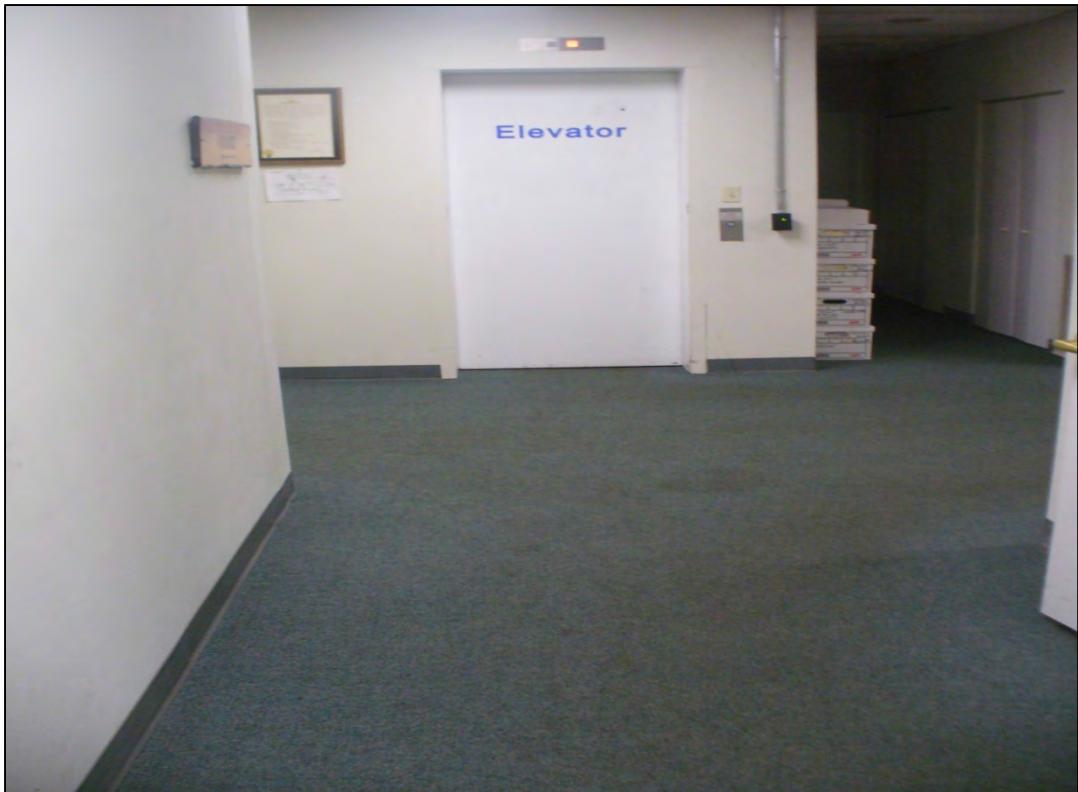
Worn out carpeting is typical throughout.

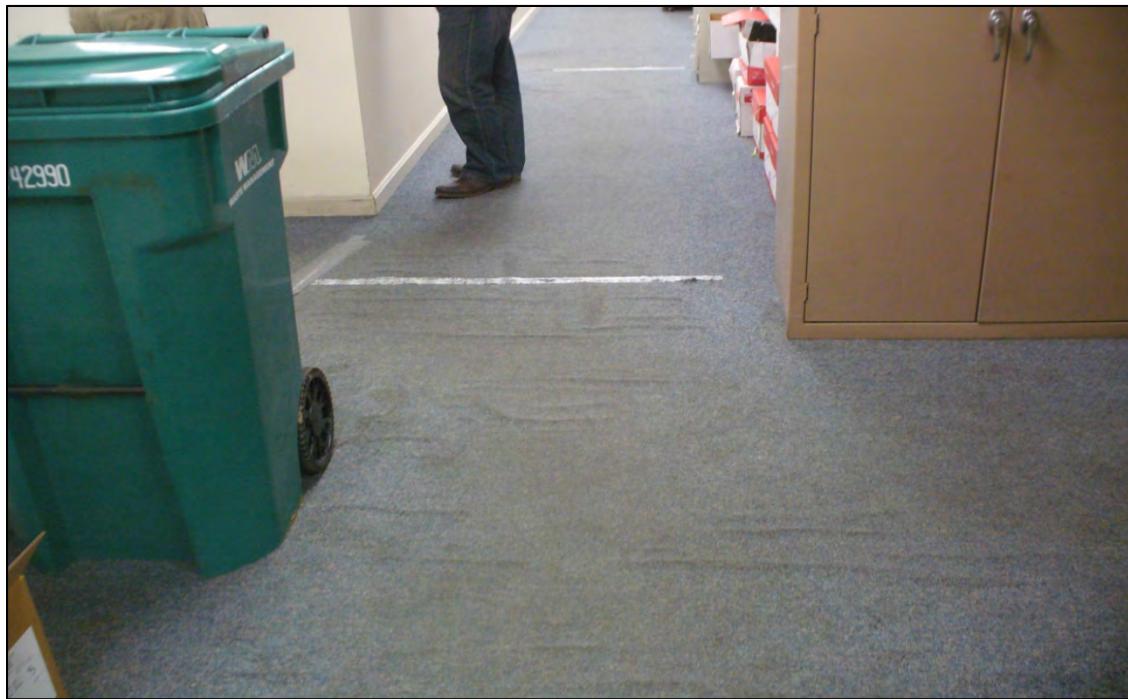
Tears, bulges, and wear on carpets.

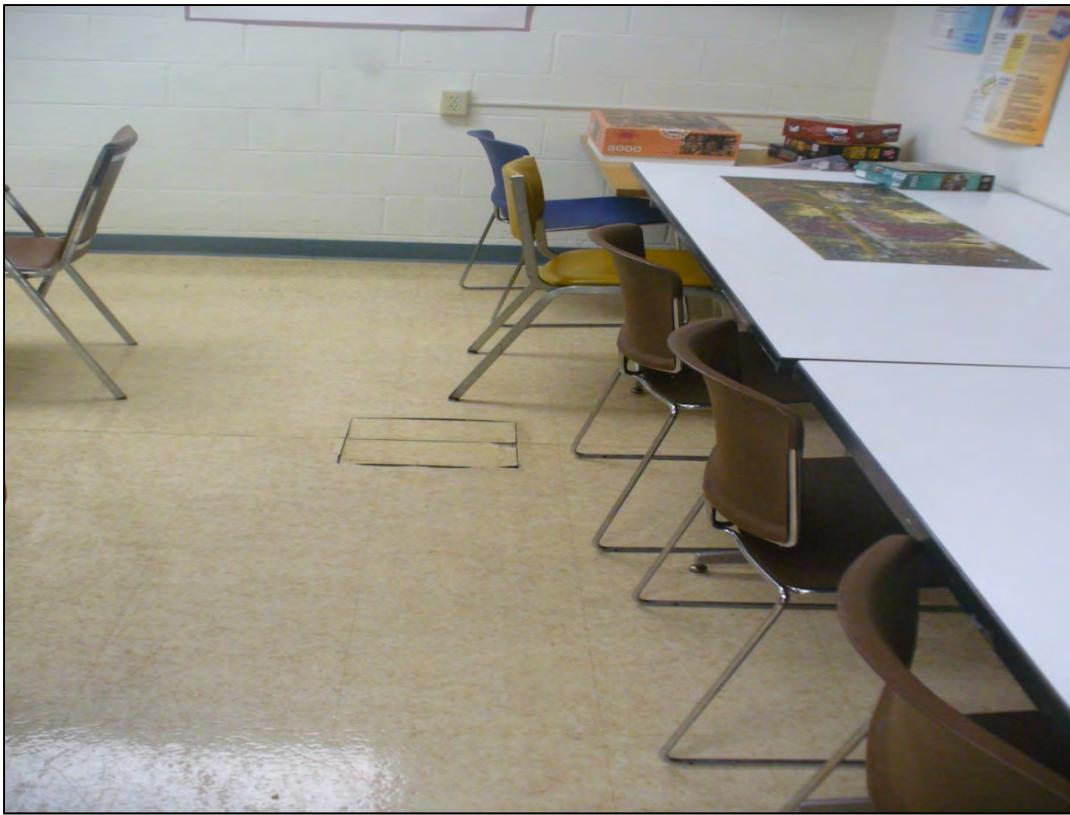
Sheet vinyl in break room needs replacement.

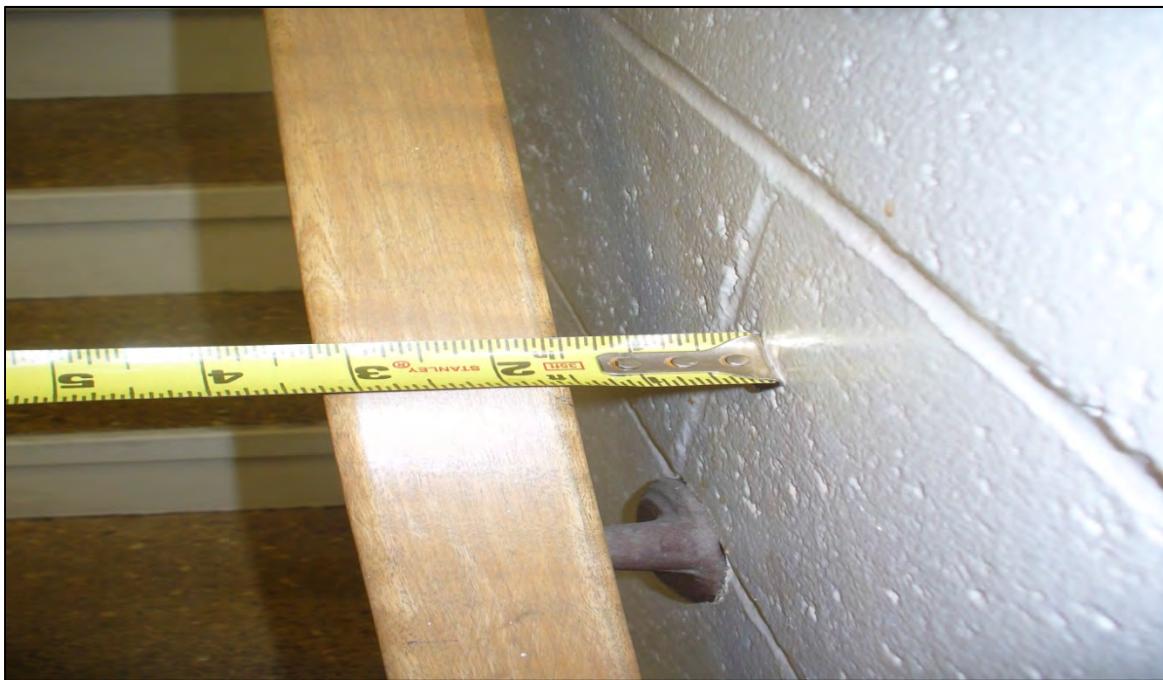
Non-compliant stair rail on communication stair between upper and lower levels.

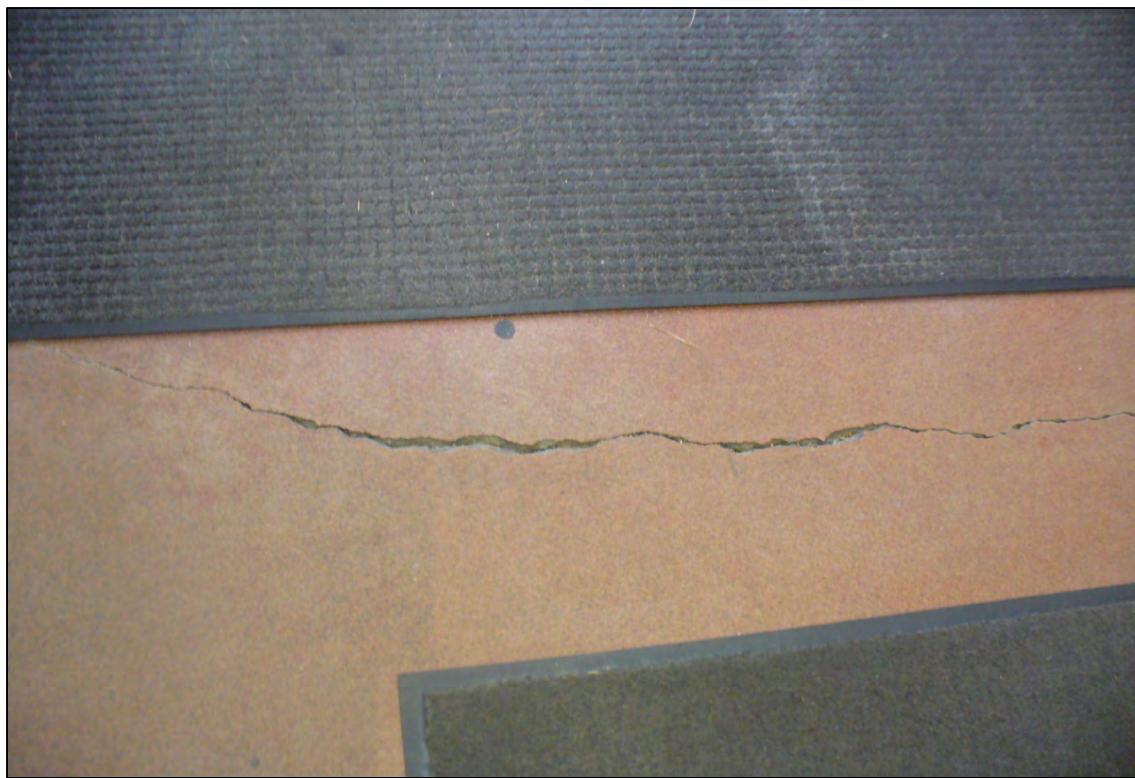
Floor cracks in concrete at vestibule on east entry at lower level.

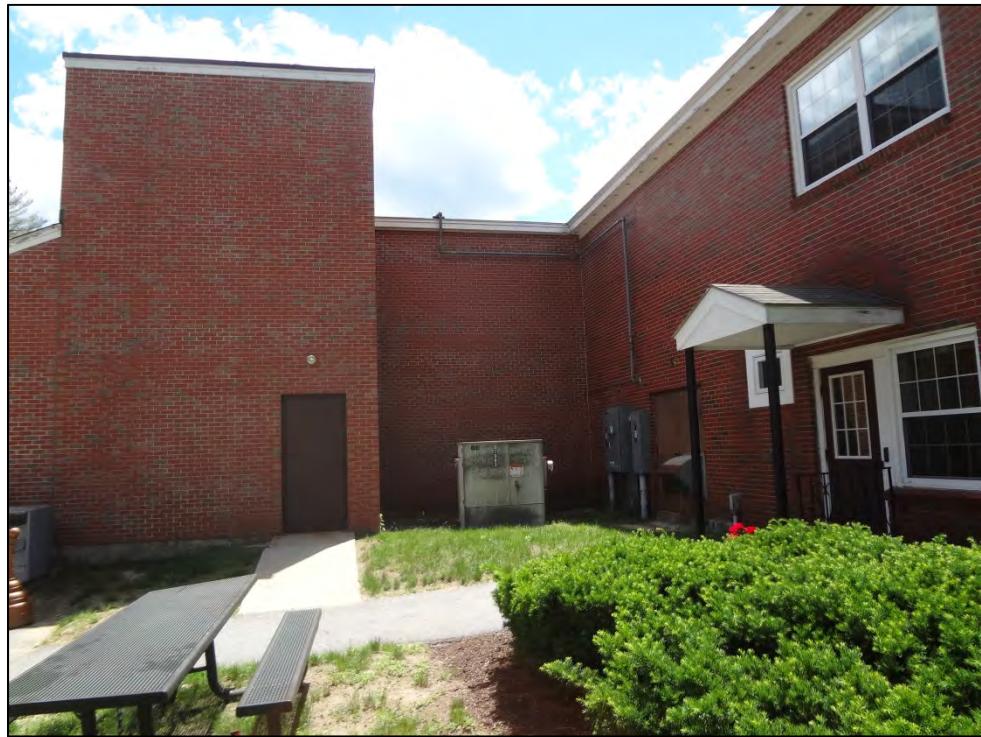
Ice dams at the northeast side of the building in the back, over the boiler room, and over the area where the main transformer is located, are particularly bad. It is not unusual that crews are called in every winter to chop ice to break-up the ice dams. The natural gas pipe that feeds the boiler room runs across the roof and down the wall in this same area. Reportedly the pipe often gets encased in ice as well. This is a definite safety issue and should be of highest priority to rectify this situation since the pipe could become broken and/or dislodged due to ice encasing it, or from ice chunks breaking loose and falling against the gas line.

Gas line on side of building prone to ice damage.
Ladder location potential.

- Relocate the natural gas line that runs across the roof, down the wall, and enters the boiler room such that it is not susceptible to damage from ice build-up. If the gas line cannot be relocated, there are several improvements that can be made. For example, provide more supports across the flat roof, as the current supports appear inadequate. Protect the gas pipe in a heavy walled half pipe enclosure, both on the roof and as it goes over the roof edge, and down the wall into the boiler room.

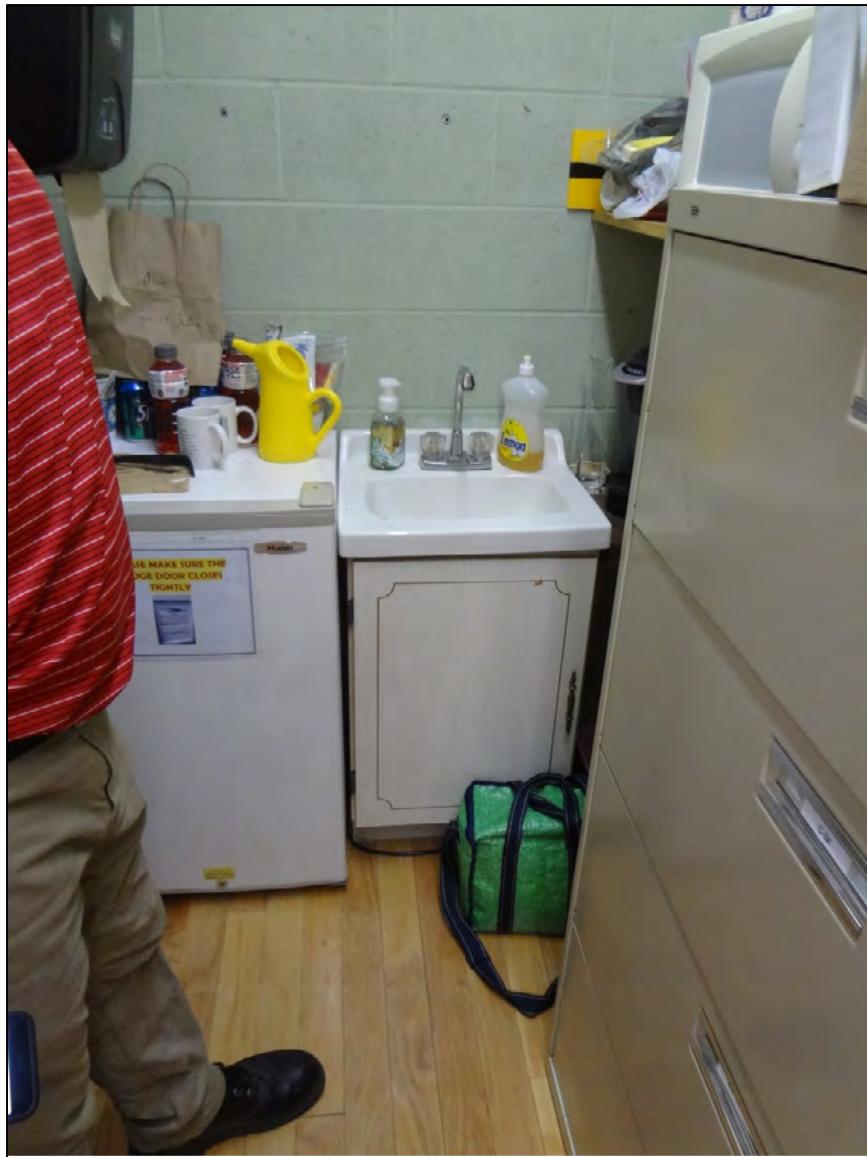
Office sink not ADA.

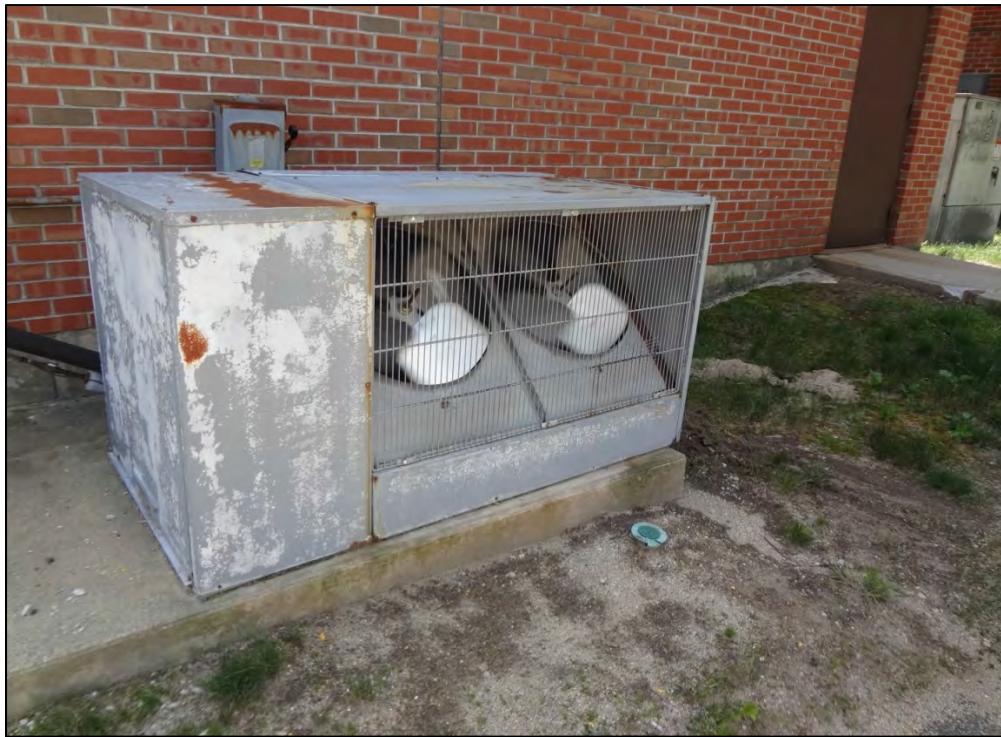
Older cooling unit in need of replacement.
