**Owner's Project Manager
Request for Qualifications (RFQ 2021-011)
Town of Salem**

RFQ 2021-011 OWNER'S PROJECT MANAGER

On Wednesday, June 21, 2017, The H.L. Turner Group Inc. (TTG) visited the site of the Salem Town Offices at 33 Geremonty Drive in Salem, NH, to perform a facility assessment of the building and surrounding site. The purpose of this assessment was to identify any existing deficiencies in the building or site that the Town should plan to address. The report is divided into four main sections. The first section gives an overview of the architectural features of the building including the exterior façade, roof, and interior finishes. The second and third sections address the major electrical and mechanical equipment, and associated deficiencies respectively. The final section is an in-depth discussion of the surrounding site, including drainage issues.

PROJECT NO. 4529 ~ SALEM TOWN OFFICE BUILDING - FACILITY ASSESSMENT

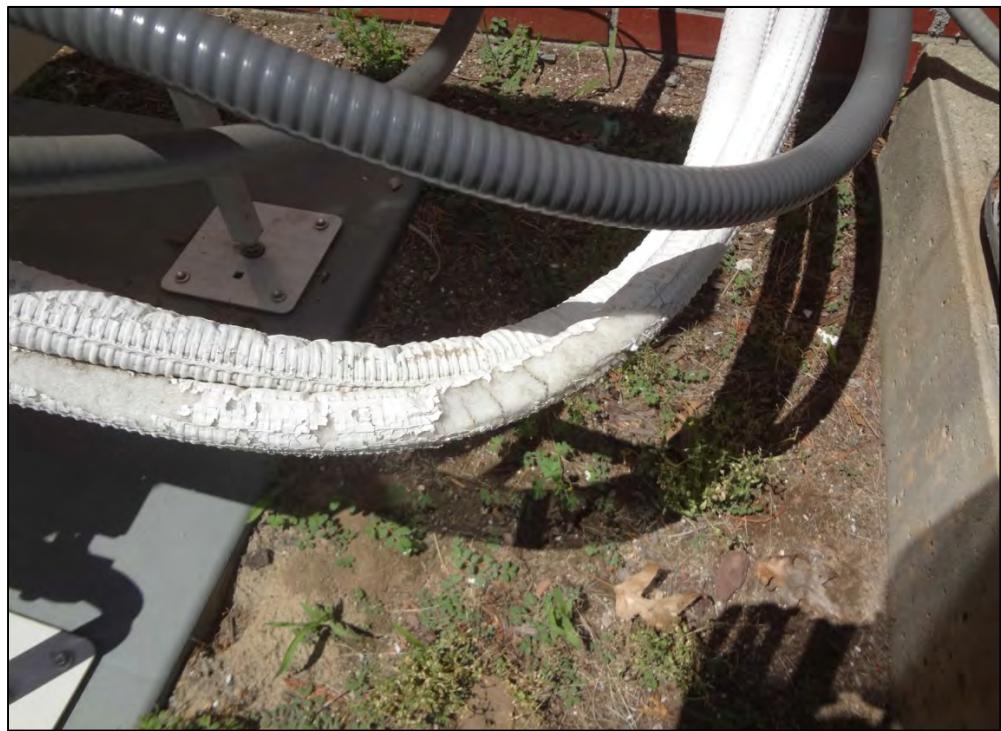
Insulation on cooling lines needing replacement.

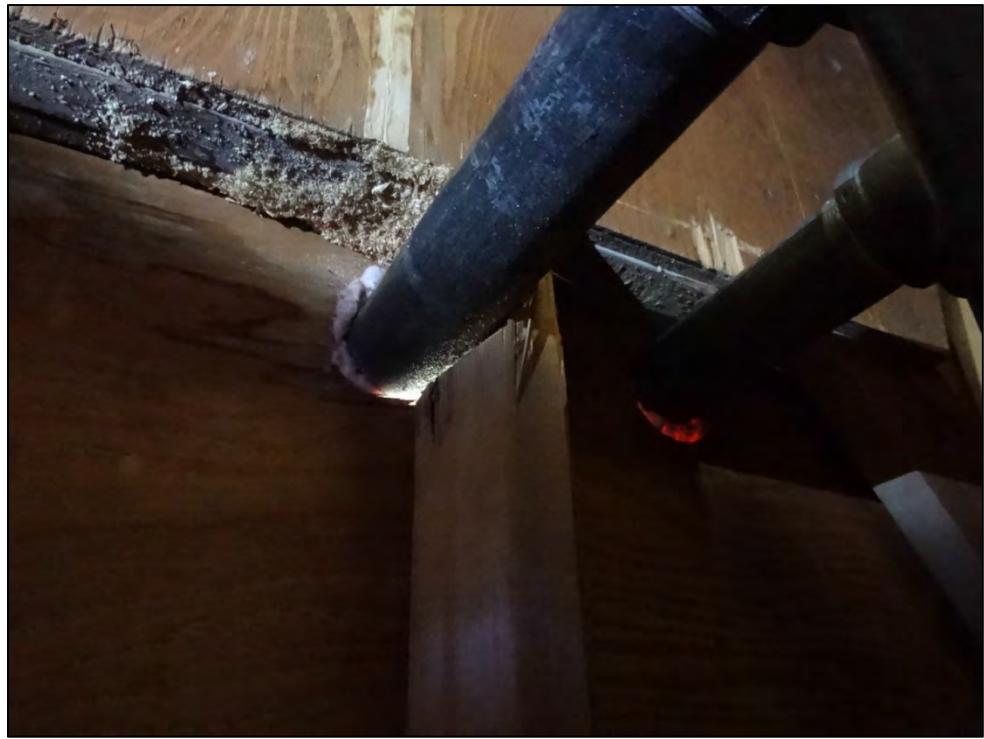
Gas line penetration through gable end.

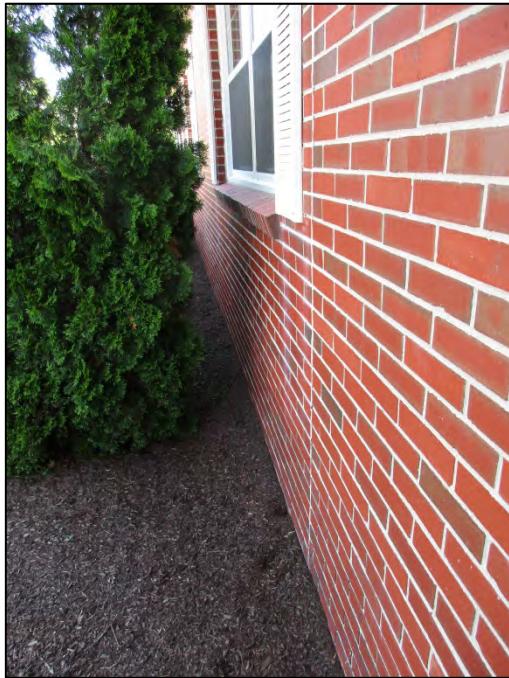
West face of building. Install stone drip edge

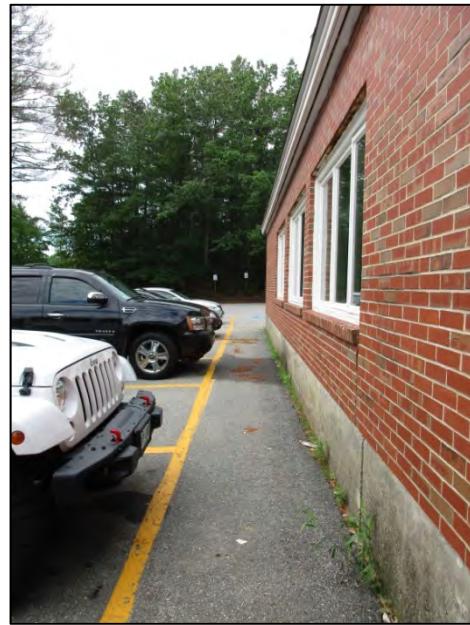
Pavement at face of foundation on east side. Note absence of roof gutter. Potential location for stone drip edge with underdrain. Installation of a guardrail or parking bumpers can help protect the building from vehicle impacts.

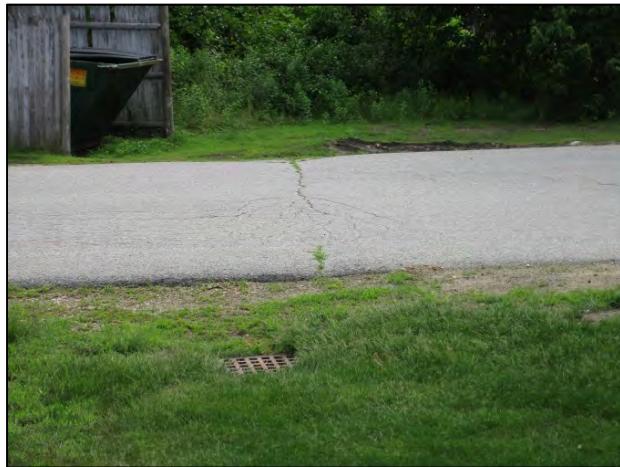
Drop inlet along exit driveway.
Note pavement crack above pipe.

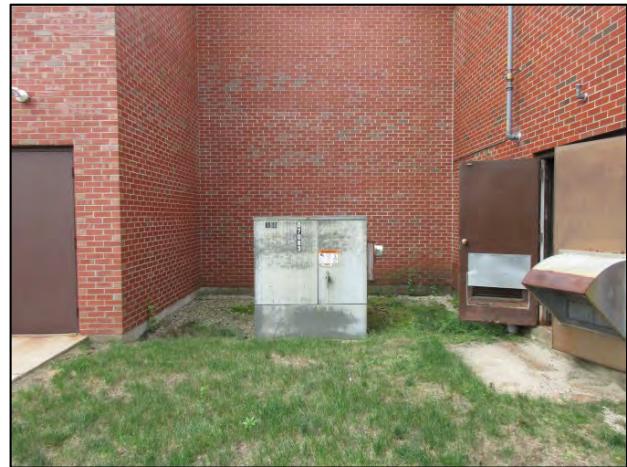
Transformer location. No means to drain away runoff.

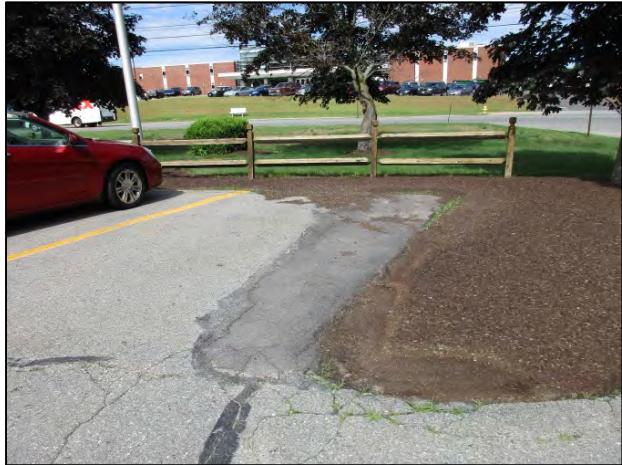
Drainage concern at the west side parking lot.
Note evidence of ponding and the pavement
repairs.

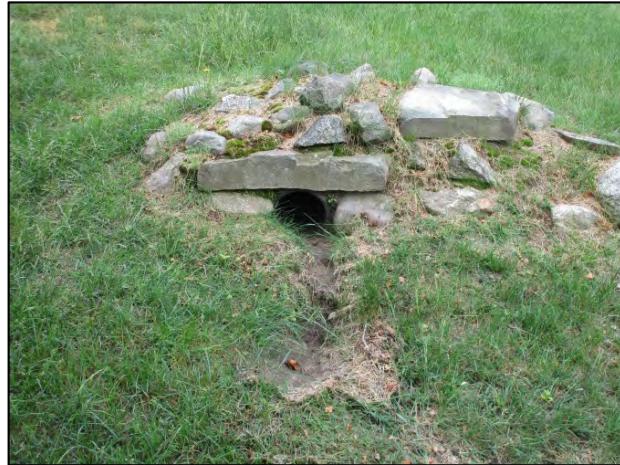
6-inch roof drain outfall on the north side.

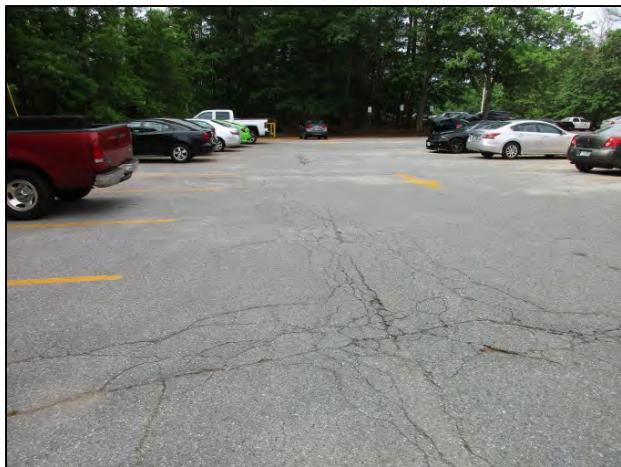
Cracked pavement on east side.

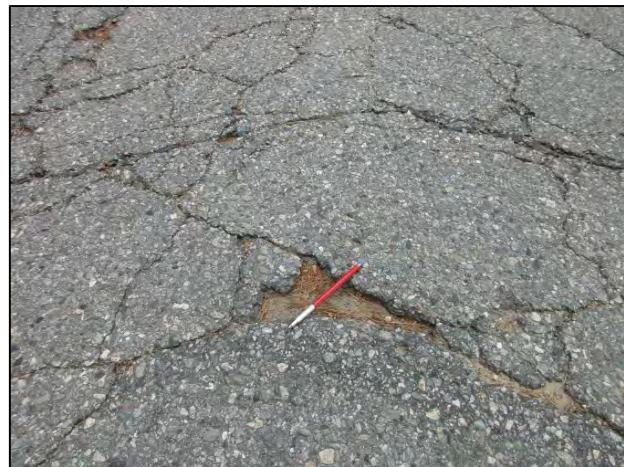
Enlarged detail of pavement cracking on east side.

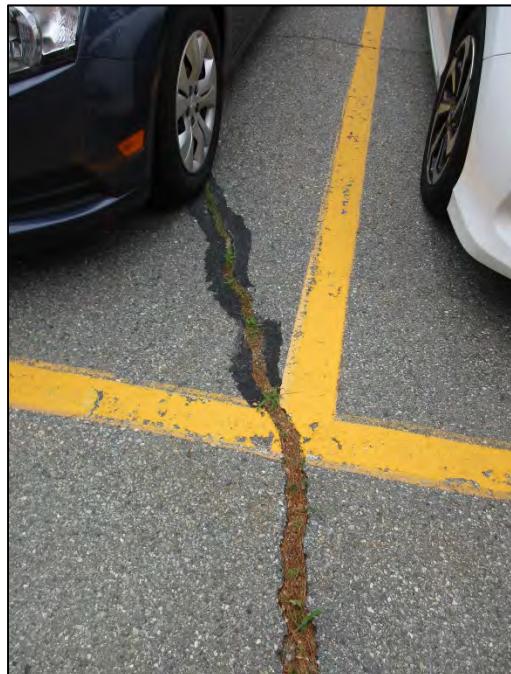
Example of past crack repair.

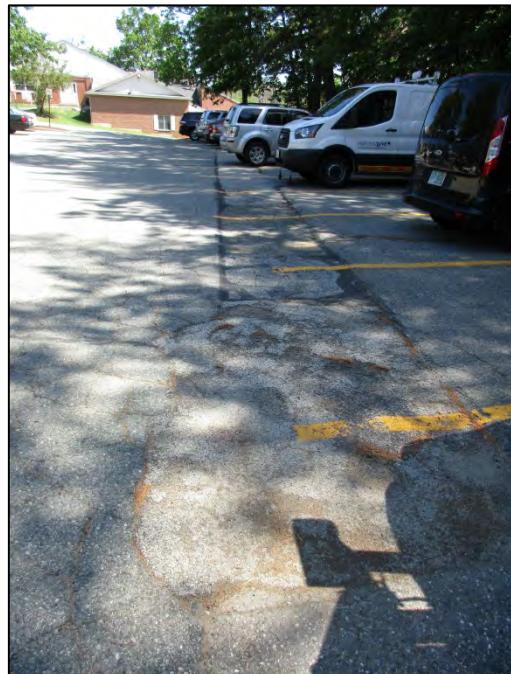
Pavement deterioration at south side parking lot.

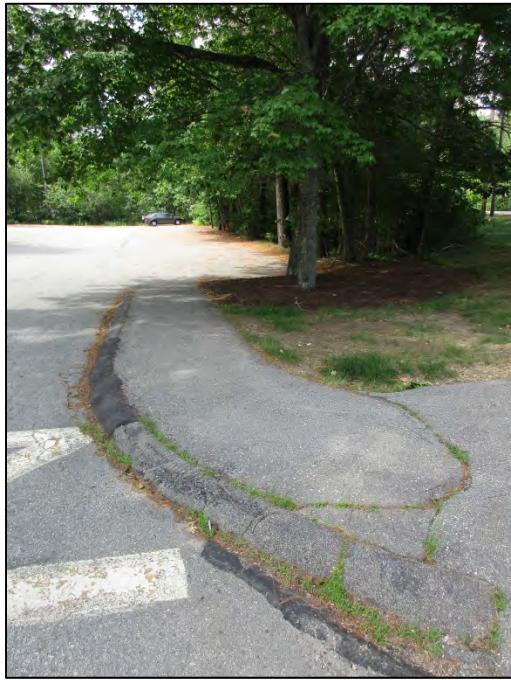
Failing sidewalk pavement and bituminous curbing.
Paint a white or yellow stripe along the top edge of
curb.

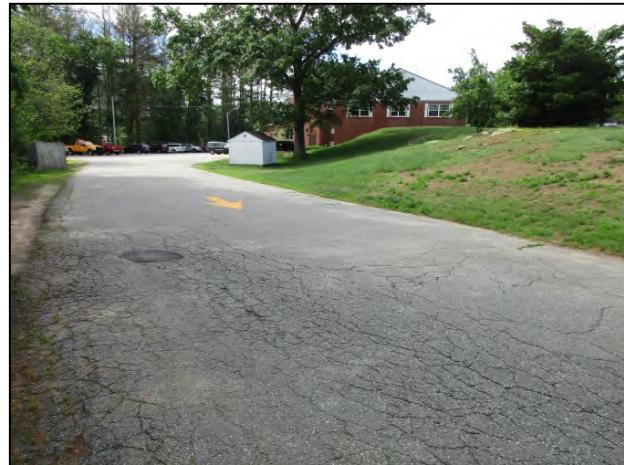
Fatigue cracking at exit driveway. Note sparse
cover on vegetated slope adjacent to pavement.

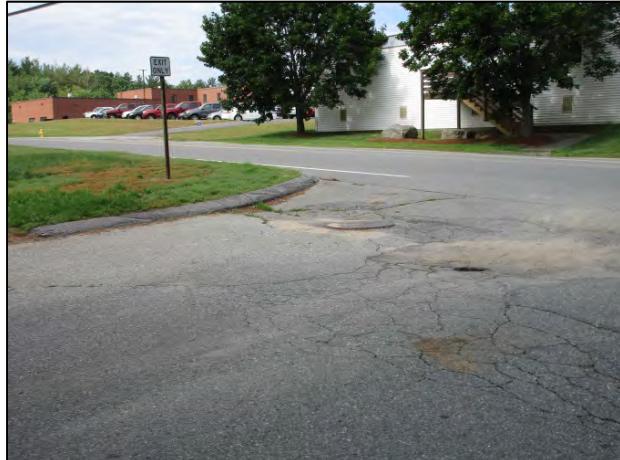
Exit driveway at intersection with Geremonty Drive.
Cracking, differential settlement.
Note undersized sign.

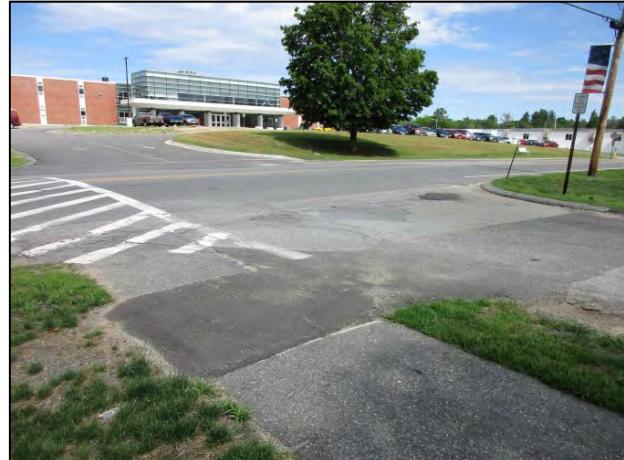
Entrance driveway at intersection with Geremonty
Drive. Cracking, trench repairs.
Note undersized sign.

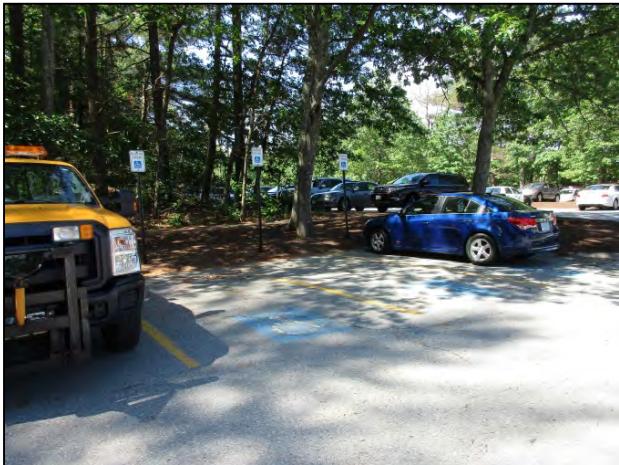
Three accessible parking spaces. Note that none of the spaces have an adjacent 'no parking' aisle.

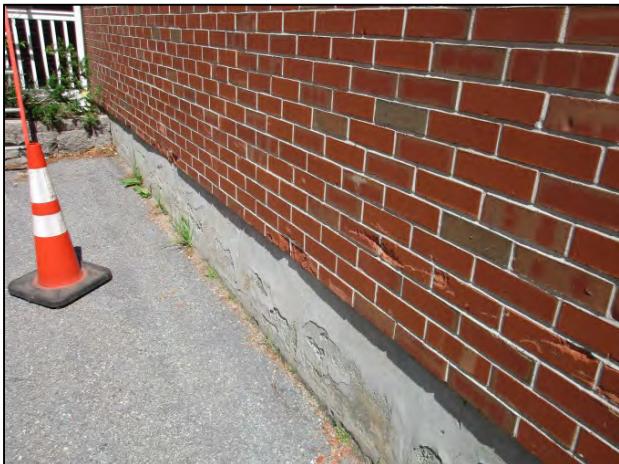
Damage to the brickwork from vehicle impacts. Bollards or a guardrail can protect the building from future damage.

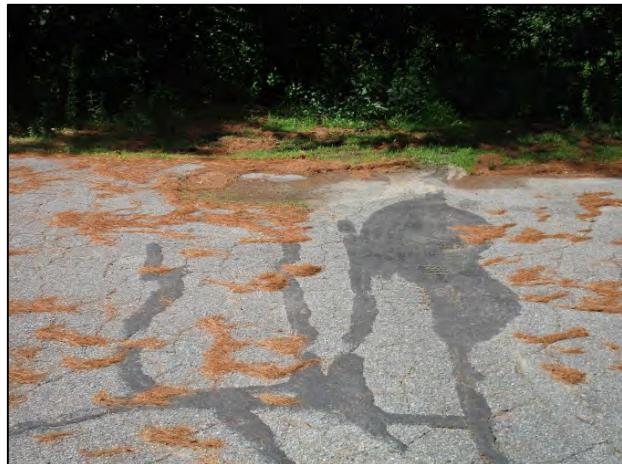
Pavement deterioration and evidence of past repairs where south side parking lot drainage runs off the asphalt and into the wooded area between Town Hall and the Courthouse site.

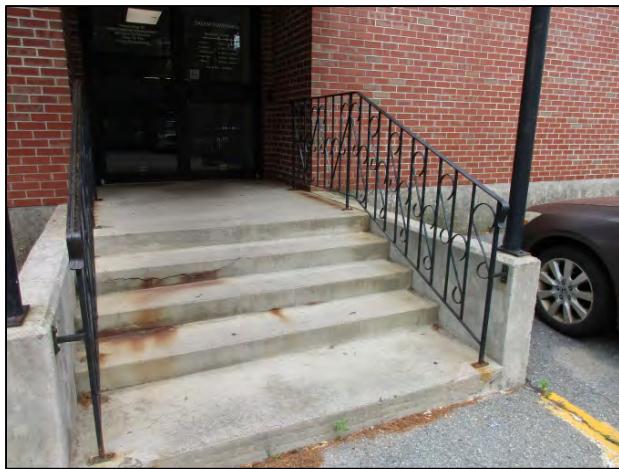
Non-ADA railings. Note cracked concrete riser and staining from corroding reinforcement steel.

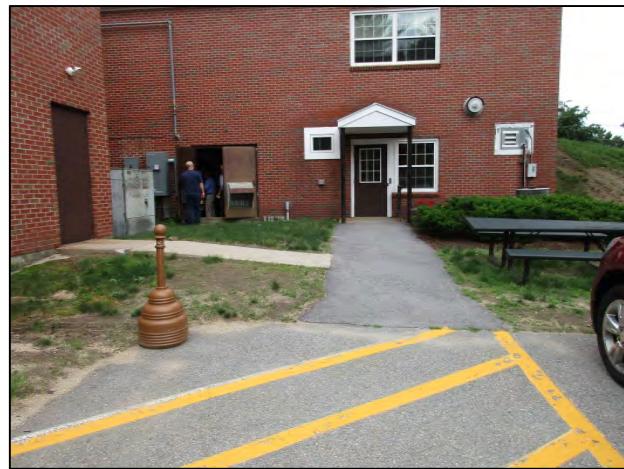
Sidewalks requiring ADA compliant railings.

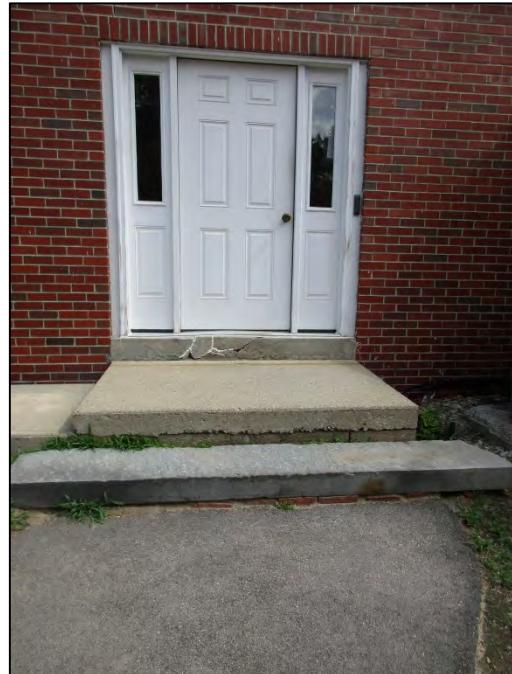
Stairs at southwest entrance. Replacement required for compliance with ADA. Note absence of handrails.

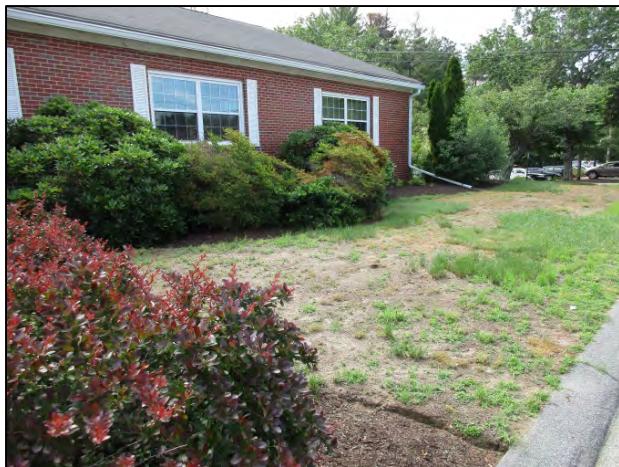
Prune landscaping along west face of building.
Note sparse vegetation (typical of several locations sitewide).

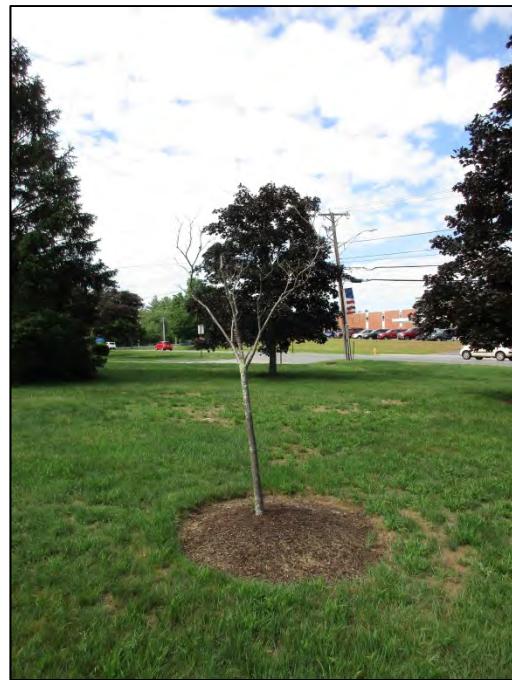
Replace the dead tree on the north side.

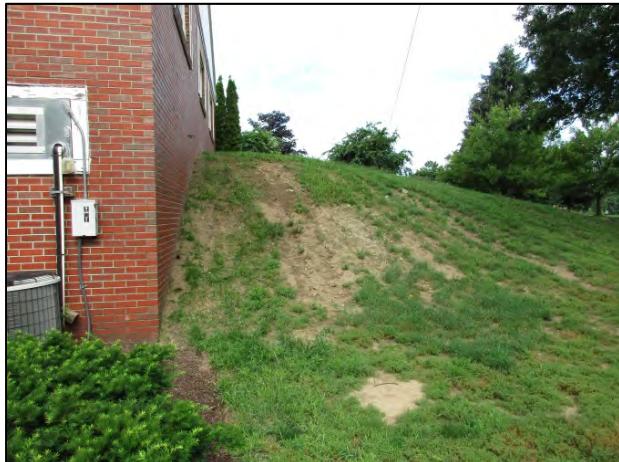
Sparse grass-cover on north side slope.

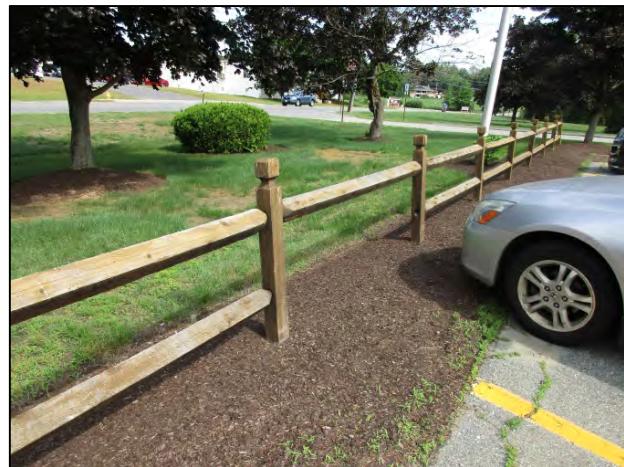
Replace fence rail.

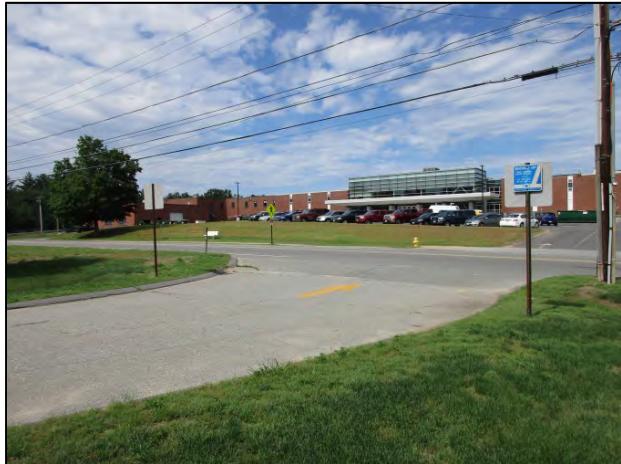
Exit driveway from west side parking lot. No stop signs at intersection with Geremonty Drive.

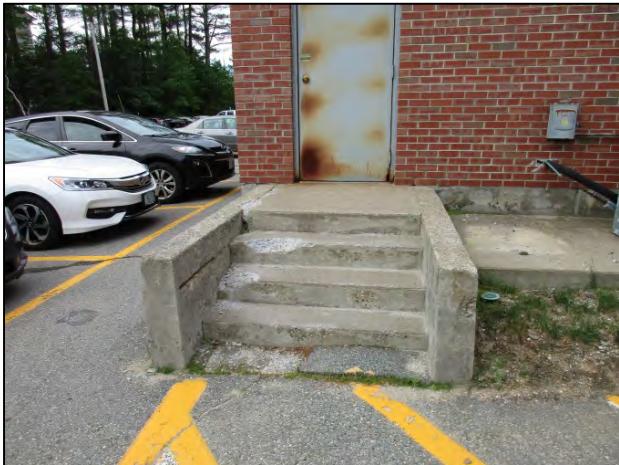
The concrete landing, stair, and retaining wall at the entrance to the mechanical/storage space on the northeast corner of the building is failing and needs to be replaced. At the same time a safety rail should be installed on each side. This is further discussed in the Site Evaluation Section of the report. The hollow metal door and frame into the mechanical space is rusted through in some areas. The door and frame should be replaced.

Deteriorating concrete at northeast stairs and landing. Also note absence of guardrails and handrails.

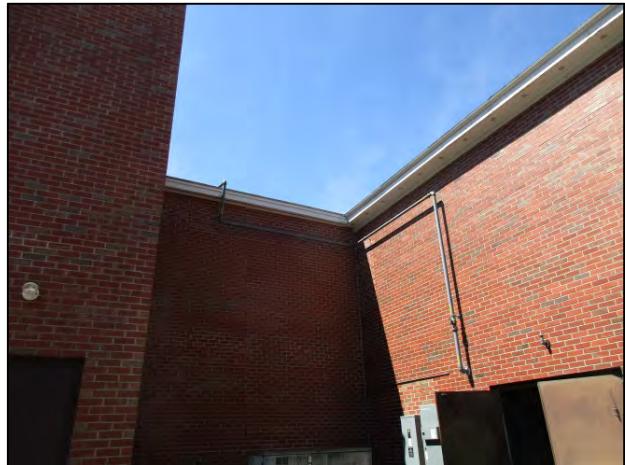
Gas line on north side prone to ice encapsulation.

- Install protection around the gas line pipe so it does not become encapsulated in ice, or provide a diversion so snowmelt and roof runoff cannot drip down the pipe.
- Install a railing along the top of the stone retaining wall at the southwest corner.
- Replace the concrete pad beneath the mechanical unit at the southwest corner.
- Stripe the space at the northwest corner of the remote parking lot to prevent vehicles from parking in the space adjacent to the sidewalk.

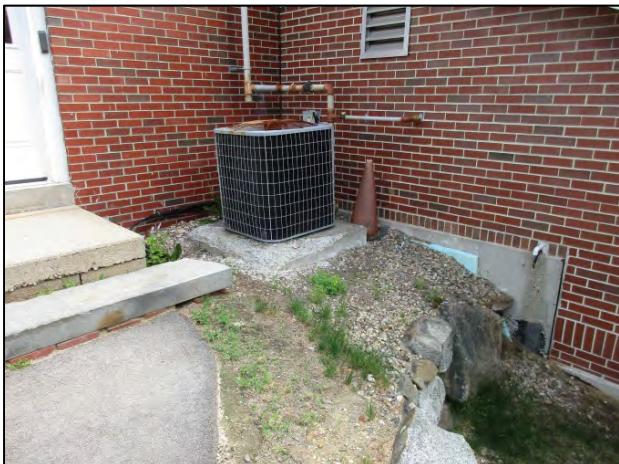
Stone retaining wall requires a guardrail and the concrete pad beneath the mechanical unit is deteriorating.

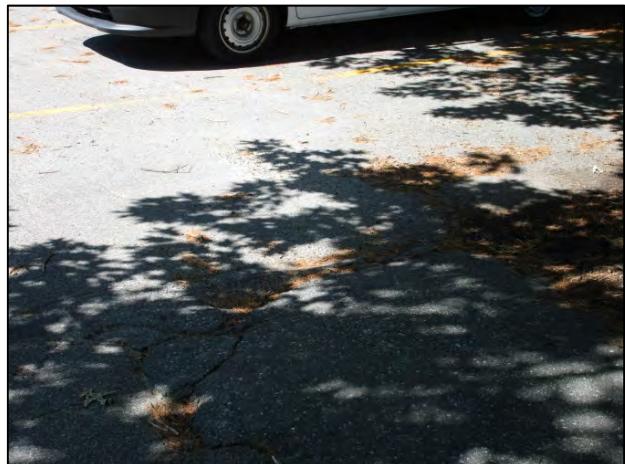
Paint striping in the parking space to prevent vehicles from parking here and obstructing access to sidewalk.
