# Conditions Assessment Report

Old Town Hall  
310 Main Street, Salem, NH

June 2021

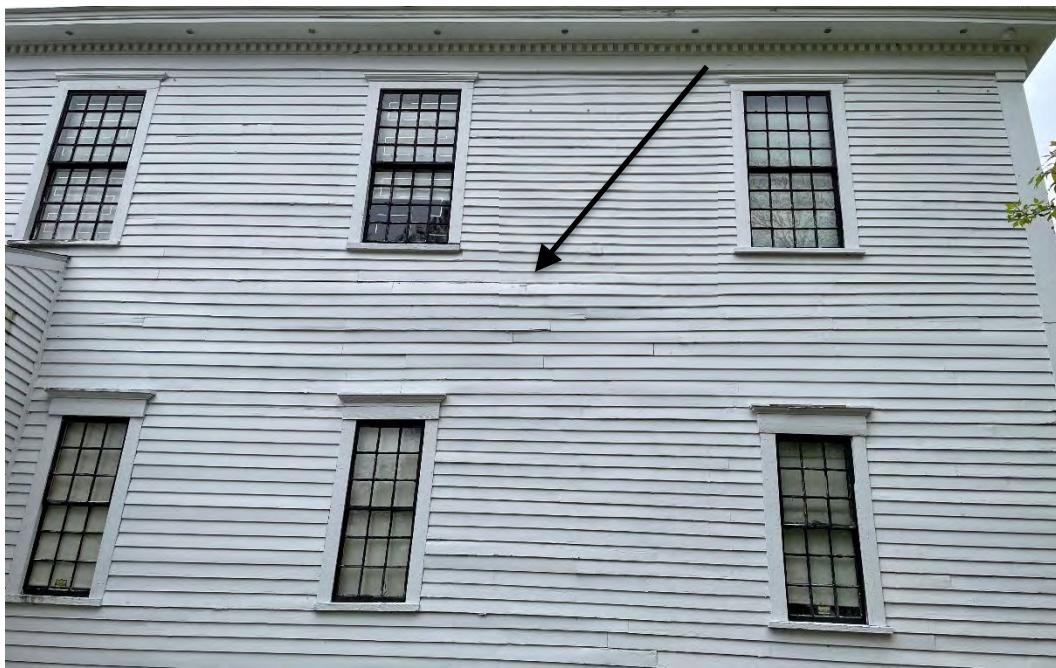
*Photo 25: Clapboards in between the first and second floors on east elevation are bulging, indicating a shift in the structure beneath. These clapboards should be removed and repaired or replaced, and the structure checked.*

The clapboards are generally in good to fair condition. Several areas on the south and east elevations show cracked or warped clapboards. Some shift in the structure is apparent above the 1937-1939 vault addition, which removed some of the structural wall support during its construction (see Structures North report). North of the vault, in approximately the area of the original northeast corner post, clapboards are visibly bulging from the sheathing. The clapboards in this area should be removed and salvaged or replaced, and a sensitive investigation of the structure behind the sheathing can be made to assess the condition of the posts. Any necessary repairs to the structure should be made with traditional joinery methods, and the existing clapboards and sheathing reused as much as possible (see Structures North report).

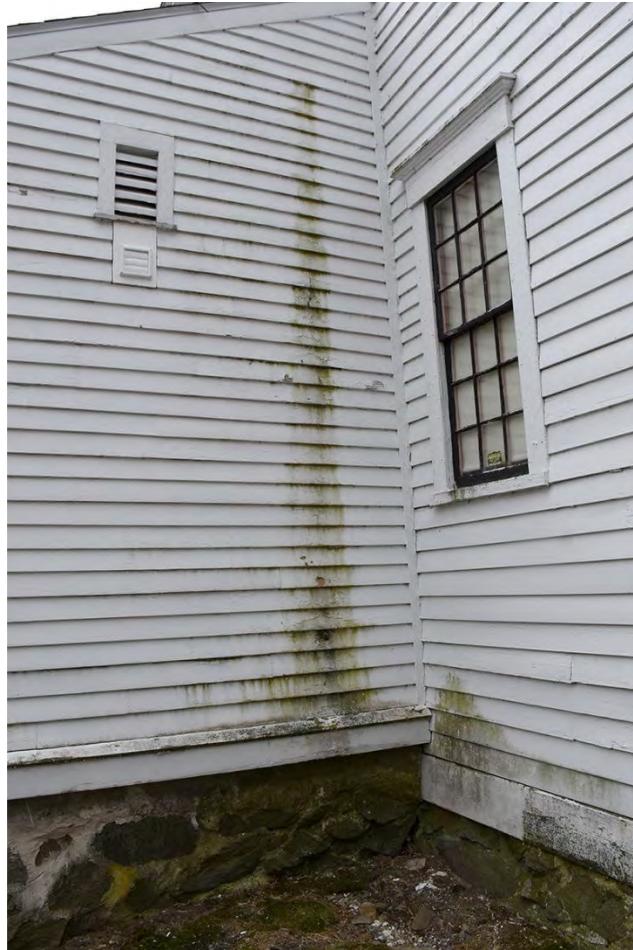
*Photo 26: Biogrowth is seen on the clapboards and foundation walls in the north corner of the vault addition. The vents are for the area above the vault ceiling.*

The paint is peeling and lifting on many areas of the exterior clapboards. The west and south elevations have a mixture of older and newer clapboards, as some areas were evidently replaced in separate repair campaigns. The south elevation has a narrower exposure of clapboards within the gable, which is also a pattern seen in historic photographs. These elevations need many repairs, as many of the clapboards are cracked and warped. Small clapboards are missing by the door on the northern end of the west elevation. The north elevation looks to have been replaced as a whole, as the clapboards have a consistent texture and dimension. East elevation also might have been replaced at the same time as the north. There is green algae/biogrowth on the interior corner of the vault shed addition indicating a water problem.

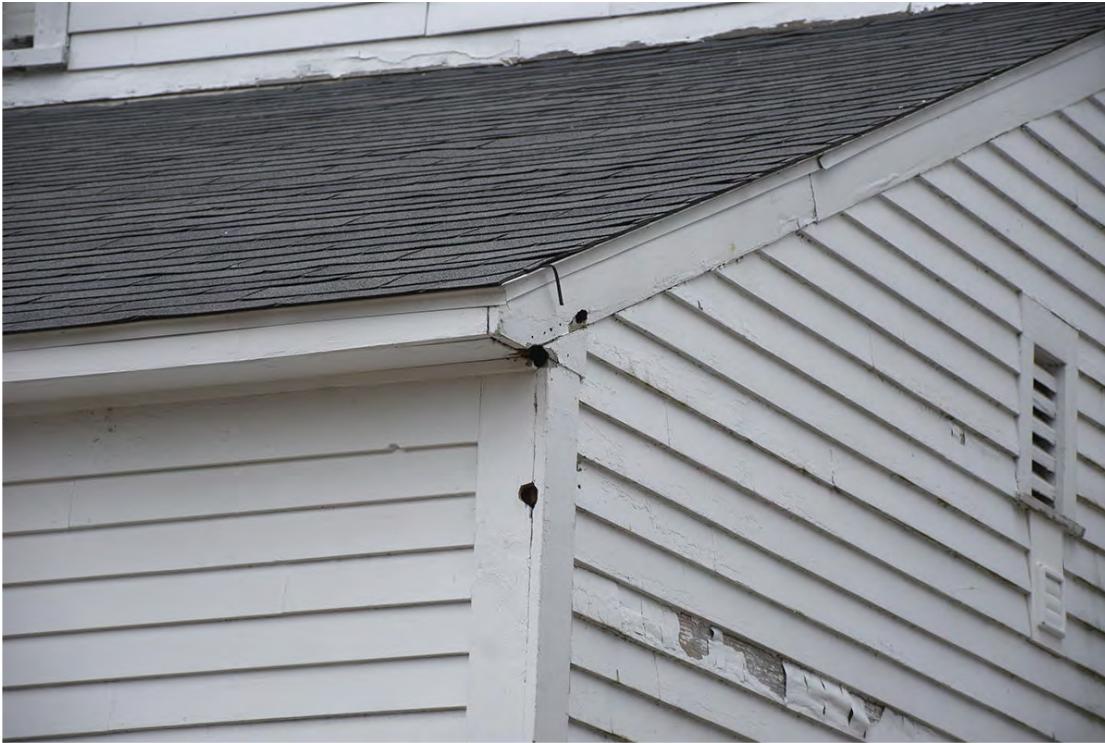
*Photo 27: Insect or animal holes in the trim on the northeast corner of the vault addition. Peeling paint is seen on the clapboards facing north.*

The trim around the doors and windows is in varying conditions. There are 1"-2" holes in the trim of the vault addition on the east side (Photo 27 above). Window trim and surrounds are in varying condition. Many of the windowsills have been replaced, and the cap moldings on the window

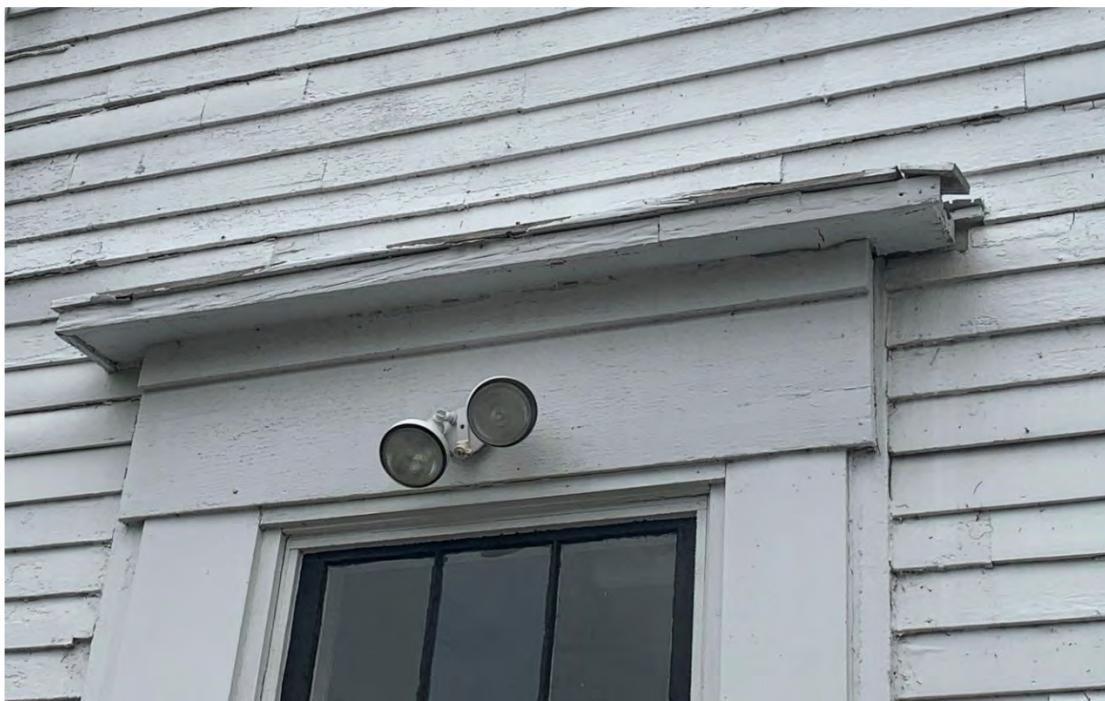
*Photo 28: Header and trim molding over the south door are in poor condition.*

headers are early twentieth-century additions. The header and cornice trim over the door on the south elevation is in poor condition and needs to be repaired (Photo 28, Page 39 above).

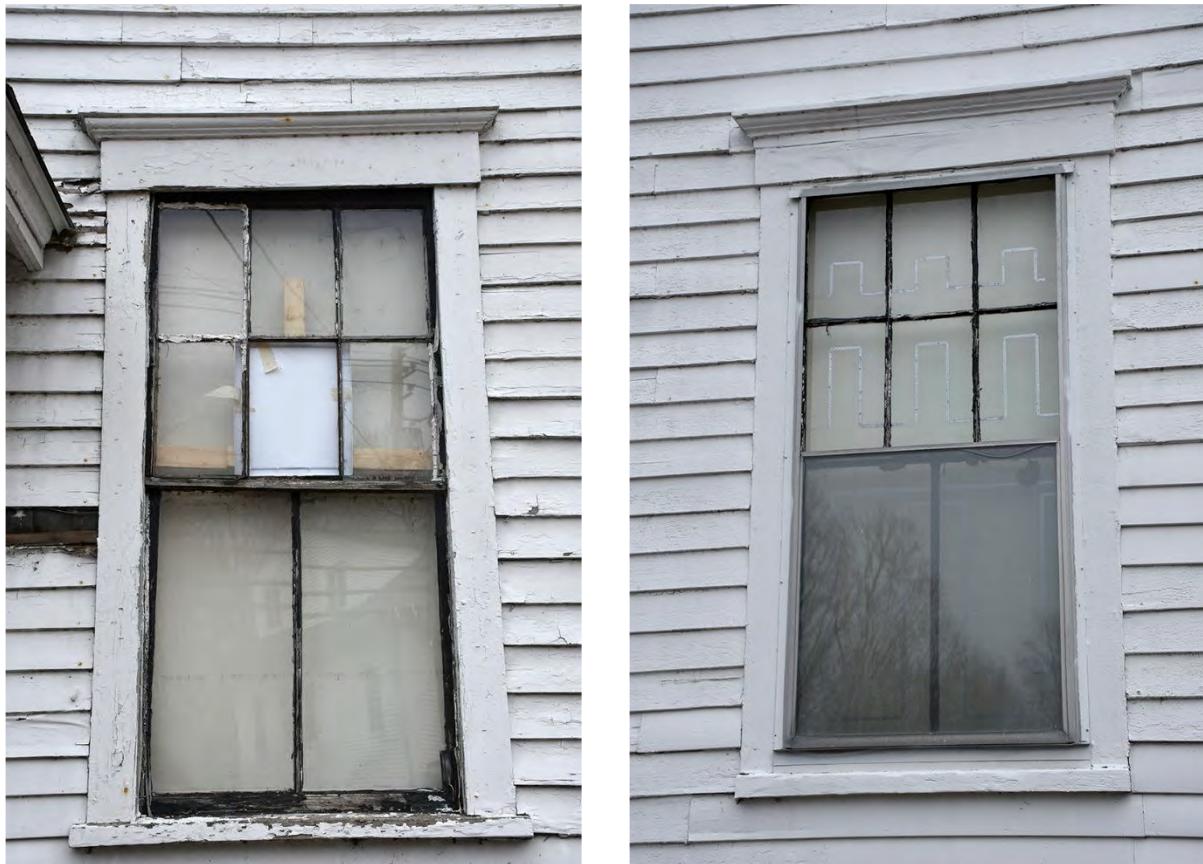
*Photo 29: At left, window by entrance on the west elevation is in poor condition with a missing pane of glass in the upper sash.*

The first-floor windows contain older, nineteenth century window sash, though the 2-light lower sash were added in the early twentieth century. The northernmost window, adjacent to the main entrance on the west elevation, is missing a pane of glass and is in extremely poor condition (Photo 29 above). The three windows in the first-floor office, in the southwest corner of the building, are the only windows that have exterior aluminum, triple-track storm windows, though the two on the

All first-floor windows have visible deterioration from weathering as well as loss of glazing putty. All windows need full restoration, including wood repairs, new glazing putty, and reinstallation to restore functionality. The 6/2 configuration, though uncommon and contrasting with the 16/16 windows of the upper floor, should be retained since it is a visual record of the changes made to the building over time. Storm windows can be installed to aid in energy efficiency during the cold months. Exterior storm windows will protect and prolong the life of the window sash, though interior storms preserve the visual appearance of the exterior.

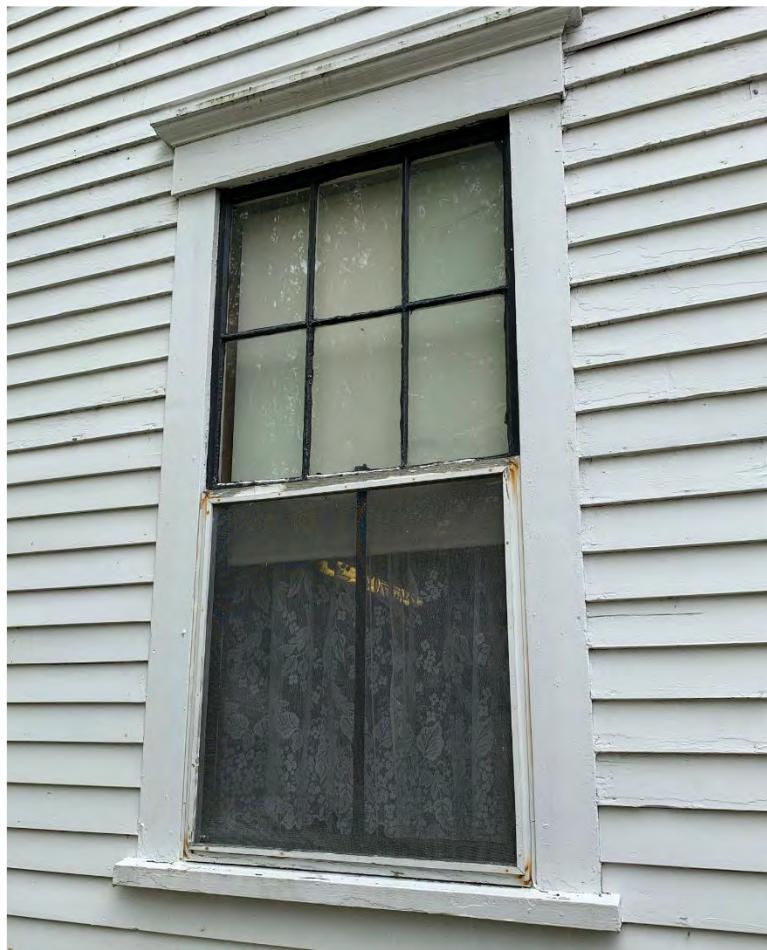
*Photo 31: Window on the first floor, north elevation, with rusted screen installed over the lower sash.*

The single window on the first floor of the north elevation has an exterior screen installed over the lower sash, which is rusted in the corners (Photo 31 above).

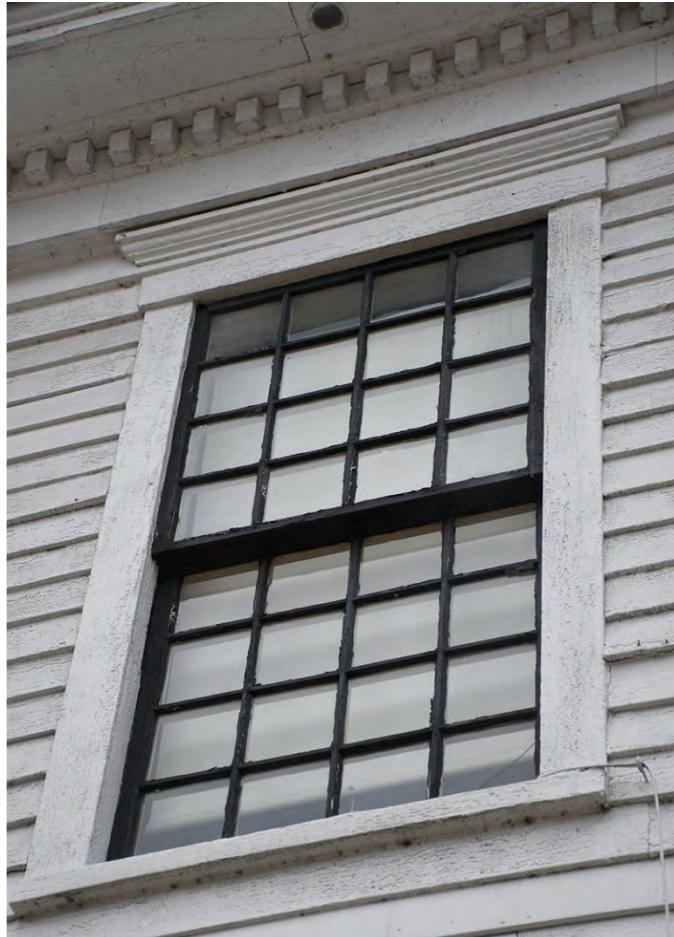
*Photo 32: 16/16 double-hung window at the second-floor level of the west elevation. Glazing putty is in poor condition, and lower right pane of glass is cracked. Early twentieth century trim cap was added to the fascia board above the header.*

The second-floor windows throughout the building have a 16/16 double-hung configuration. These are ca. 1900 additions as part of the Searles renovation. All the windows and most of the sills are in poor condition (Photo 32 above). The second-floor windows of the east elevation also have the heat tape applied to the interior, though they no longer function.

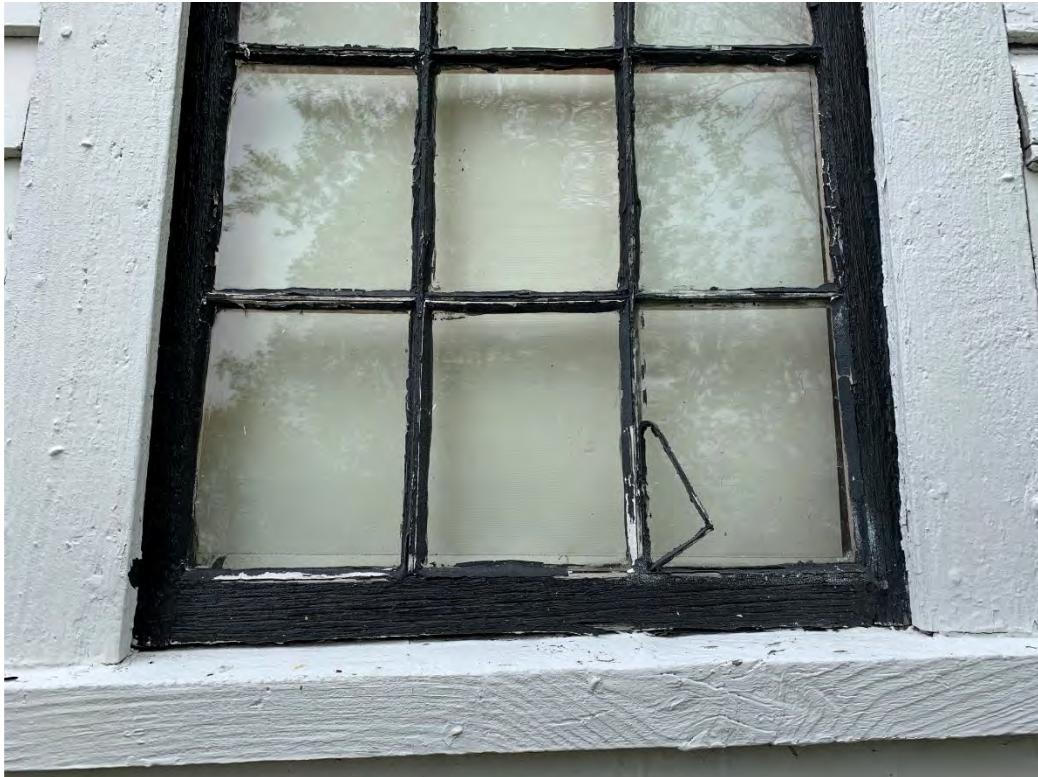
*Photo 33: 9/9 double-hung window on the first floor of the east elevation. These may be the oldest surviving windows in the building, potentially dating to the eighteenth century.*

The 9/9 double-hung sash on the east elevation are the oldest in the building, some sash possibly dating to the first half of the nineteenth century. These windows are also in very poor condition, showing paint and putty loss on the exterior and degradation of the wood (Photo 33 above). A full restoration is necessary and will likely require a greater amount of wood repair or replacement.

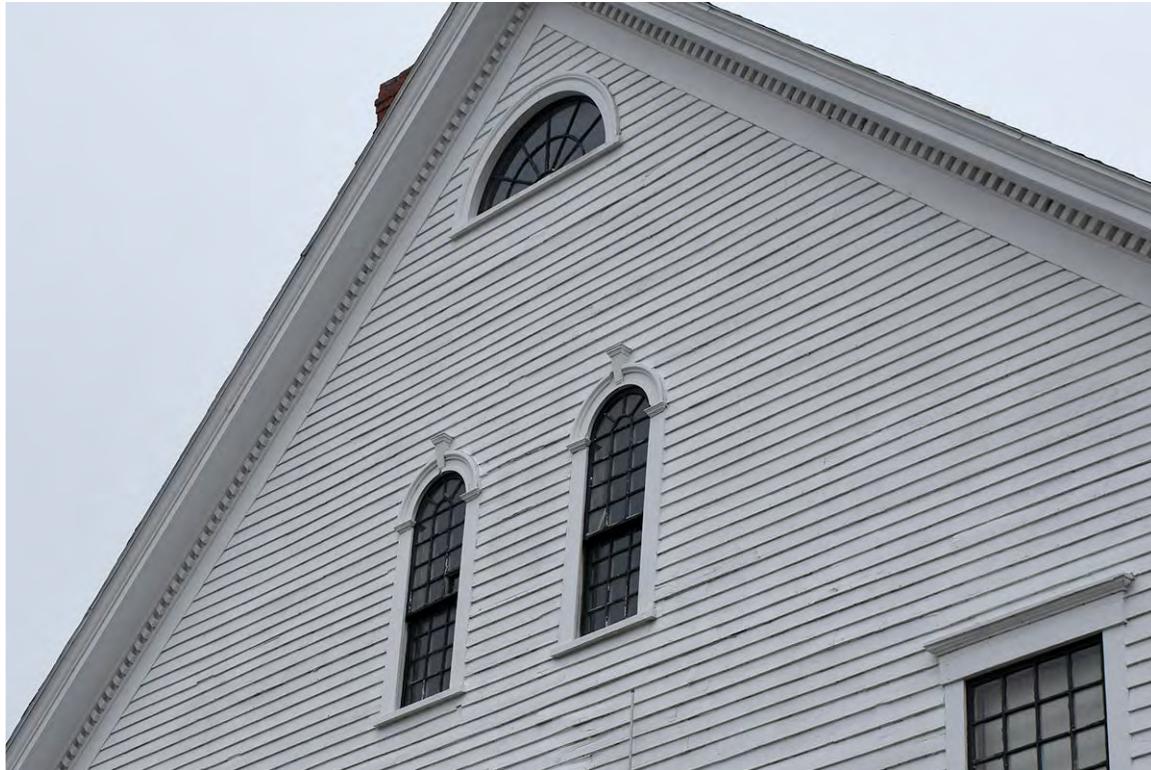
*Photo 34: South elevation, paired arched windows and lunette within the gable are twentieth century additions. Glazing putty on each window is visibly lifting or missing.*

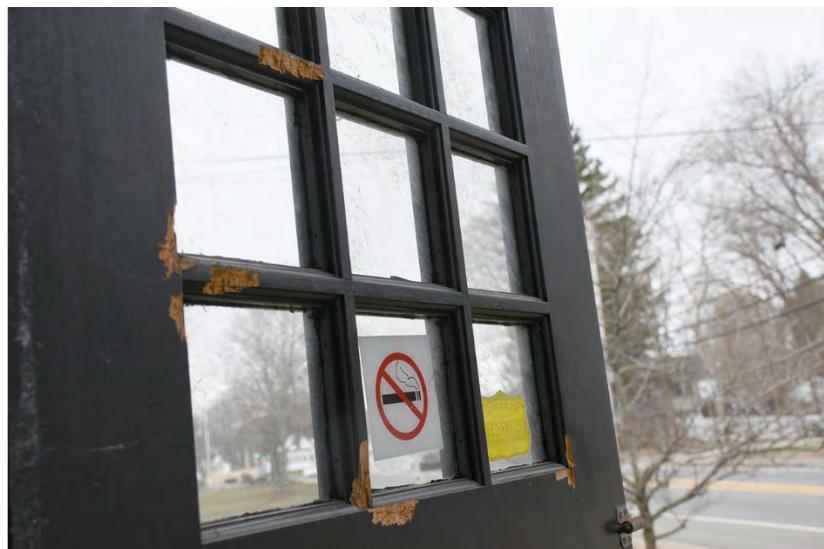
The main entry doors on the west elevation were added in 1908 when the northern stair addition was constructed. These double doors are in good condition and still function as the main entrance to the building. The exterior of the doors is painted black, and the 12-light panel in the upper third of each door has small, square panes of glass that generally match the design of the Colonial Revival 16/16 sash windows of the second floor. Above the door, the 14-lite (2 x 7) transom window also has square panes of glass, though the transom is boarded up on the interior. A wood ramp provides accessible entry and sits directly upon a large stone step. The right-hand door has recent damage to the interior of the muntins in the upper panel of lights (Photo 36, Page 46 below). The damage should be repaired and the doors repainted.

*Photo 36: Interior of the main entry doors, recent damage possibly by rodents.*

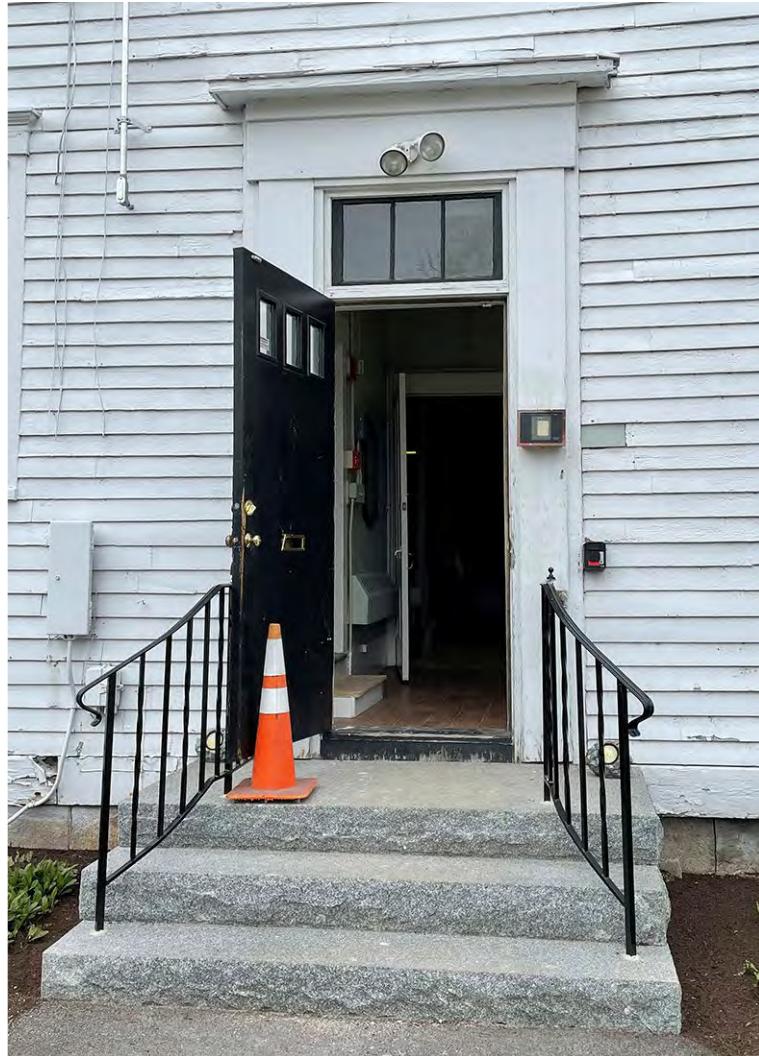
*Photo 37: South elevation doorway. The current door is planned for replacement with a solid wood door. The granite steps are approximately 5-6 years old, and the metal railings were recently installed. The clapboards are in visibly poor condition on this side.*

The doorway on the south elevation is an original entrance location, though the door is a later twentieth century replacement and is planned to be replaced with a modern, solid wood door (Photo 37). The three-lite transom above the doorway is seen in the nineteenth century historic photograph and is an early feature. The trim cap above the header is in poor condition (Photo 28, Page 39). The granite stone steps were installed 5-6 years ago, and the black metal rails were installed in the past year.

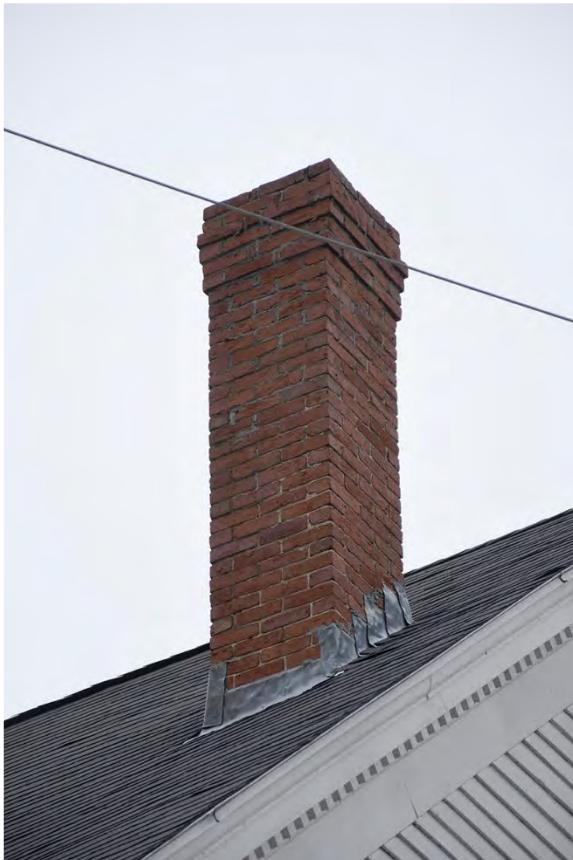
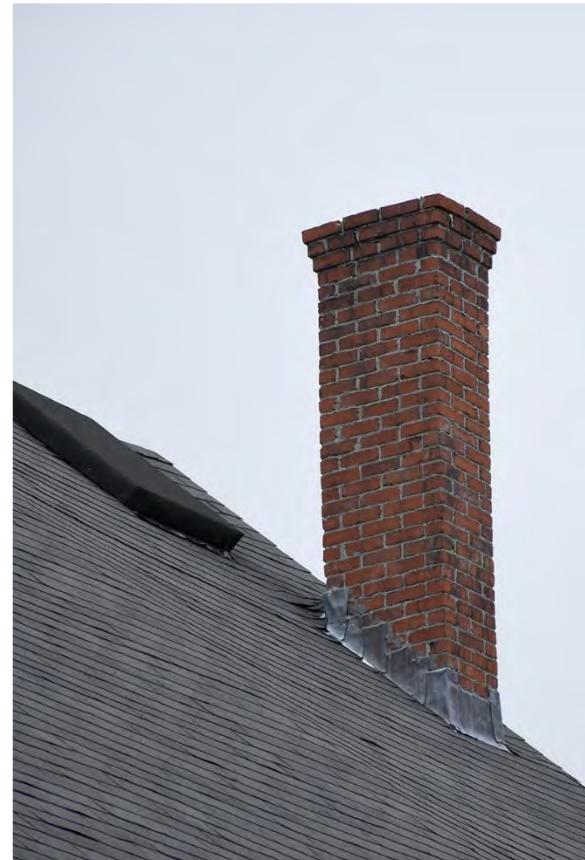
Both chimneys above the roof line are in good condition (Photo 38 and Photo 39 below). The chimney on the southwest end predates the chimney on the northeast end, which dates to the 1908 addition. Both chimneys show evidence of repointing repairs. Both have lead step-flashing that looks to be in good condition. The north chimney is still in use for furnace exhaust, and its cap is in need of cleaning and light repointing.

*Photo 38: At left, early chimney in the southwest section of the building.*

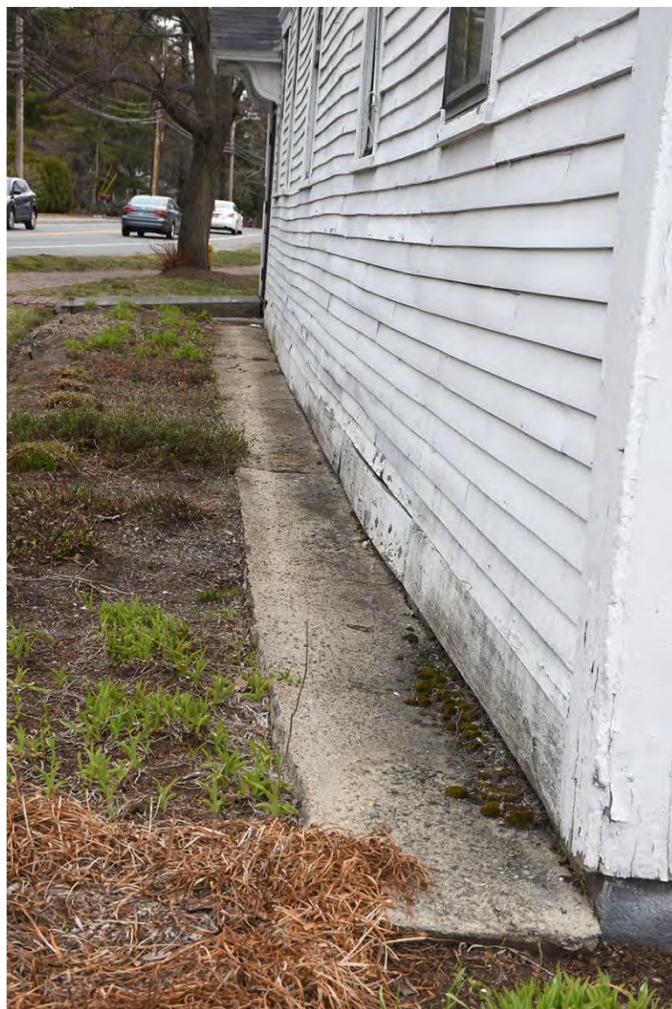
The foundation varies around the building in both material and condition. On the west elevation, the granite block foundation is barely visible between the water table and the concrete apron that lines the front of the building, ostensibly to serve as a splash pad for rainwater coming off the roof. This apron is visibly tilting back towards the building, directing water back onto the foundation. Moss is growing on the concrete apron, and discoloration and rot is seen on the skirtboards as evidence of moisture retention. The concrete should be removed and a gravel or crushed stone border installed.

*Photo 40: Foundation on the west elevation is mostly hidden by the low water table and the concrete apron installed to protect the foundations from rain runoff from the roof above. Moisture retention is evident in the moss growing along the edge near the foundation.*

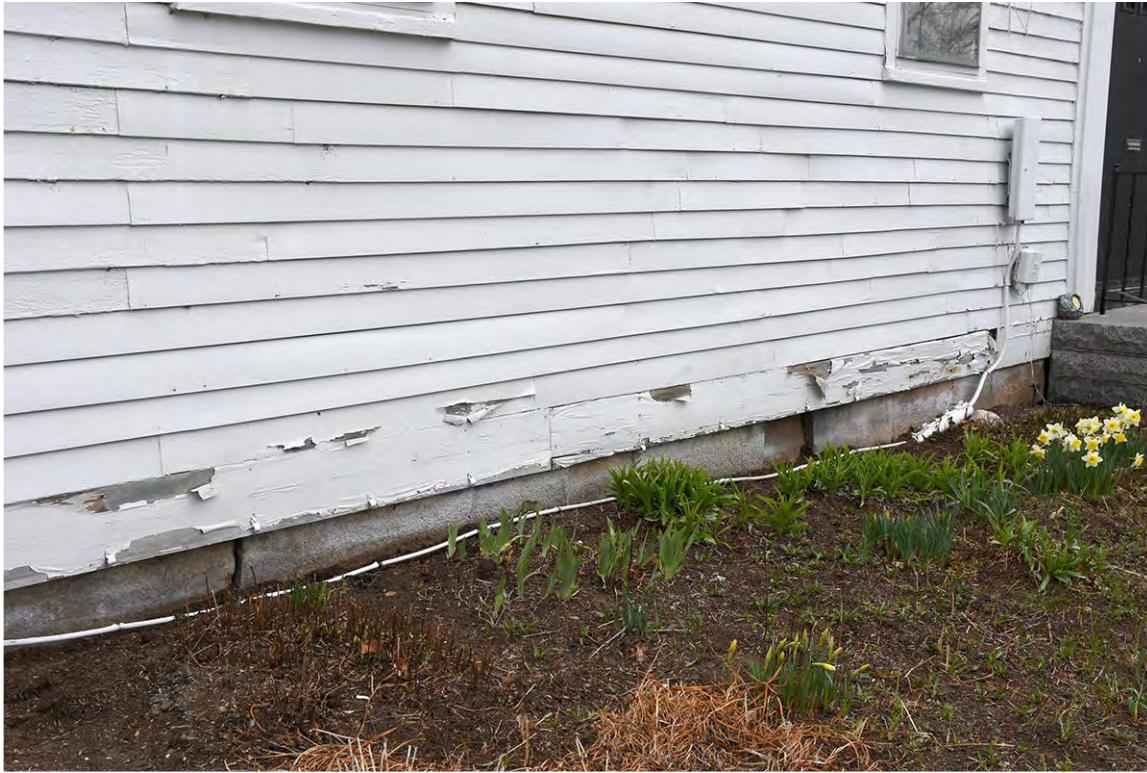
*Photo 41: Granite foundation blocks on the south elevation are displaced and have missing mortar. They also have a fine layer of white paint sprayed on the surface, likely spillover from a previous painting campaign. Plantings should be pulled back from the foundation walls.*

The foundation blocks on the south elevation are more exposed and are visibly out of alignment, with unmortared gaps between the blocks (Photo 41 above). They also have a fine coat of white paint covering most of them, likely from a previous paint job using a sprayer. The paint should be carefully removed with a gentle chemical paint stripper, and the blocks reset (where necessary) and mortared. Plantings are placed directly against this foundation and should be pulled back 6-10 inches in order to prevent moisture build-up. Again, a gravel or crushed stone border should be installed to allow moisture to evaporate at the foundation walls.

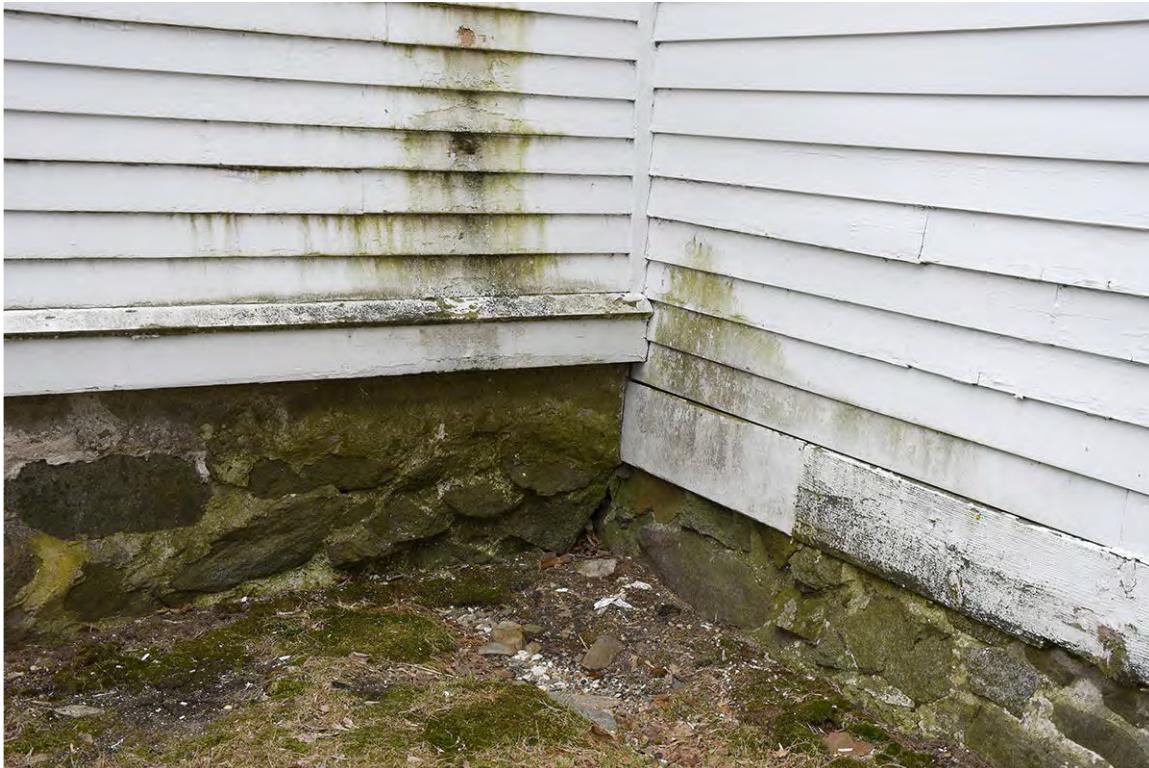
*Photo 42: North corner of the shed addition on the east elevation, showing moss and biogrowth on both the foundation and the clapboards, indicating moisture retention.*

The north elevation foundation, which dates to 1908 is also minimally exposed. It is constructed of mortared fieldstone. The east side of the building also has mortared fieldstone except for the area of the original north corner, which has larger, granite face stones (Photo 4, Page 17). The shed addition containing the vault on the east also has a mortared fieldstone foundation topped by a poured concrete slab. The foundation beneath the slab has open joints and should be repointed (Photo 43, Page 52). The joint between the addition and the main building foundation has visible biogrowth in the form of moss on the stones and clapboards (Photo 42 above). Moisture remediation in this area might be necessary, though an interior, north-facing corner is a common area for moisture problems. The biogrowth should be carefully cleaned off with a non-toxic detergent and natural-bristle brush. A gravel or crushed stone border could be installed here to allow for moisture to evaporate more quickly.

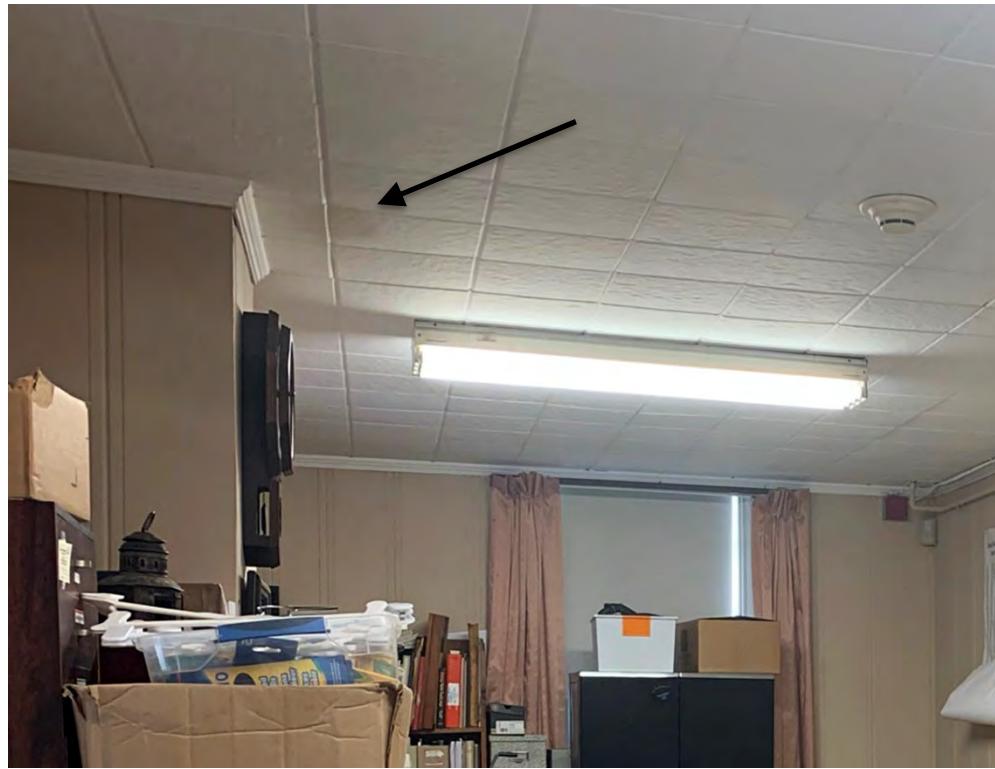
*Photo 47: Small area of water staining in the ceiling tiles adjacent to the interior chimney stack.*

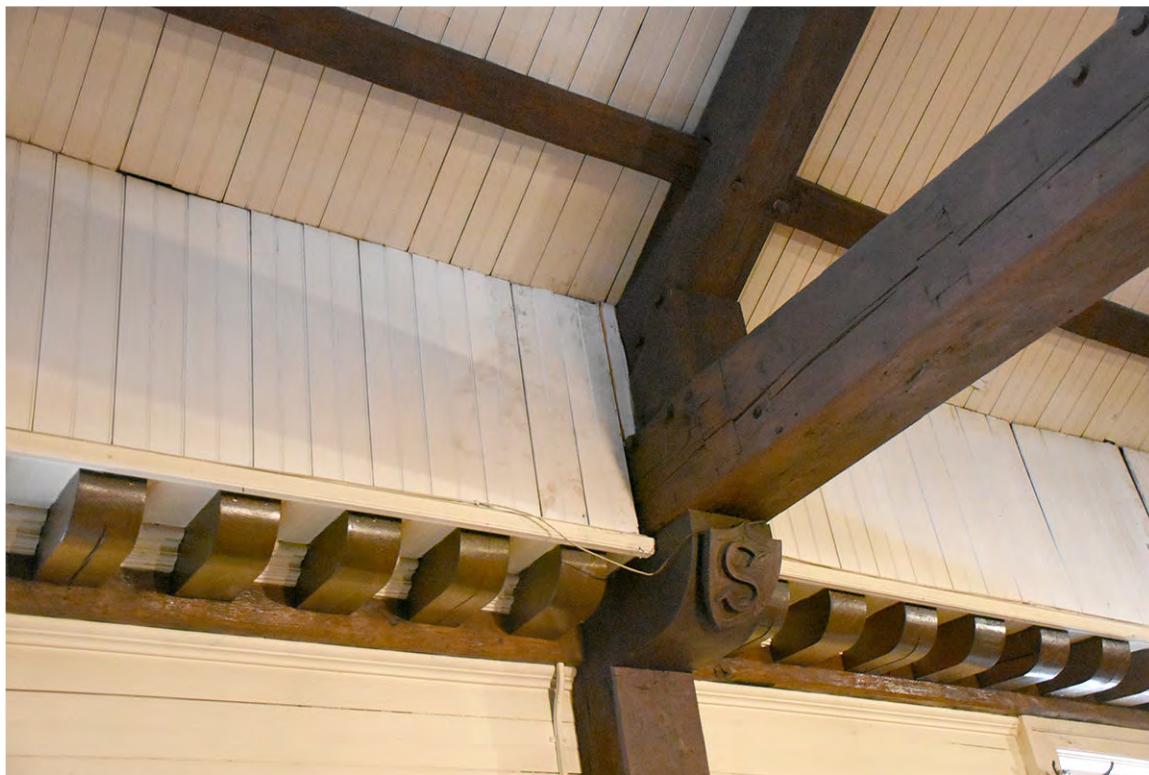
*Photo 48: Slight discoloration on the painted beadboard panels adjacent to the carrying beam. Wires and conduit are surface-mounted along trim around the room.*

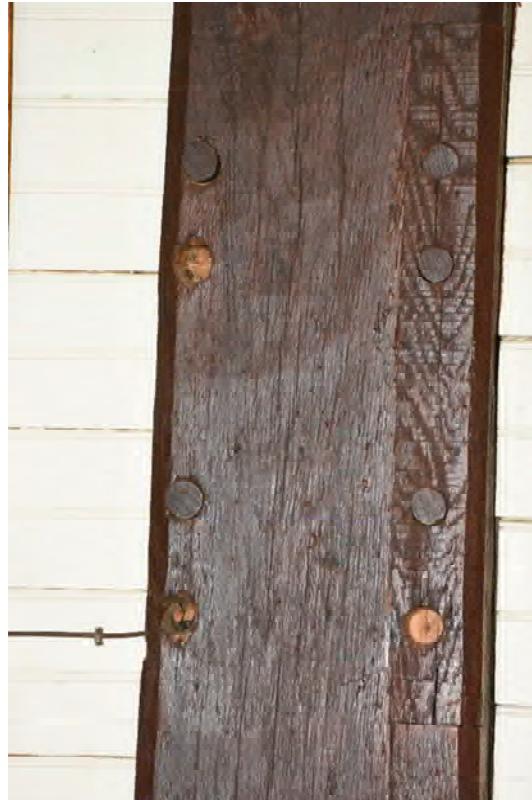
*Photo 49: Post with added, decorative pegs missing.*

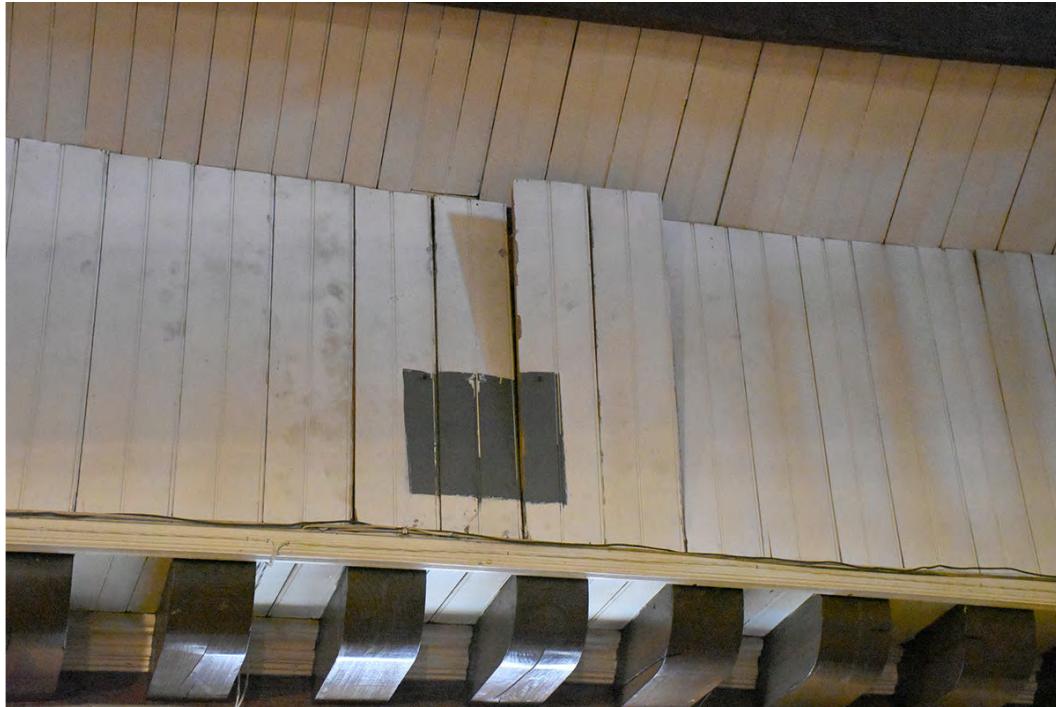
*Photo 50: Beadboard panels in the southeast corner show displacement, painted ghost of the former location of a PA speaker.*

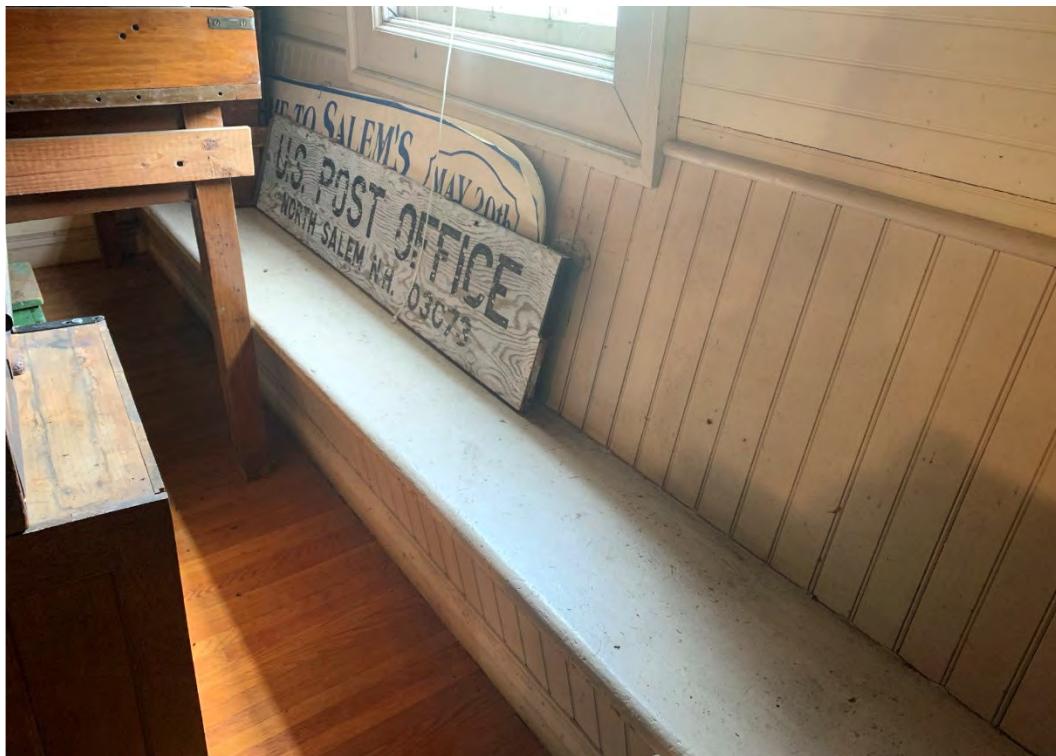
*Photo 51: Bench on the west wall of the second-floor hall, showing surface wear through the paint*

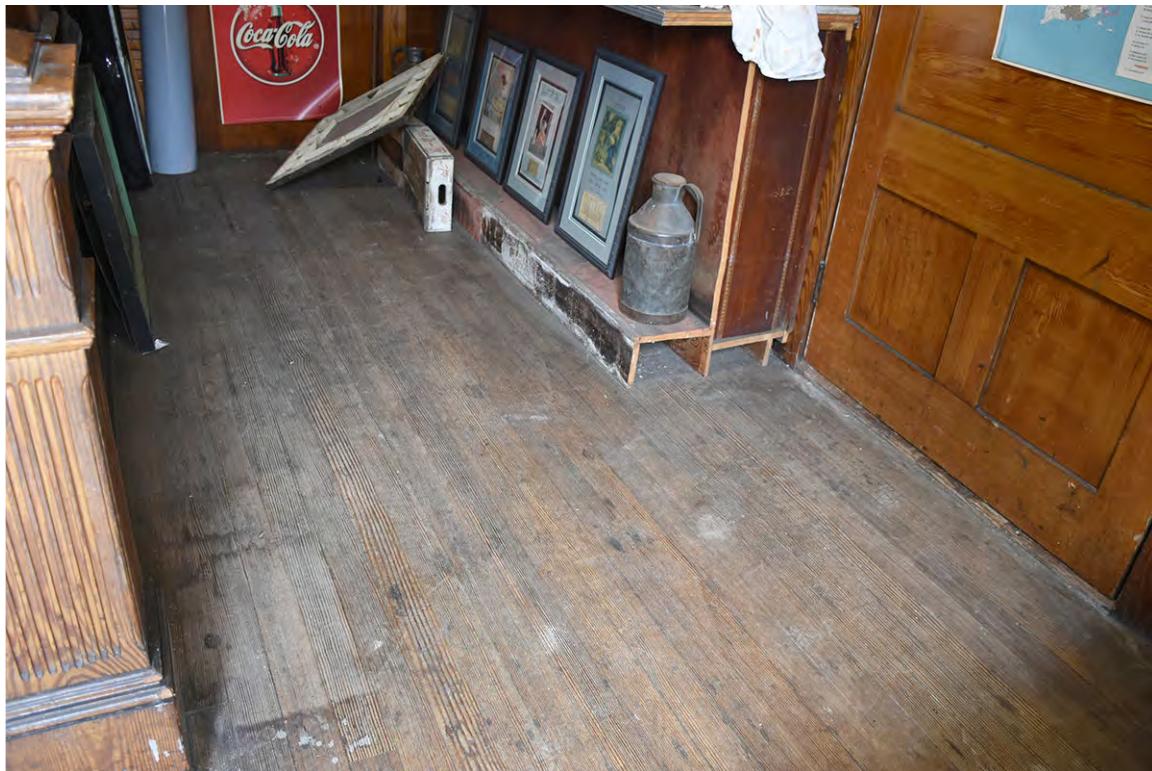
*Photo 54: Flooring on the first-floor level of the main entrance on the north end. Surface wear and water staining is visible. The floors need to be refinished with a protective clear coat of varnish.*

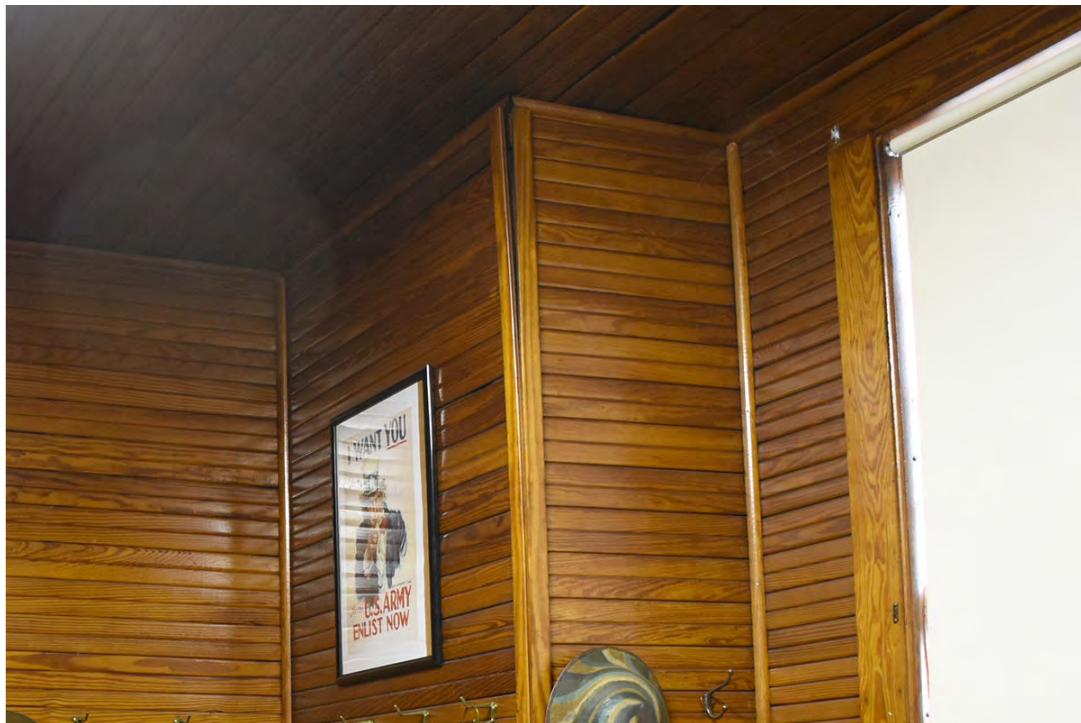
*Photo 57: Chimney stack encased in beadboard in the “Military Room,” edging strips are pulling away at the top corner.*

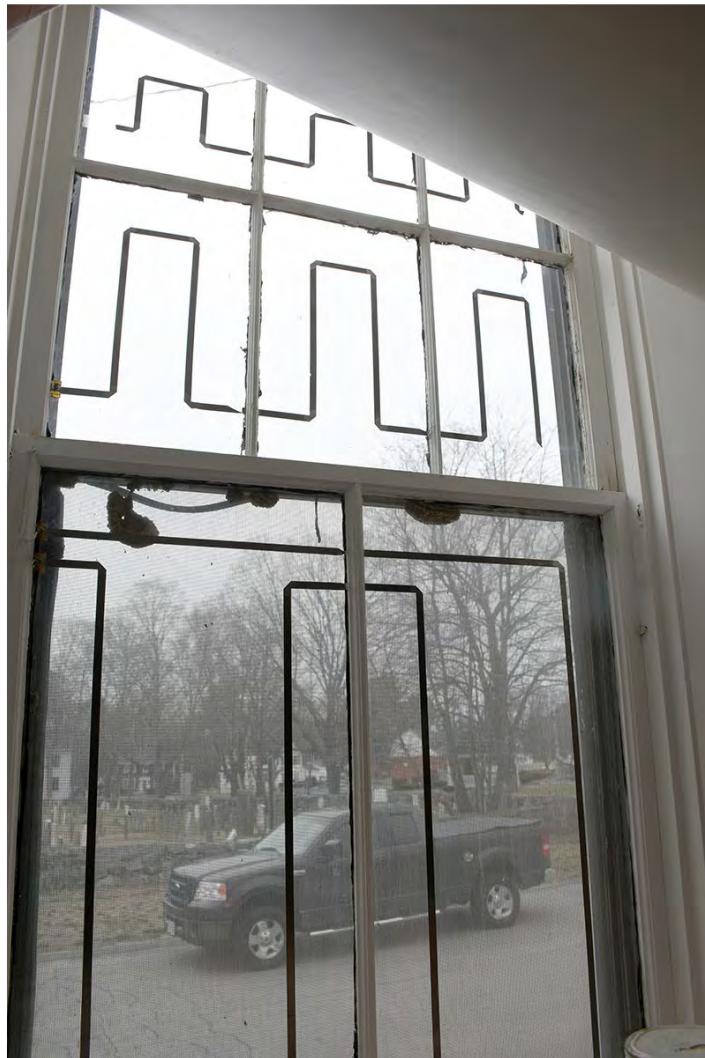
*Photo 58: Window interior on south wall of first floor office. Electrical heat tape has been applied to the interior of each glass pane, and wasp nests are apparent on the exterior of the lower sash.*

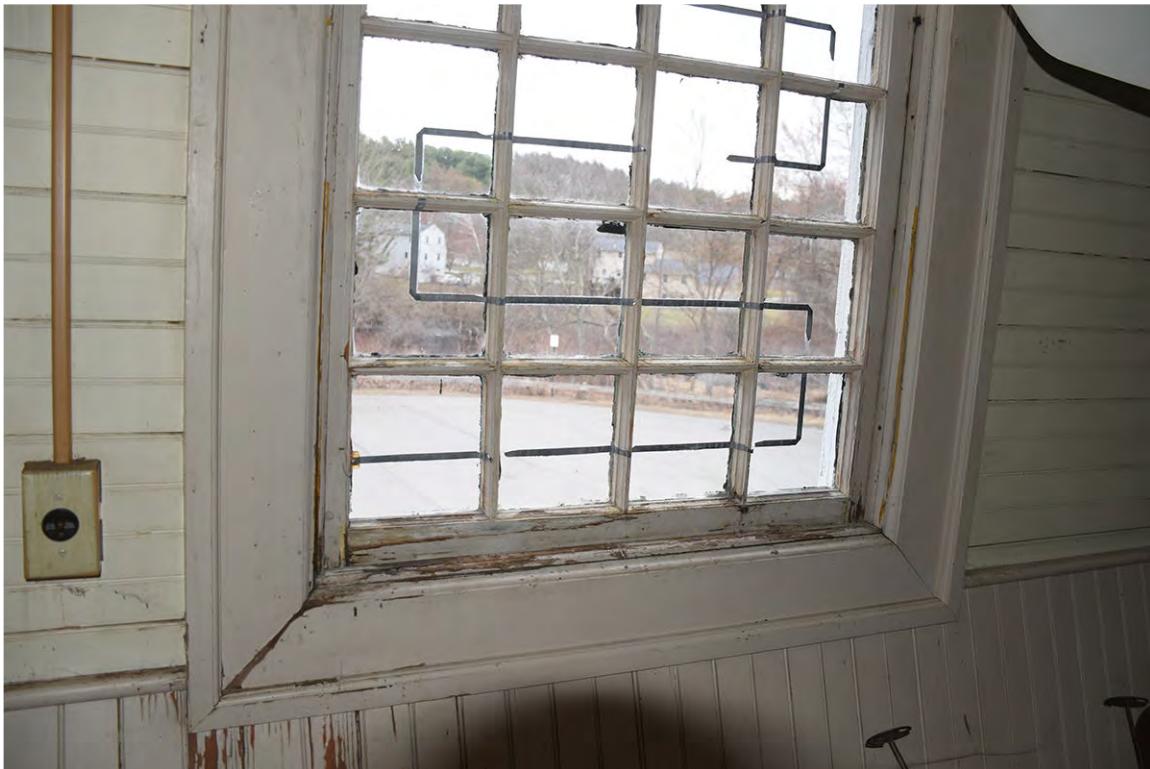
*Photo 59: Window interior in the east wall of the second-floor main room. Interior sills were removed in the 1900 renovation. Deterioration and water damage is apparent in the lower sash and trim.*

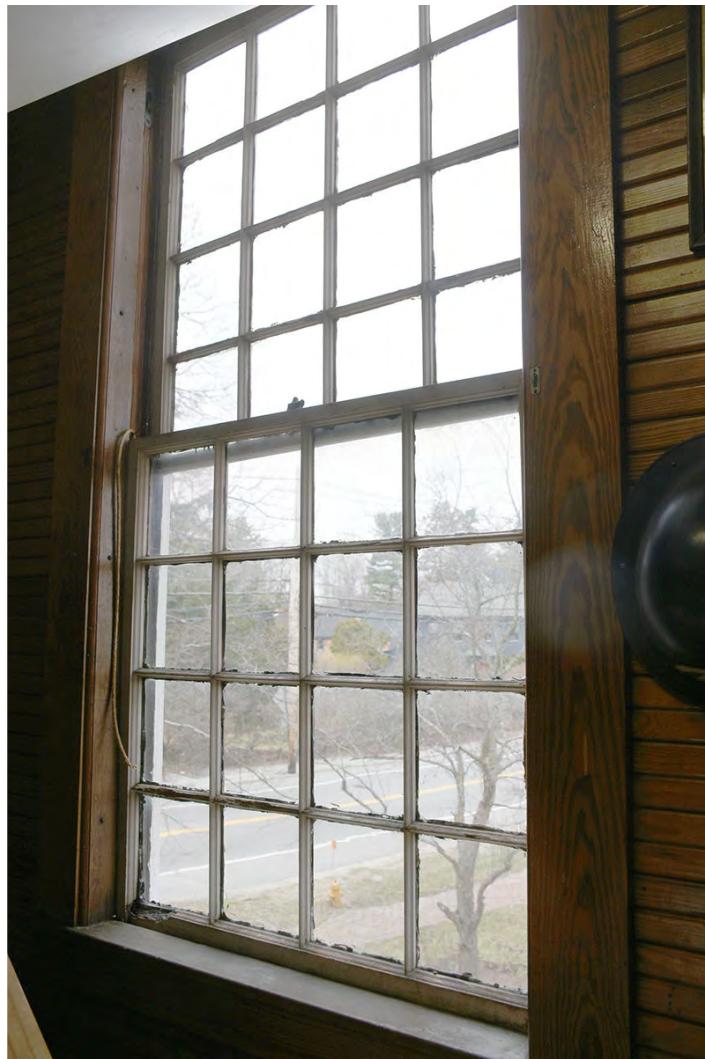
*Photo 60: Interior of the north window in the "Military Room" showing a broken sash cord and rot/deterioration of the muntins and lower rail of the lower sash. This is one of the few windows with sash weights and cords.*
