# Conditions Assessment Report

Old Town Hall  
310 Main Street, Salem, NH

June 2021

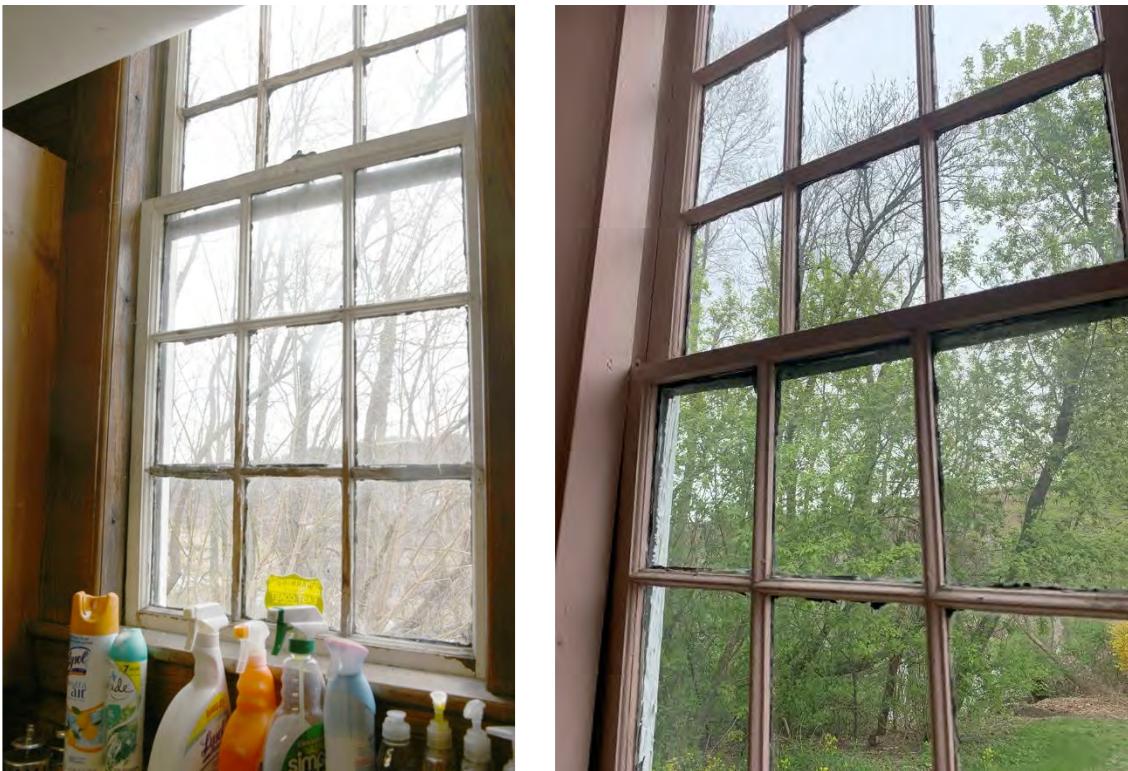
*Window interior of 9/9 window on east wall in kitchen Photo 61: (left) and in the main room Photo 62: (right). Muntins have severe deterioration, and upper and lower sash do not meet properly. Window muntins differ, showing the use of sash from different time periods.*

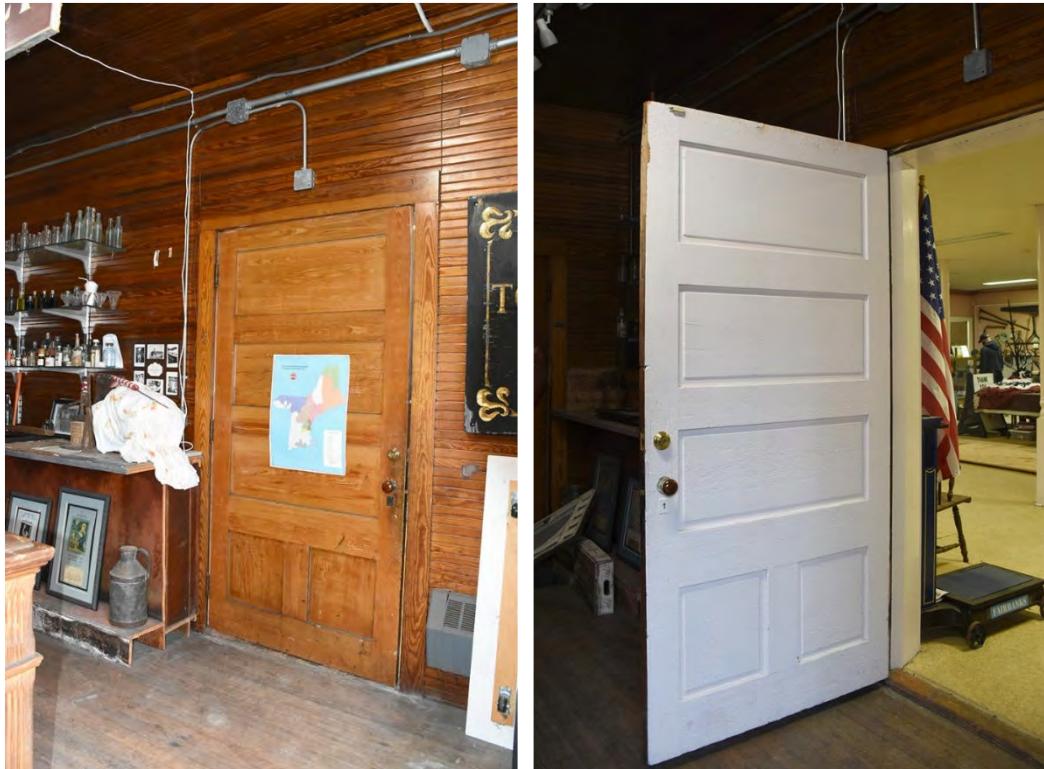
*Photo 63: Five-panel door from the main entrance into the first-floor town hall room. Wear and surface abrasion is apparent on the corner and around the doorknob and lock.*

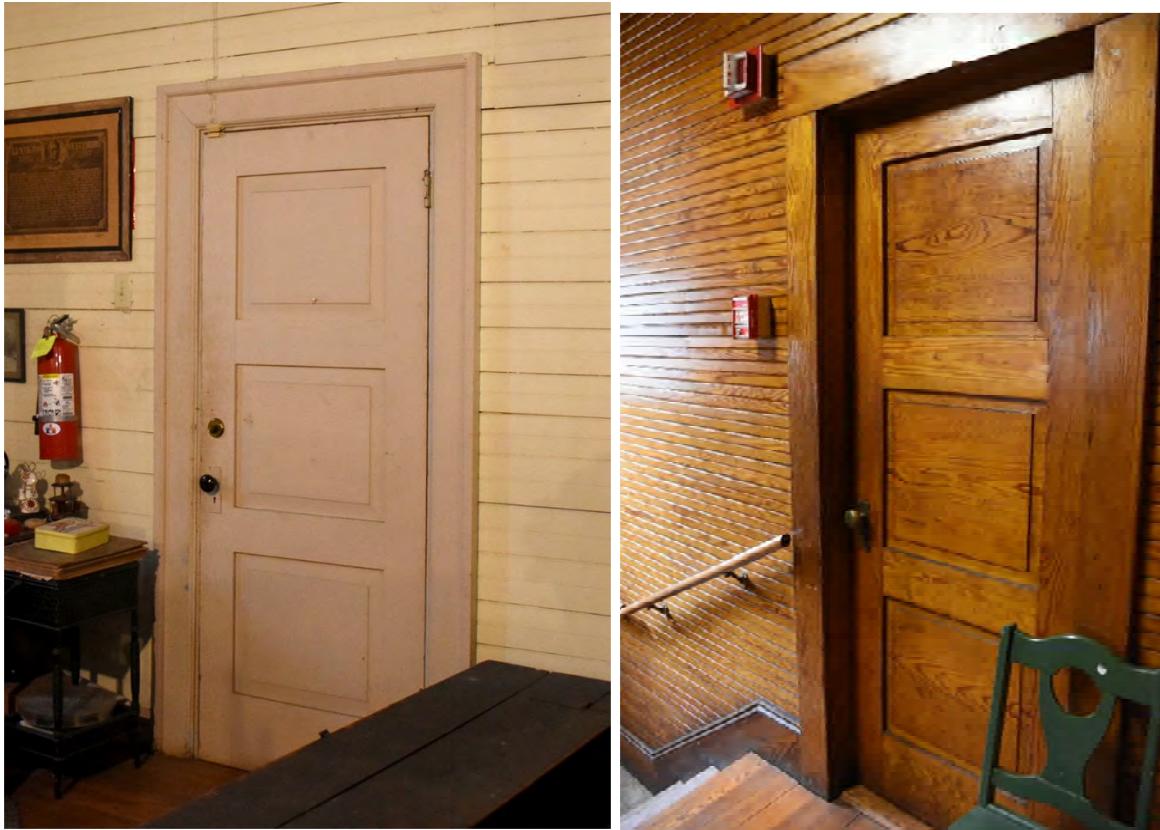
*Photo 64: (left) leading to the southeast stair hall, shows wear and soiling around the locks and hardware.*
