**2021 ANNUAL WETLAND  
MONITORING REPORT  
(REPORT 2)**

**TUSCAN VILLAGE  
POLICY BROOK FLOODPLAIN  
IMPROVEMENT PROJECT**

Salem, New Hampshire

September 15, 2021

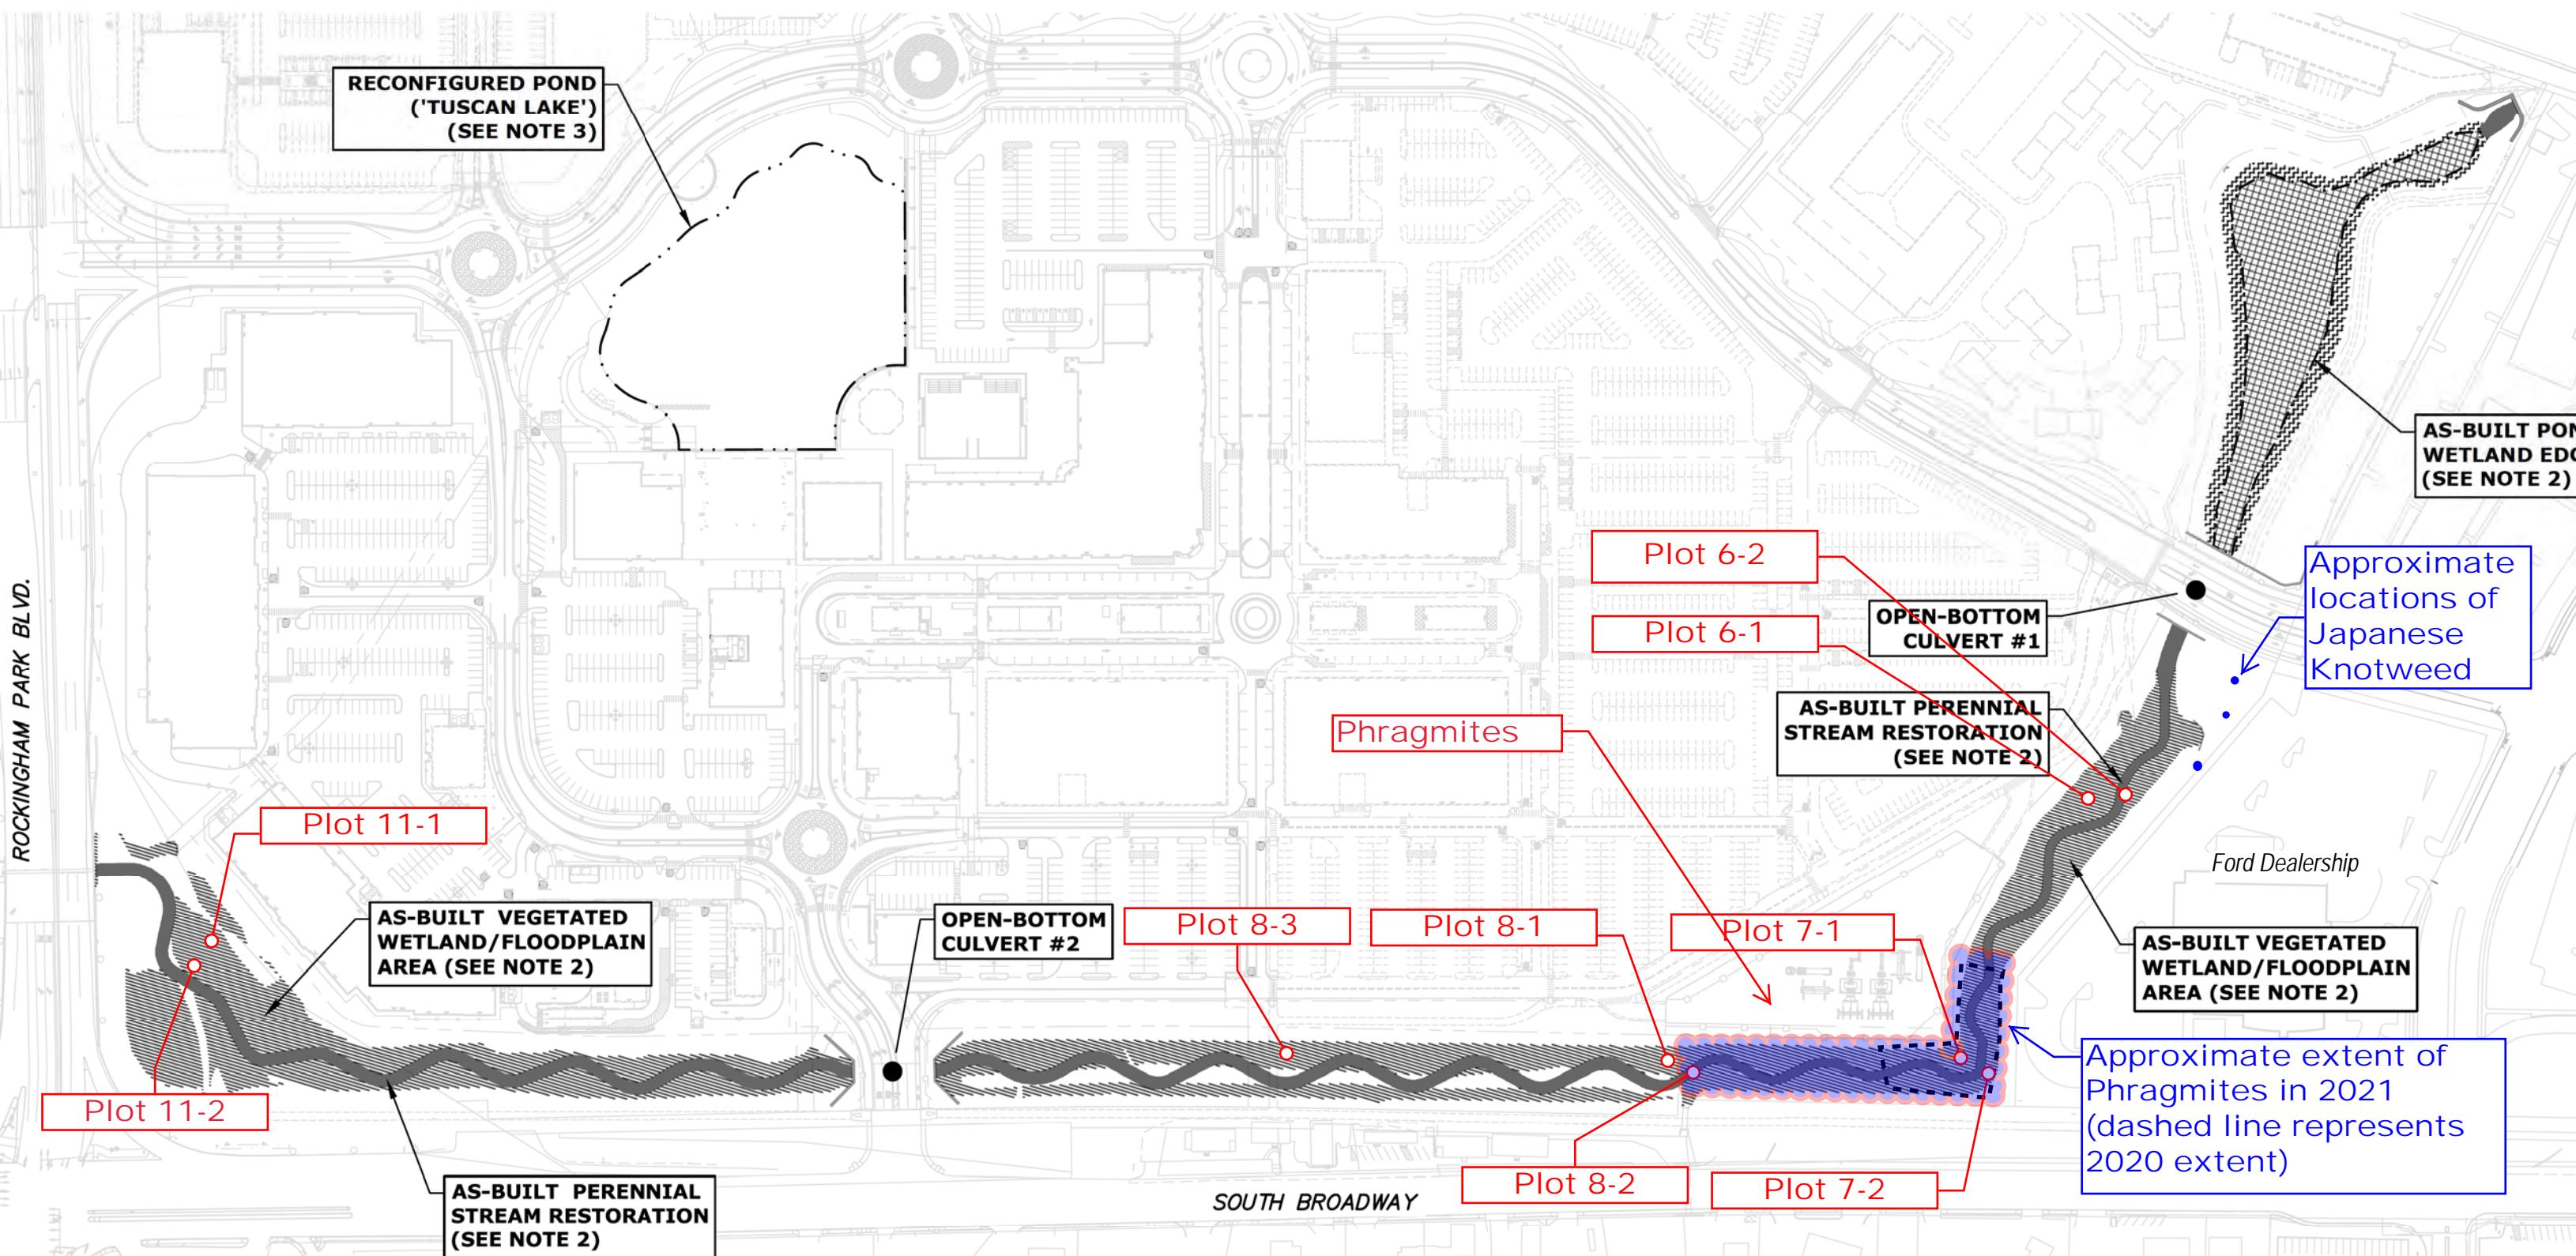
## Tuscan Village Floodplain Improvement Project--2021 Wetland Monitoring Plan

Reference Plan: Wetland Creation Record Drawing, Tighe&Bond, 9/16/20 (as-built plan)

There are three invasive species of concern on the site, one more than was observed in 2020. These are Purple Loosestrife, Phragmites, and Japanese Knotweed. Cover of all invasive species across all plots rose from under 3% to over 5% but distribution is not even. Japanese Knotweed was observed in 3 discrete patches high on the embankment adjacent to the Ford Dealership. Phragmites cover is denser and it has spread downstream from where it was initially observed in 2020. The approximate location of Knotweed and Phragmites is depicted on the monitoring plan.

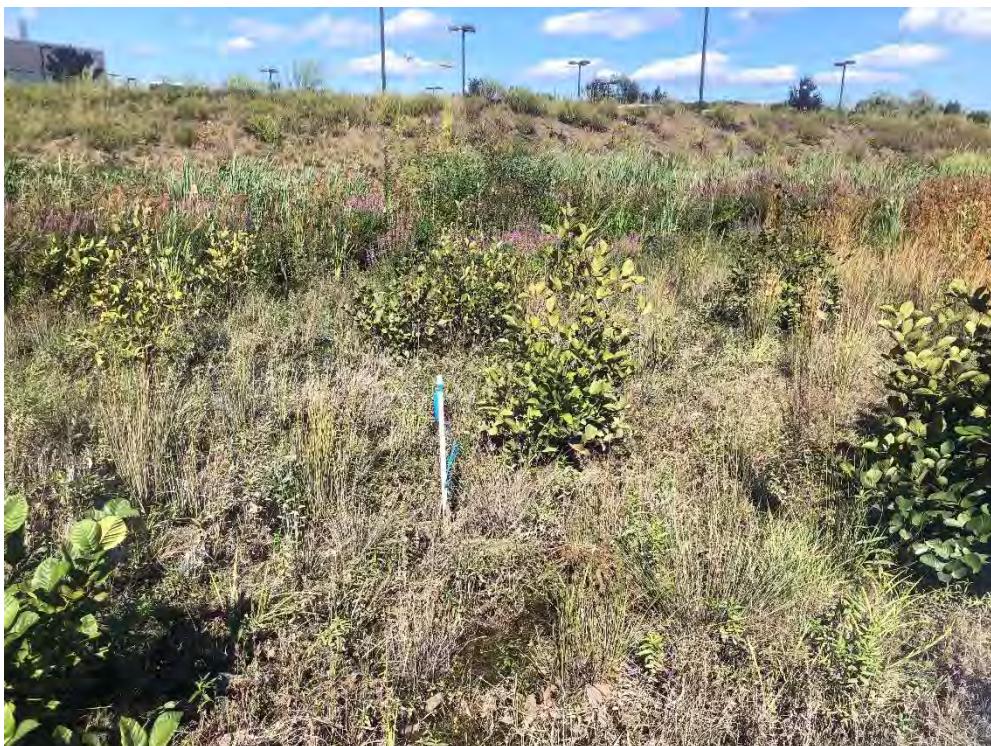
**Photo 2: Data Plot 6-1**

PLOT ID	COMPOSITION OF PLANTS		INDICATOR STATUS	% AREAL COVER	COMMENTS
	COMMON NAME	SCIENTIFIC NAME			
6-1	<b>SHRUBS</b>				
	Speckled Alder	<i>Alnus rugosa</i>	FACW	10	
	Willow	<i>Salix</i> sp.	FACW	2	
	Winterberry	<i>Ilex verticillata</i>	FACW	2	apparent expansion of dormant cutting installation
<b>HERBS</b>					
	Soft Rush	<i>Juncus effusus</i>	FACW	25	
	Slender False Foxglove	<i>Agalinis tenuifolia</i>	FACW	15	
	Canada Rush	<i>Juncus canadensis</i>	OBL	5	
	Nut Sedge	<i>Cyperus esculentus</i>	FACW	5	
	Path Rush	<i>Juncus tenuis</i>	FAC	10	
	Red Clover	<i>Trifolium repens</i>	FACU		
	Purple loosestrife	<i>Lythrum salicaria</i>	OBL	(10)	
	TOTAL % COVER (excluding invasive sp).....			74 %	up 2% from 2020

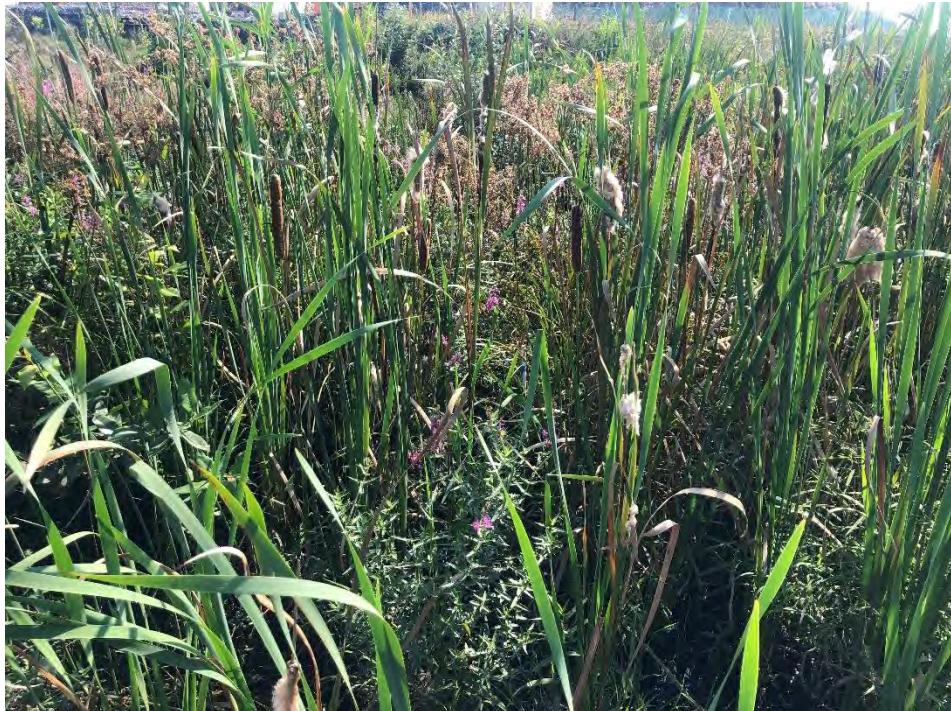
**Photo 3: Data Plot 6-2**

PLOT ID	COMPOSITION OF PLANTS		INDICATOR STATUS	% AREAL COVER	COMMENTS
	COMMON NAME	SCIENTIFIC NAME			
6-2	<b>SHRUBS</b>				
	Willow	Salix sp.	FACW	20	Dormant cutting installation
	<b>HERBS</b>				
	Woolgrass	<i>Scirpus cyperinus</i>	FACW	30	
	Cattail	<i>Typha latifolia</i>	OBL	30	
	Soft Rush	<i>Juncus effusus</i>	FACW	10	
	Rice Cutgrass	<i>Leersia oryzoides</i>	OBL	2	
	Yellow Sedge	<i>Carex flava</i>	OBL	2	
	Northern Water Plantain	<i>Alisma plantago-aquatica</i>	OBL	2	growth of these aquatic species indicates more prolonged inundation
	Water Primrose	<i>Ludwigia palustris</i>	OBL	5	
	Nodding Beggarticks	<i>Bidens cernua</i>	OBL		
	Phragmites	<i>Phragmites australis</i>	FACW	(5)	
	Purple loosestrife	<i>Lythrum salicaria</i>	OBL	(10)	
	TOTAL % COVER (excluding invasive sp).....			100 %	up 8% from 2020

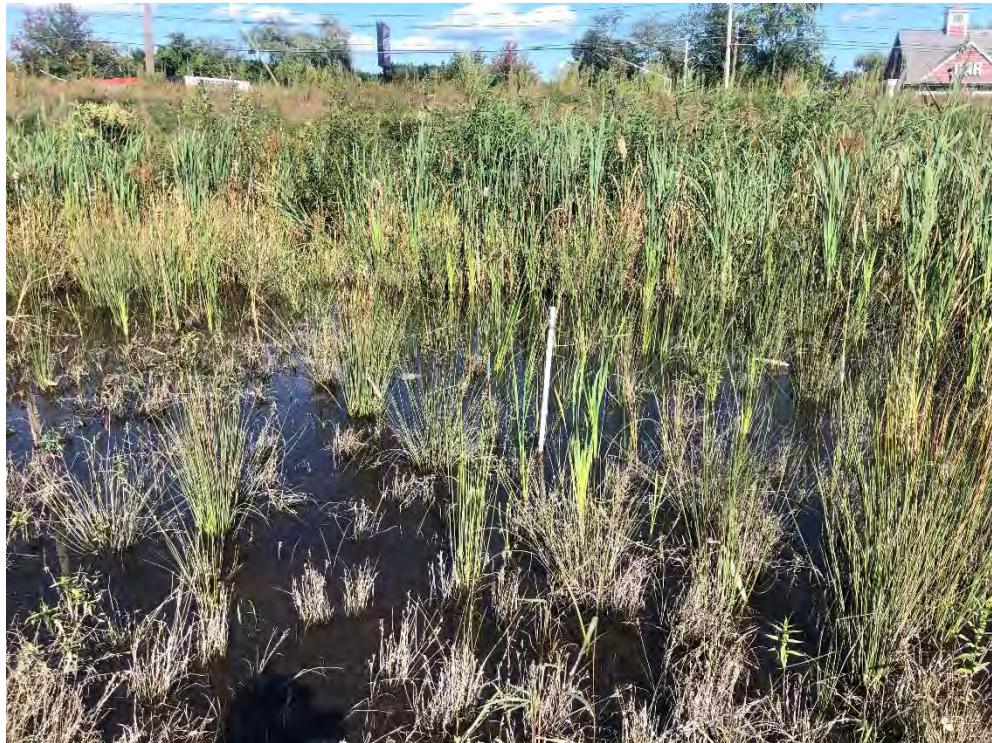
**Photo 5: Plot 7-1**

PLOT ID	COMPOSITION OF PLANTS		INDICATOR STATUS	% AREAL COVER	COMMENTS
	COMMON NAME	SCIENTIFIC NAME			
7-1	<b>SHRUBS</b>				
	Willow	Salix sp.	FACW	2	Dormant cutting installation
	Winterberry	<i>Ilex verticillata</i>	FACW	2	2 planted individuals
	Speckled Alder	<i>Alnus rugosa</i>	FACW	2	apparent expansion of planted material
	<b>HERBS</b>				
	Path Rush	<i>Juncus tenuis</i>	FAC	10	
	Nut Sedge	<i>Cyperus esculentus</i>	FACW	10	
	Cattail	<i>Typha latifolia</i>	OBL	10	
	Purple Stem Beggars Tick	<i>Bidens connata</i>	OBL	2	
	Soft Rush	<i>Juncus effusus</i>	FACW	20	
	Willow Herb	<i>Epilobium leptophyllum</i>	OBL	5	
	Slender False Foxglove	<i>Agalinis tenuifolia</i>	FACW		
	Purple loosestrife	<i>Lythrum salicaria</i>	OBL	(2)	
	Phragmites	<i>Phragmites australis</i>	FACW	(2)	<i>NEW, has expanded into this area</i>
	TOTAL % COVER (excluding invasive sp).....				63 % up 4% from 2020

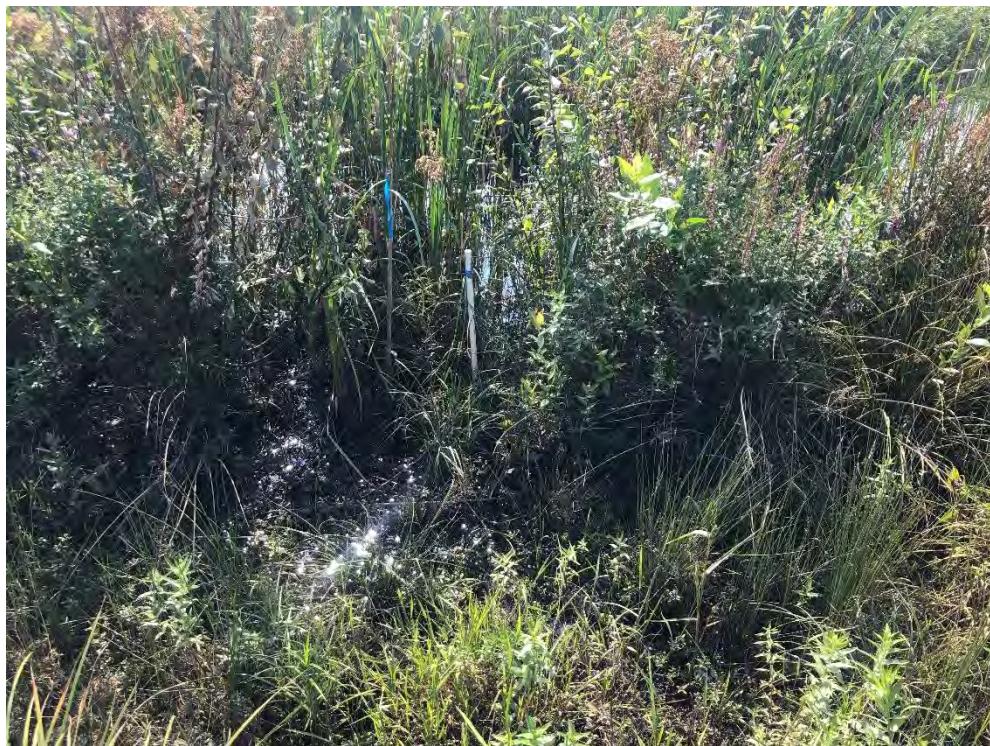
**Photo 6: Plot 7-2**

PLOT ID	COMPOSITION OF PLANTS		INDICATOR STATUS	% AREAL COVER	COMMENTS
	COMMON NAME	SCIENTIFIC NAME			
7-2	<b>SHRUBS</b>				
	Willow	Salix sp.	FACW	35	Dormant cutting installation
	<b>HERBS</b>				
	Cattail	<i>Typha latifolia</i>	OBL	30	
	Woolgrass	<i>Scirpus cyperinus</i>	FACW	20	
	Soft Rush	<i>Juncus effusus</i>	FACW	10	
	Water Primrose	<i>Ludwigia palustris</i>	OBL	2	
	Marsh Bedstraw	<i>Galium palustre</i>	OBL	2	
	Common Groundsel	<i>Senecio vulgaris</i>	FACU		<i>these species appear to have been forced out by wetter conditions</i>
	Nut Sedge	<i>Cyperus esculentus</i>	FACW		
	Purple loosestrife	<i>Lythrum salicaria</i>	OBL	(5)	
	TOTAL % COVER (excluding invasive sp).....			99 %	up 2% from 2020

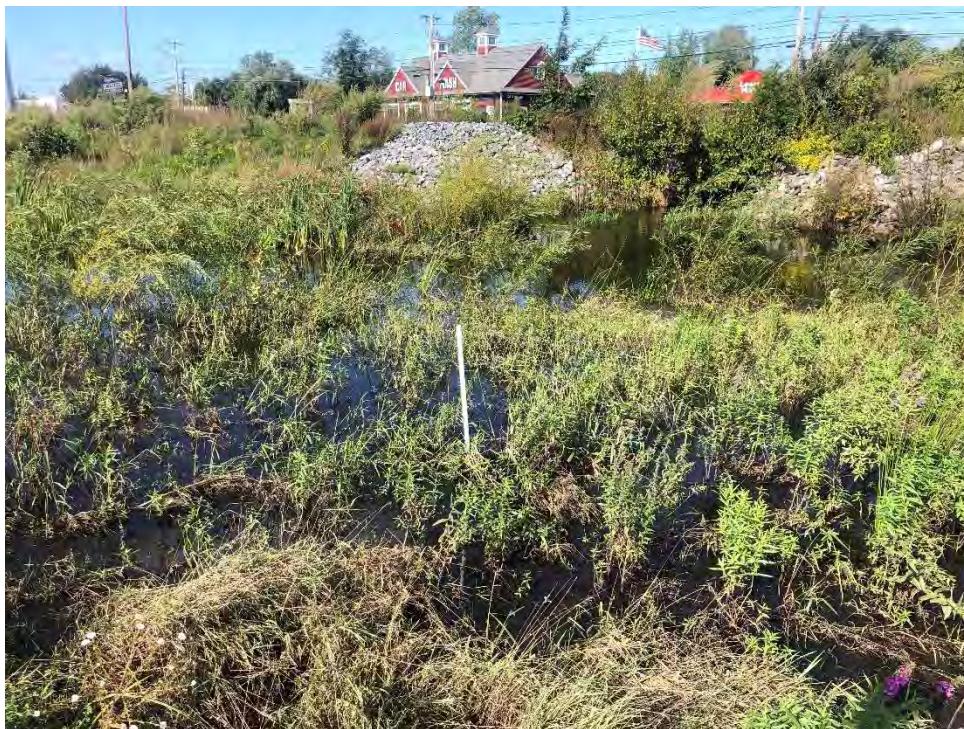
**Photo 8: Data Plot 8-1**

In the middle and lower floodplain, (Plots 8-1, 8-2, 8-3, & 11-1) the wetter hydrology has pushed out upland leaning and early opportunistic species such as *Pennsylvania Smartweed*, *groundsel*, *clover*, *vetch*, *birds foot trefoil*, and *crabgrass*. Since these sections of the floodplain were completed more recently and had also experienced a relatively dry season last year, this type of growth accounted for a larger percentage of the overall cover. Overall cover therefore declined in these areas but was accompanied by a promising shift toward more desirable wetland species.

PLOT ID	COMPOSITION OF PLANTS		INDICATOR STATUS	% AREAL COVER	COMMENTS
	COMMON NAME	SCIENTIFIC NAME			
8-1	<b>SHRUBS</b>				
	Willow	Salix sp.	FACW	5	apparent expansion of dormant cutting instalation
	<b>HERBS</b>				
	Barnyard Grass	<i>Echinochloa crusgalli</i>	FACU	15	
	Nut Sedge	<i>Cyperus esculentus</i>	FACW	5	
	Soft Rush	<i>Juncus effusus</i>	FACW	10	
	Purple loosestrife	<i>Lythrum salicaria</i>	OBL	(15)	
	Red Clover	<i>Trifolium repens</i>	FACU	25	
	Birdsfoot Trefoil	<i>Lotus corniculatus</i>	FACU	20	
	Slender False Foxglove	<i>Agalinis tenuifolia</i>	FACW	15	
	Common Groundsel	<i>Senecio vulgaris</i>	FAVU	10	
	Crabgrass	<i>Digitaria sanguinalis</i>	FACU	10	These UPL leaning species have been pushed out of the area by persistent inundation
	Common Vetch	<i>Vicia sativa</i>	FACU	5	
	TOTAL % COVER (excluding invasive sp).....				down 60% at the time of monitoring due to high water

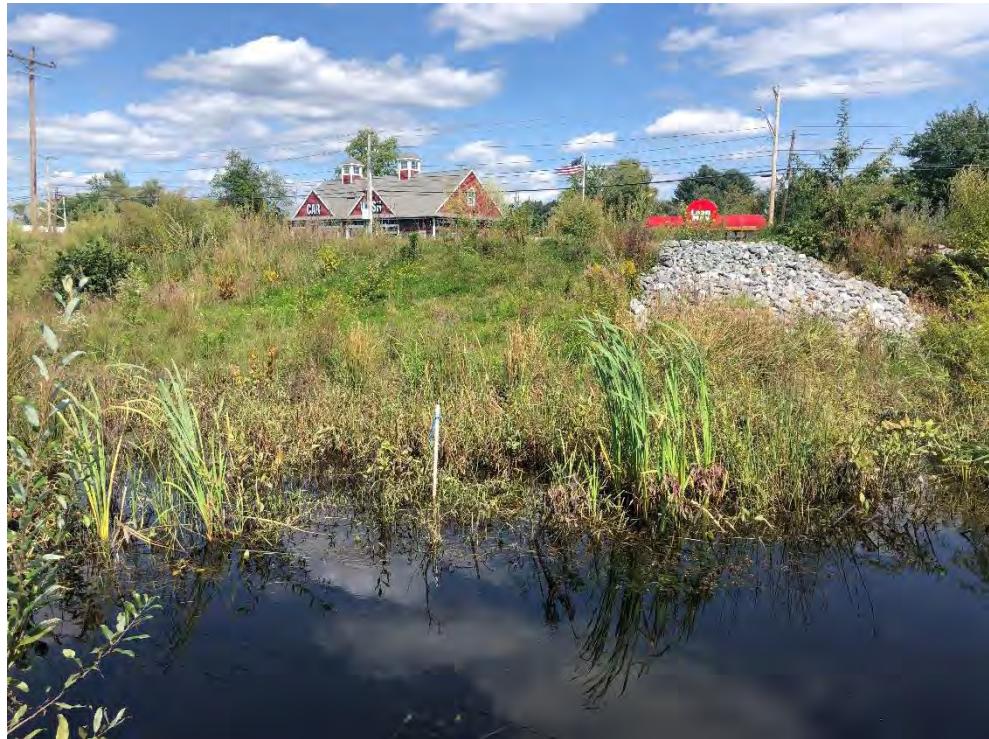
**Photo 9: Data plot 8-2**

PLOT ID	COMPOSITION OF PLANTS		INDICATOR STATUS	% AREAL COVER	COMMENTS
	COMMON NAME	SCIENTIFIC NAME			
8-2	<b>SHRUBS</b>				
	Willow	Salix sp.	FACW	20	Dormant cutting installation
	Silky dogwood	<i>Cornus amomum</i>	FACW	15	Dormant cutting installation
	<b>HERBS</b>				
	Barnyard Grass	<i>Echinochloa crusgalli</i>	FACU	20	
	Nut Sedge	<i>Cyperus esculentus</i>	FACW	2	
	Cattail	<i>Typha latifolia</i>	OBL	5	
	Northern Water Plantain	<i>Alisma plantago-aquatica</i>	OBL	5	
	Pennsylvania Smartweed	<i>Persicaria pensylvanica</i>	FACW	5	
	Water Primrose	<i>Ludwigia palustirs</i>	OBL	5	
	Common Groundsel	<i>Senecio vulgaris</i>	FAVU		
	Purple Stem Beggars Tick	<i>Bidens connata</i>	OBL		
TOTAL % COVER (excluding invasive sp).....			77%	down 10% from 2020

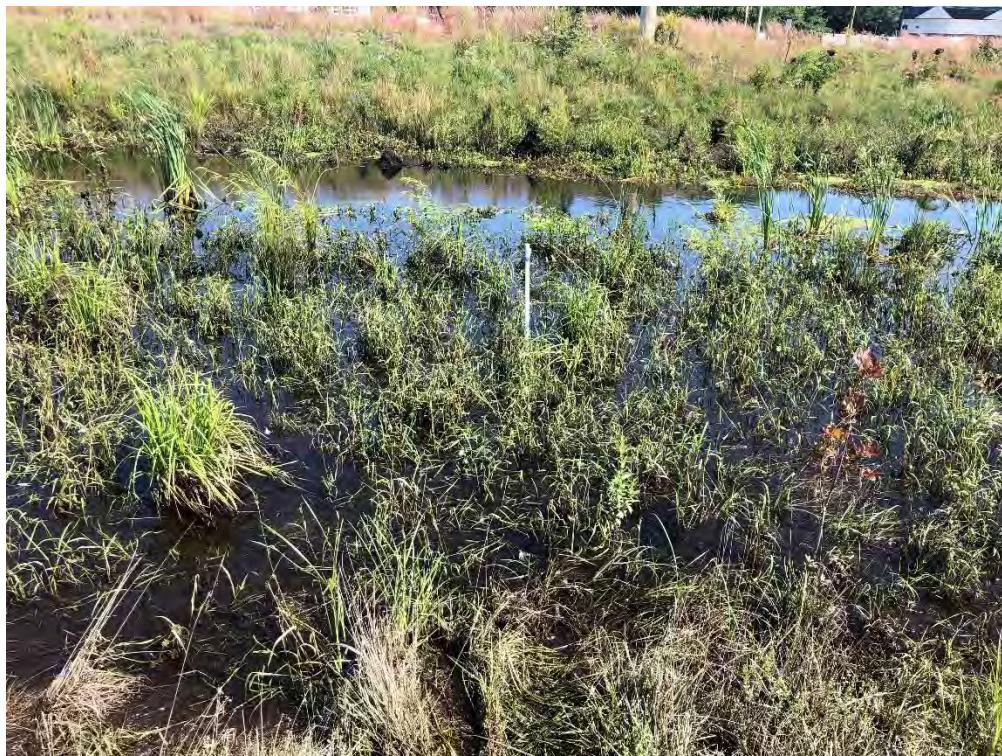
**Photo 10: Data Plot 8-3**

PLOT ID	COMPOSITION OF PLANTS		INDICATOR STATUS	% AREAL COVER	COMMENTS
	COMMON NAME	SCIENTIFIC NAME			
8-3	<b>SHRUBS</b>				
	Willow	Salix sp.	FACW	5	Dormant cutting installation
	Winterberry	<i>Ilex verticillata</i>	FACW	2	
	<b>HERBS</b>				
	Barnyard Grass	<i>Echinochloa crusgalli</i>	FACU	20	
	Pennsylvania Smartweed	<i>Persicaria pensylvanica</i>	FACW	10	
	Nut Sedge	<i>Cyperus esculentus</i>	FACW	2	
	Northern Water Plantain	<i>Alisma plantago-aquatica</i>	OBL	5	
	Yellow Sedge	<i>Carex flava</i>	OBL	5	
	Crabgrass	<i>Digitaria sanguinalis</i>	FACU		
	Common Groundsel	<i>Senecio vulgaris</i>	FACU		
	Slender False Foxglove	<i>Agalinis tenuifolia</i>	FACW		
	TOTAL % COVER (excluding invasive sp).....				49 % down 15% from 2020

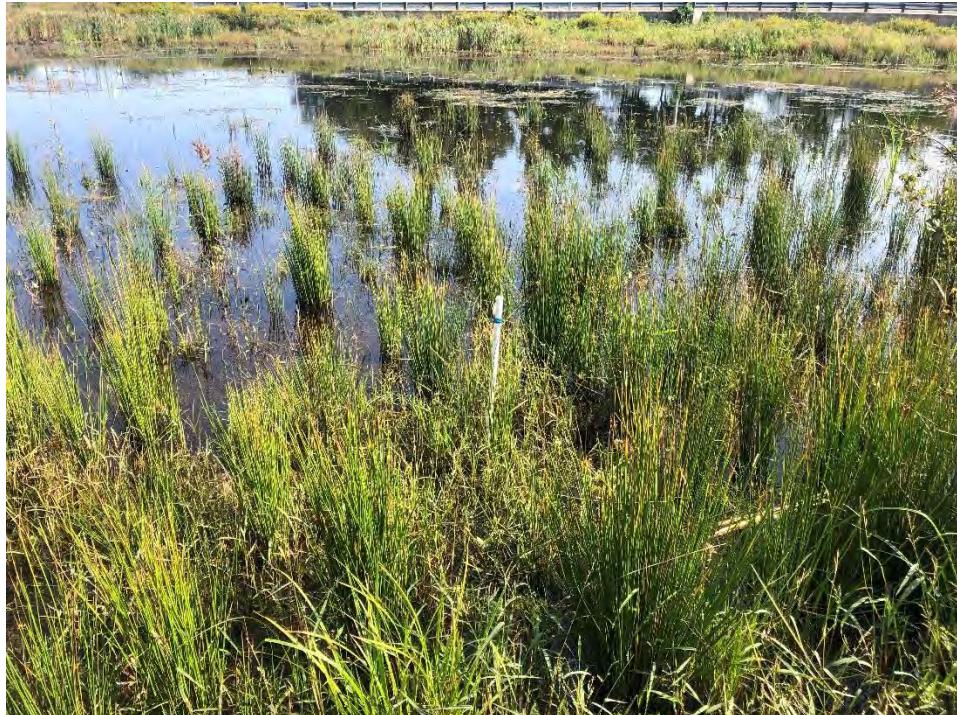
**Photo 11: Data Plot 11-1**

PLOT ID	COMPOSITION OF PLANTS		INDICATOR STATUS	% AREAL COVER	COMMENTS
	COMMON NAME	SCIENTIFIC NAME			
11-1	<b>SHRUBS</b>				
11-1	Speckled Alder	<i>Alnus rugosa</i>	FACW	5	2 planted individuals
	Winterberry	<i>Ilex verticillata</i>	FACW	2	2 planted individuals
	<b>HERBS</b>				
	Nut Sedge	<i>Cyperus esculentus</i>	FACW	5	
	Soft Rush	<i>Juncus effusus</i>	FACW	30	
	Northern Water Plantain	<i>Alisma plantago-aquatica</i>	OBL	10	
	Pennsylvania Smartweed	<i>Persicaria pensylvanica</i>	FACW	2	
	Rabbits-Foot Clover	<i>Trifolium arvense</i>	NA		
	Birdsfoot Trefoil—	<i>Lotus corniculatus</i> —	FACU		
	TOTAL % COVER (excluding invasive sp).....				54 % down 8% from 2020

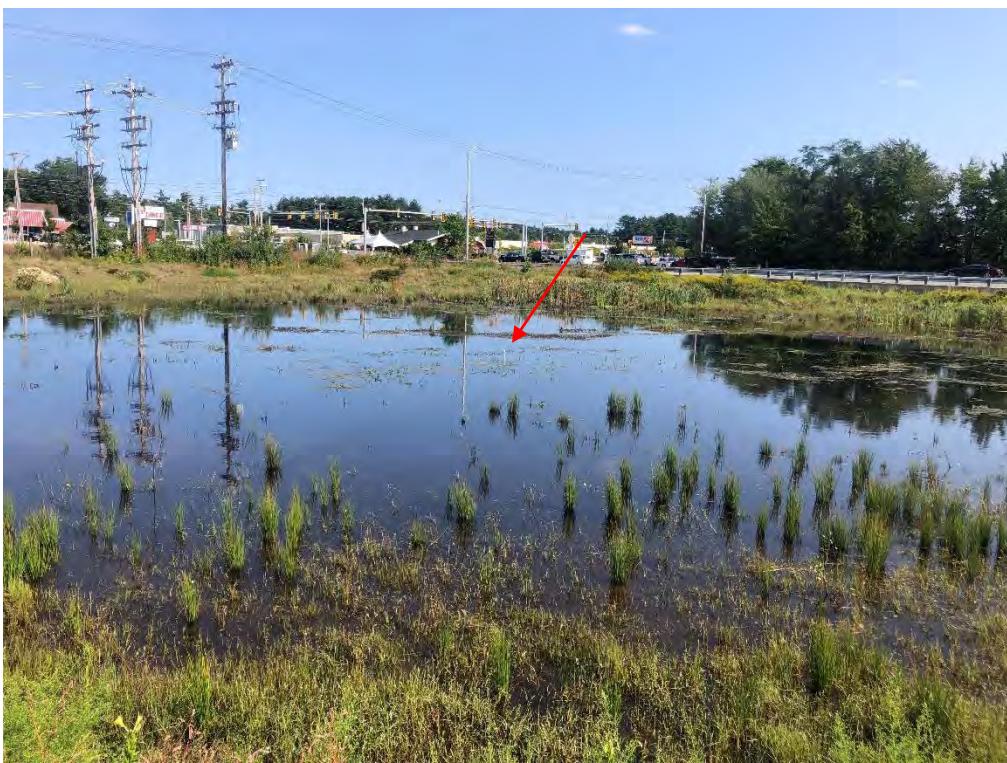
**Photo 11: Data Plot 11-2**

A somewhat different scenario exists on the interior of the lower floodplain (plot 11-2) which appears to have been persistently inundated to a depth that has prevented most

vegetation from growing. This area is dominated by Northern Water Plantain and Water Primrose with a scattering of cattail and Soft rush. Under these conditions, the lower floodplain will likely develop as emergent wetland along its edges with something closer to aquatic bed wetland in the deeper area immediately along the channel.

PLOT ID	COMPOSITION OF PLANTS		INDICATOR STATUS	% AREAL COVER	COMMENTS
	COMMON NAME	SCIENTIFIC NAME			
11-2	SHRUBS				
	Willow	Salix sp.	FACW		Dormant cutting installation, installed ~30 feet from bank due to extent of flooding at time of installation
	HERBS				
	Northern Water Plantain	<i>Alisma plantago-aquatica</i>	OBL	5	
	Red Root Flat Sedge	<i>Cyperus erythrorhizos</i>	OBL		Plot was flooded by more than 12" which appears to be a persistent A. plantago was the only recognizable species but its not clear if others, particularly willow are still viable
	Barnyard Grass	<i>Echinochloa crusgalli</i>	FACU		
	Common Groundsel	<i>Senecio vulgaris</i>	FACU		
	Pennsylvania Smartweed	<i>Persicaria pensylvanica</i>	FACW		
	Purple loosestrife	<i>Lythrum salicaria</i>	OBL		
	TOTAL % COVER (excluding invasive sp).....				5 % down 92% from 2020

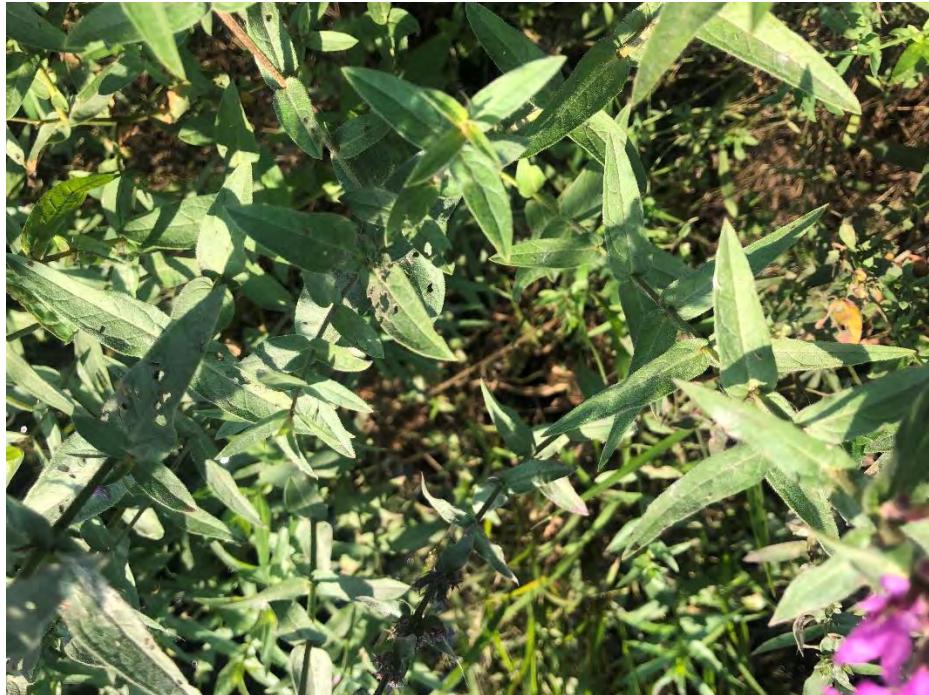
Purple Loosestrife is widely distributed along the floodplain in nearly all shallowly inundated and saturated areas. Galerucella beetle remains active at the site. Although the less feeding damage was observed this year on Purple Loosestrife, the beetle does appear to be exerting some control over the population of this invasive plant. Though widely distributed, much of the Purple Loosestrife is short and with relatively fewer plants flowering than would be expected within a vigorous population. This may also be due in part to high water levels and the availability of food (Purple Loosestrife) both of which effect the reproductive cycle of the beetle. The relative success of Purple Loosestrife can be expected to vary from year to year depending on these factors.

**Photo 13: Galerucella beetle is still active on the site but less plant damage is visible in 2021**

Purple Loosestrife is widespread in the floodplain but the most practical and effective long term control is already in place in the form of biological control by Galerucella beetle. There is evidence that the beetle is currently exerting pressure on the Purple Loosestrife population.

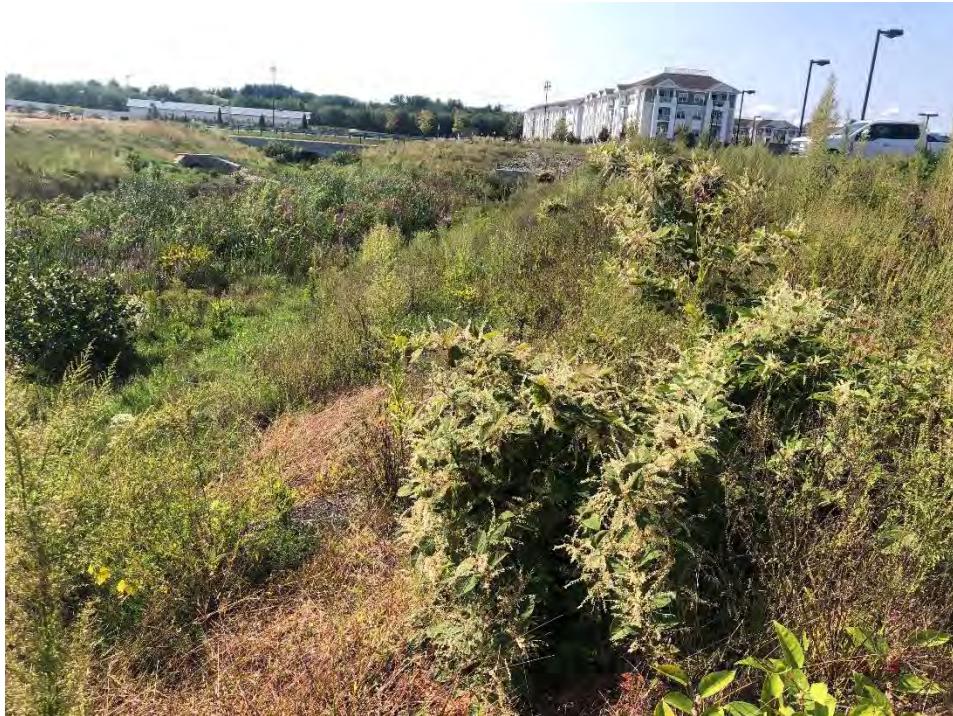
Eradication of Phragmites from the floodplain and Japanese Knotweed from the embankment is of paramount importance. Either of these species has the potential to have very negative effects on the floodplain, not only from a biological perspective but also an aesthetic perspective, which is an important consideration for the Tuscan Village development.

**Photo 14: Japanese Knotweed on the embankment adjacent to Ford Dealership**

Aggressive corrective action to address the two invasive species Phragmites and Japanese Knotweed has been recommended and discussed with Tuscan Village personnel. The recommended method for treating the small patches of Japanese Knotweed on the embankment is a foliar treatment of Glyphosate based herbicide and follow up treatment of regrowth in early summer of 2022. Alternative methods may involve careful removal of the above ground portions of the plant smothering with black plastic and mulch, or a combination of smothering and herbicide. The recommended method for treatment of the Phragmites is targeted application of Glyphosate based herbicide using a hand wiping technique to avoid collateral damage to desirable vegetation.

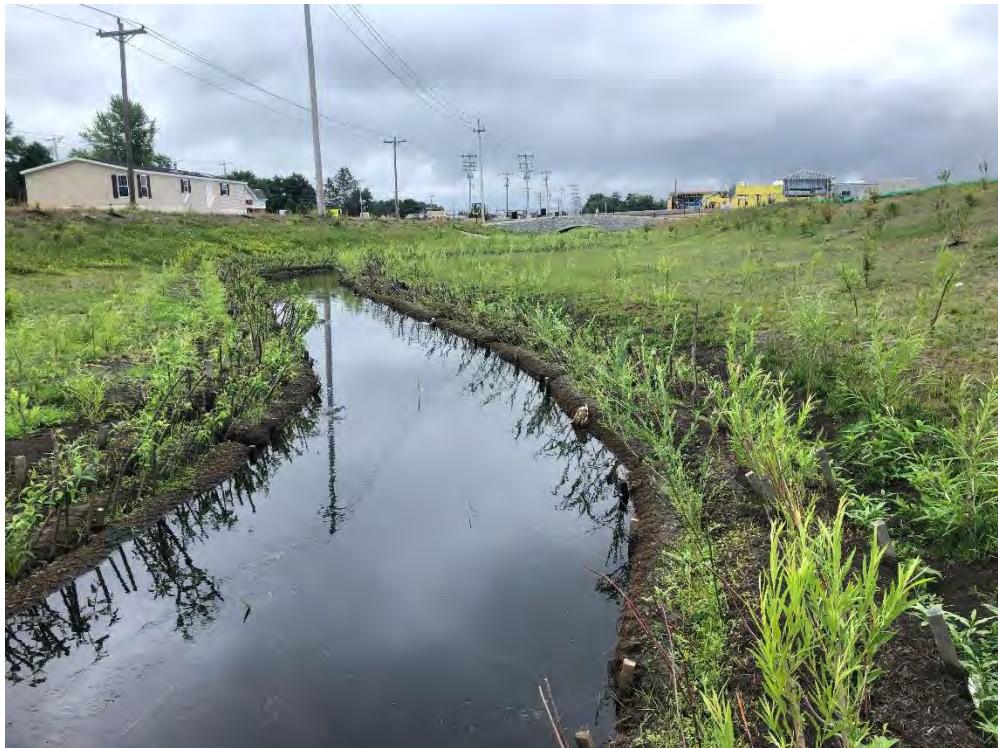
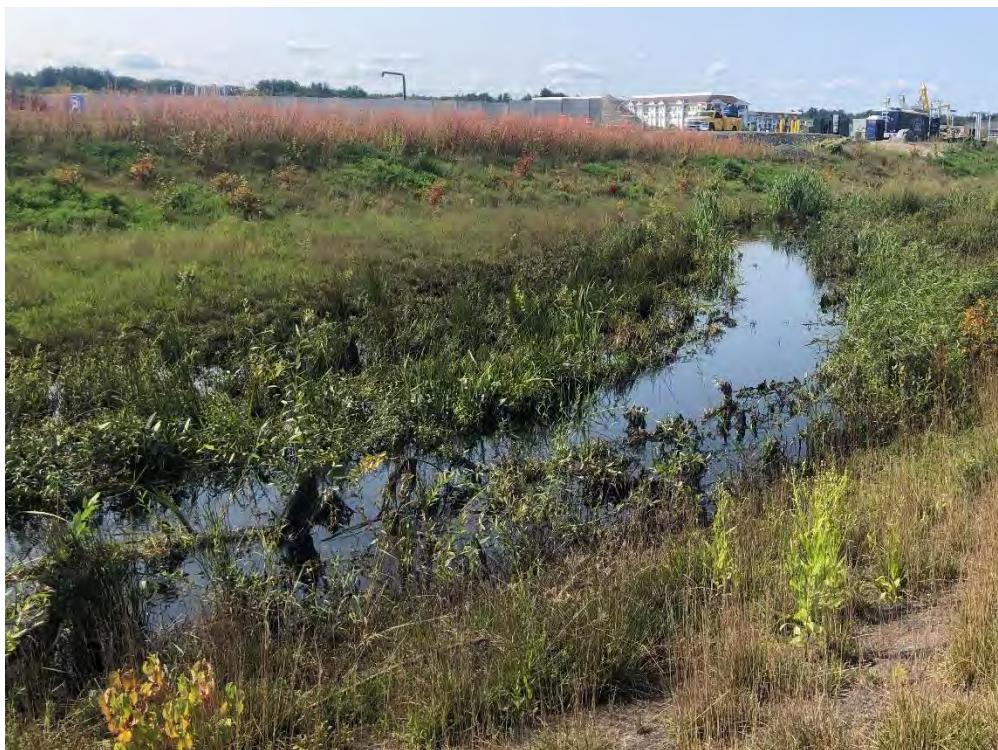
**Photo 15&16: Same section of floodplain (taken from opposite directions) June 2020 (above) and September 2021 (below)**

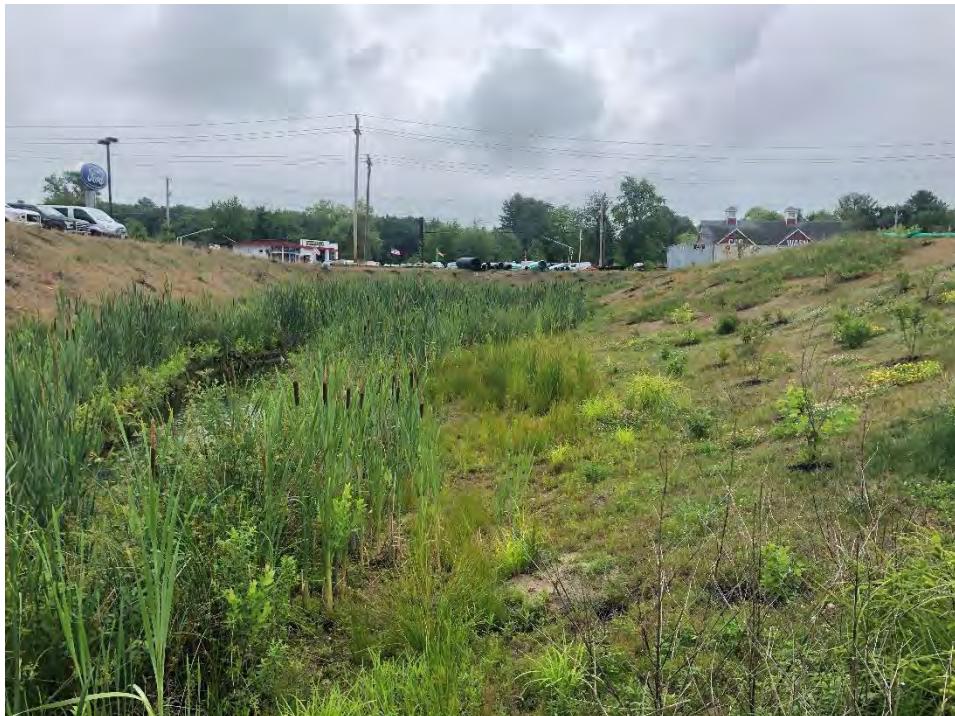
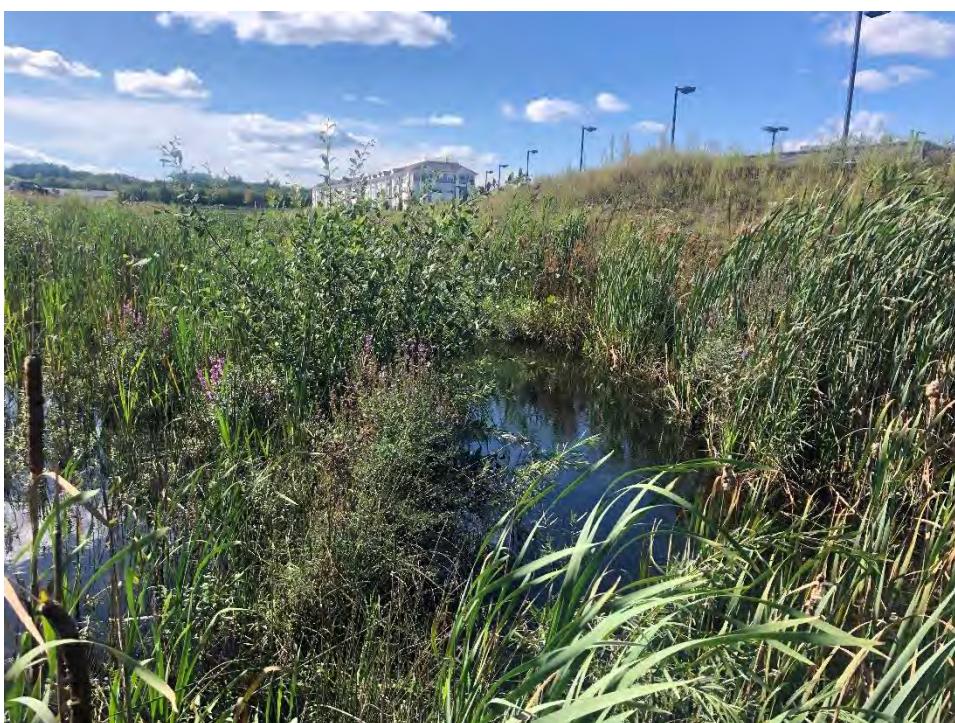
**Photo 17 & 18: The stretch of channel adjacent to the Ford dealership (taken from opposite directions) Sept 2020 (above) and September 2021 (below)**
