**HAZARDOUS MATERIALS SURVEY  
COMMERCIAL BUILDING  
4 SOUTH BROADWAY  
SALEM, NEW HAMPSHIRE**

**January 2020**

**Project 19039**

January 9, 2020

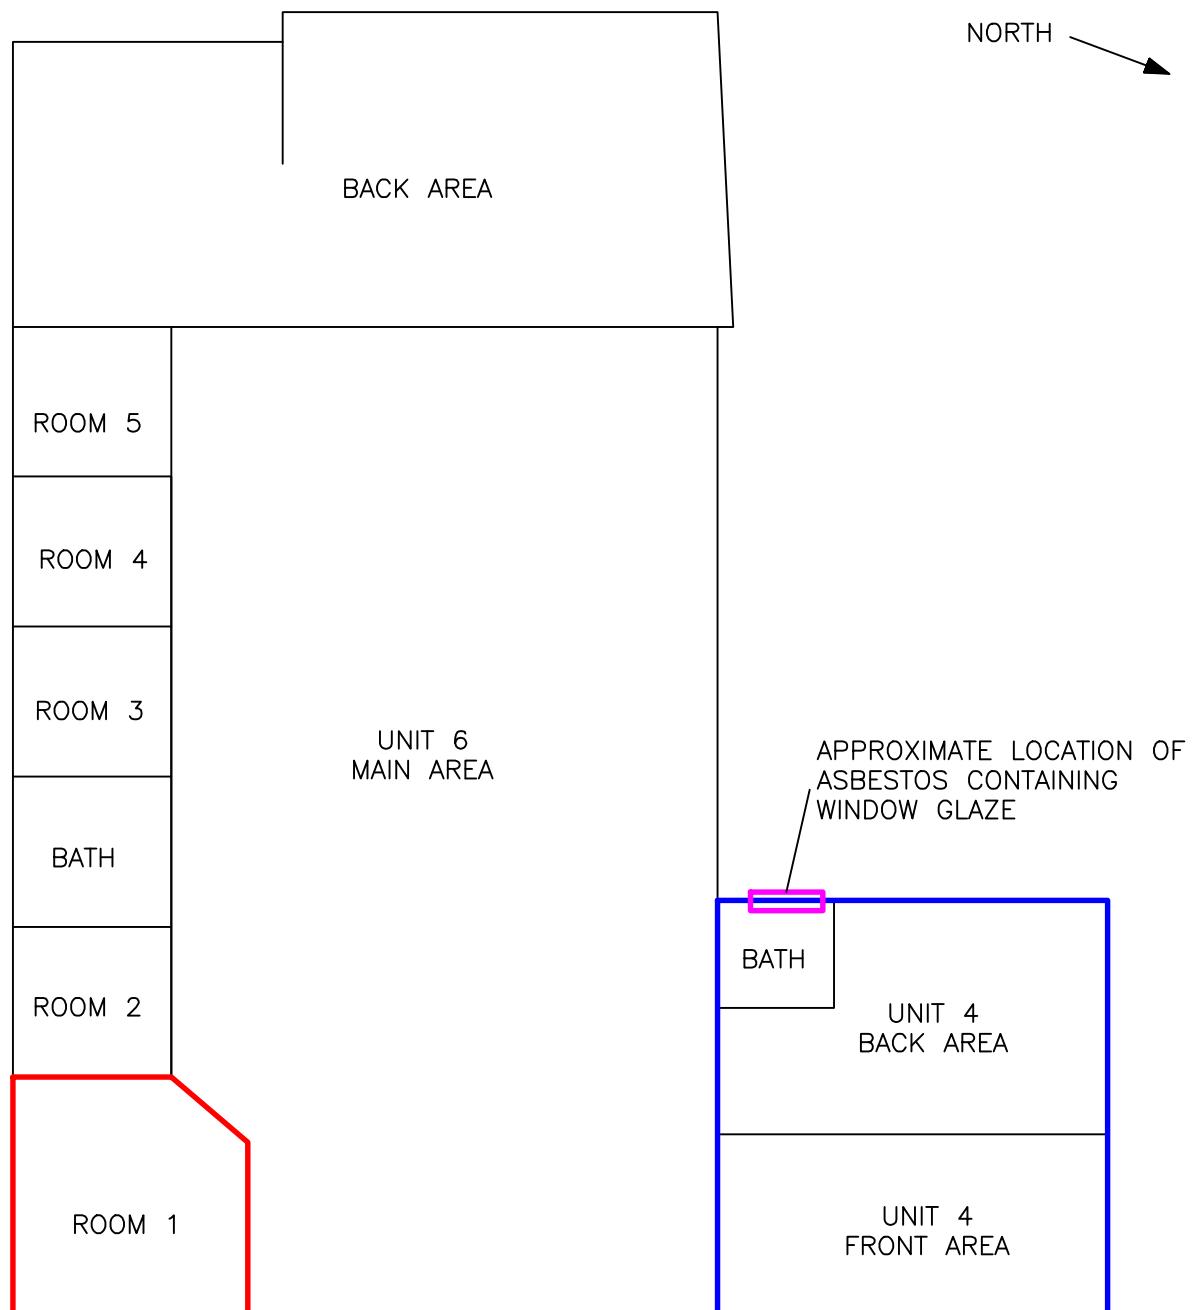
FIGURE: 1  
PROJECT NO.: 19039  
DATE: JANUARY 2020

Based on the review of analytical data associated with the above bulk sample collection, asbestos was **positively** identified at the 14 South Broadway building. Please refer to **Appendix E** which summarizes the materials, locations, and estimated quantities that tested positive for asbestos at the 4 South Broadway building. Site photographs are included in **Appendix A**. A Site Plan is included as **Figure 1**.
