# Conditions Assessment Report

Old Town Hall  
310 Main Street, Salem, NH

June 2021

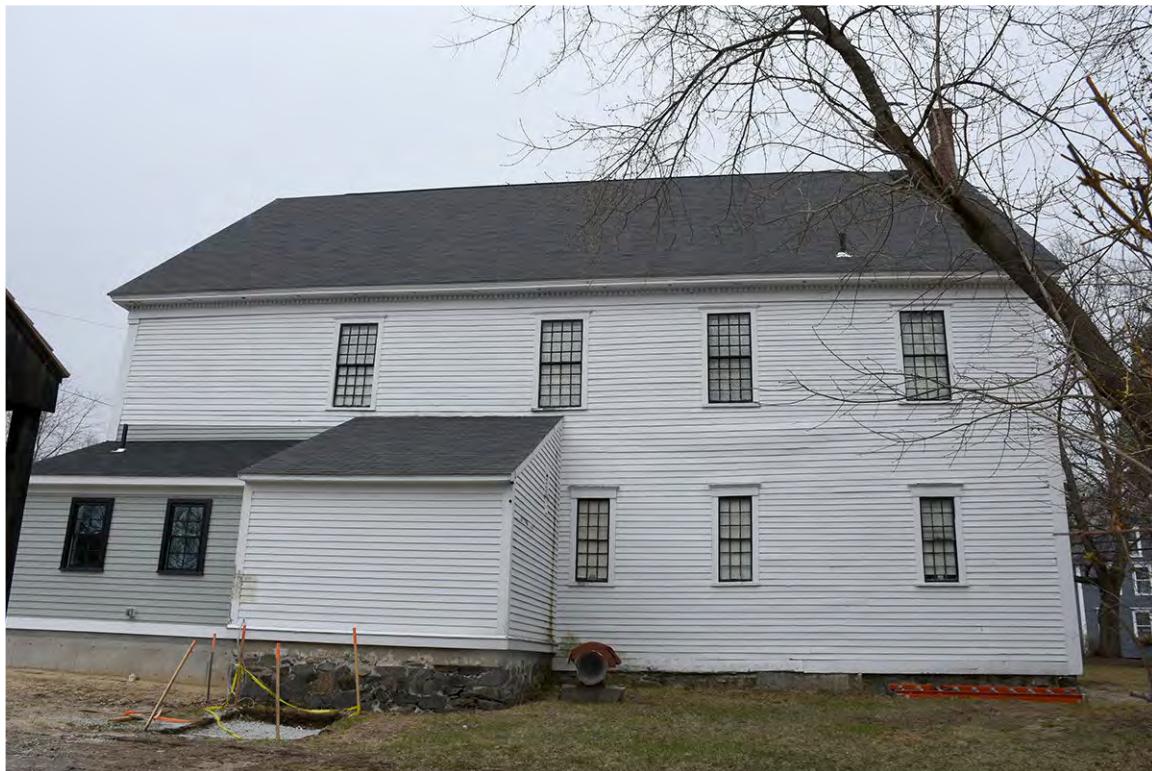
*Photo 4: East elevation, facing the Spicket River. The larger shed addition was constructed to house the vault in 1938-9, and the bathroom addition at left was just constructed to replace an older shed addition.*

The north elevation foundation, which dates to 1908 is also minimally exposed. It is constructed of mortared fieldstone. The east side of the building also has mortared fieldstone except for the area of the original north corner, which has larger, granite face stones (Photo 4, Page 17). The shed addition containing the vault on the east also has a mortared fieldstone foundation topped by a poured concrete slab. The foundation beneath the slab has open joints and should be repointed (Photo 43, Page 52). The joint between the addition and the main building foundation has visible biogrowth in the form of moss on the stones and clapboards (Photo 42 above). Moisture remediation in this area might be necessary, though an interior, north-facing corner is a common area for moisture problems. The biogrowth should be carefully cleaned off with a non-toxic detergent and natural-bristle brush. A gravel or crushed stone border could be installed here to allow for moisture to evaporate more quickly.

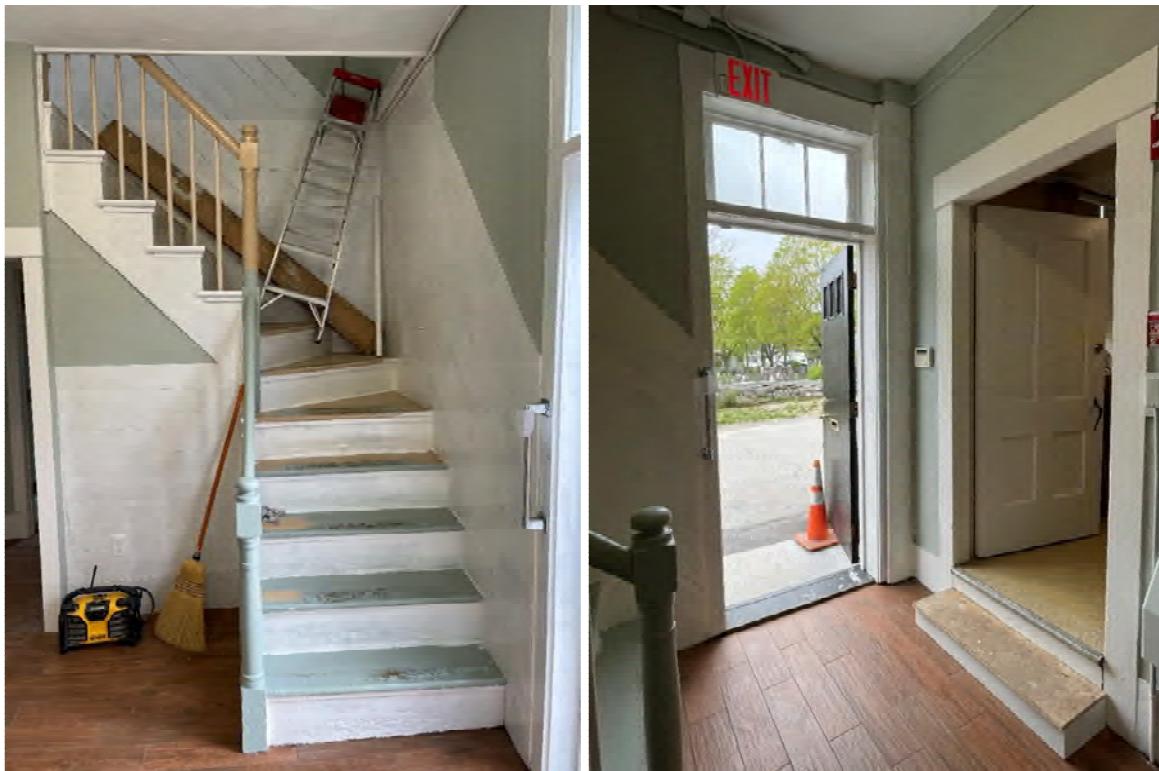
*Photo 6: (left) Stairs in the southeast corner, in the process of being repainted.*

The stairway in the southeast corner of the building, adjacent to the side entrance, is likely very early, one of two original staircases (Photo 6, Page 20). The railing and balusters may be twentieth

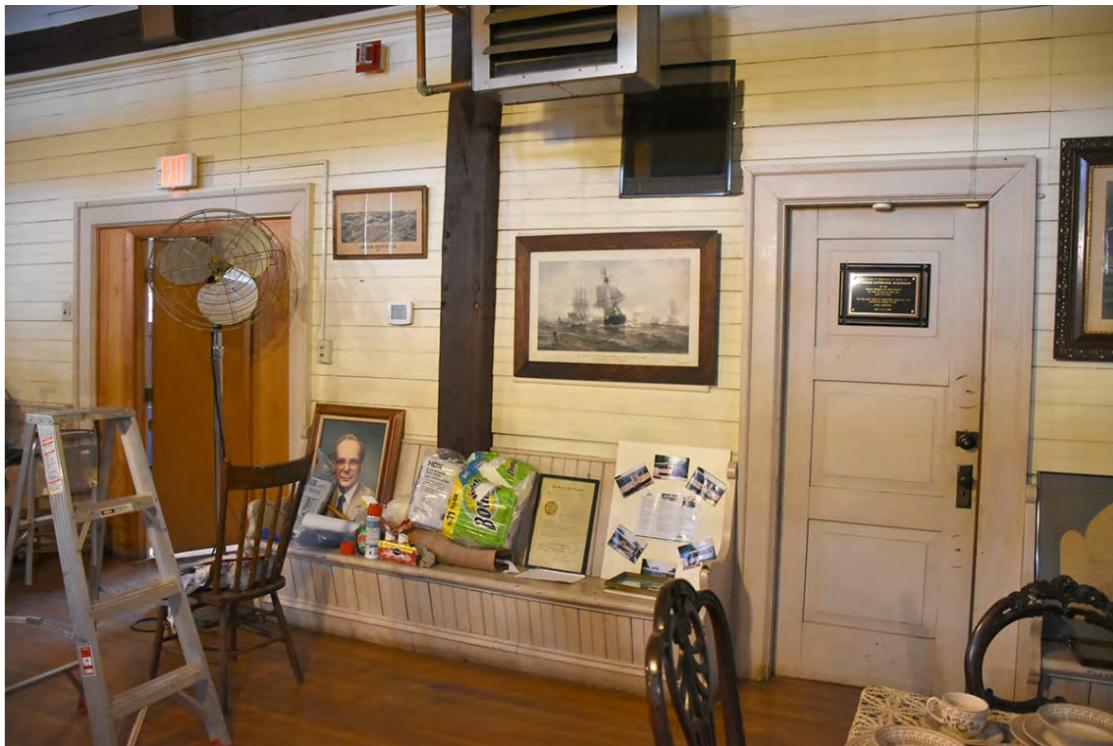
*Photo 15: Main hall on the second floor, looking northwest. Door to the north stair at left, door to the “Military Room” at right.*

Photo 64 and Photo 65 above). Those leading into the main room are painted and in good working condition. The surfaces of all are worn from use and could use repainting, especially the door to the “Military Room,” which has a number of locks and security sensors on it (Photo 15, Page 27). The door leading from the “Military Room” to the stair hall (Photo 65 above), as well as the door directly below it from the kitchen to the stair hall, is varnished rather than painted and both are in very good condition. These doors generally remain locked and unused.

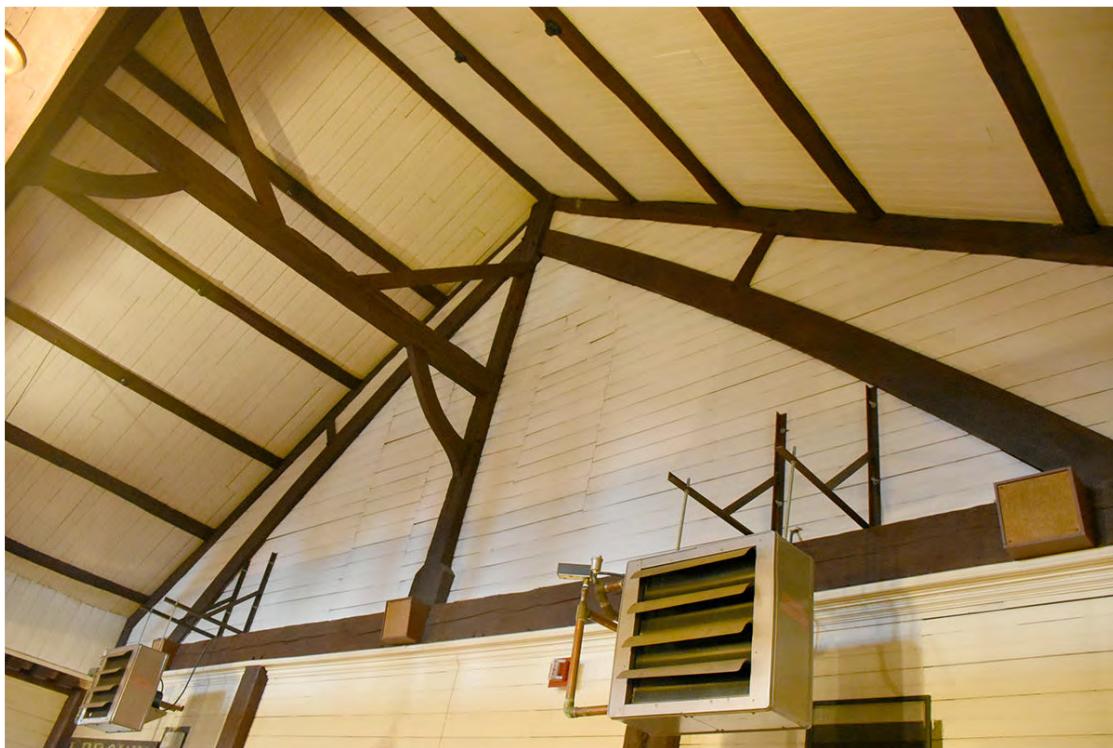
*Photo 16: Exposed roof framing in the second-floor hall, north wall. The former openings for the paired arched windows are visible in the beaded matchboard sheathing.*

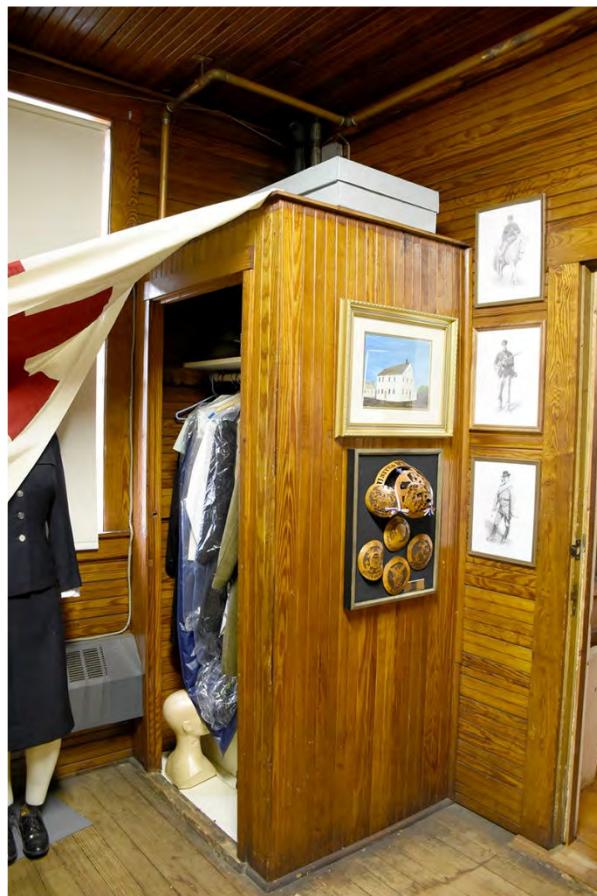
*Photo 21: Water closet in the "Military Room", now used as a storage closet. Vent pipe still remains, extending through the roof.*

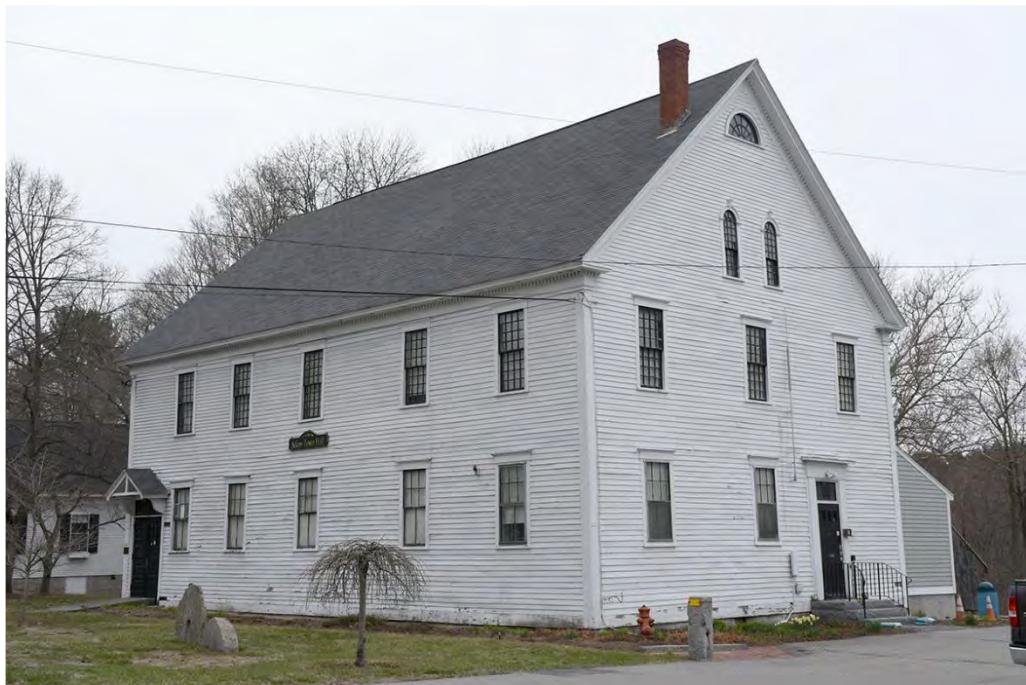
The exterior of the Old Town Hall is generally in good condition. Recent maintenance efforts have been focused on the bathroom addition in the southeast corner of the building, which was fully rebuilt in 2021. Otherwise very few exterior repairs have been undertaken since the roof was replaced in 2008.

*Photo 24: Exterior façade and south elevation.*

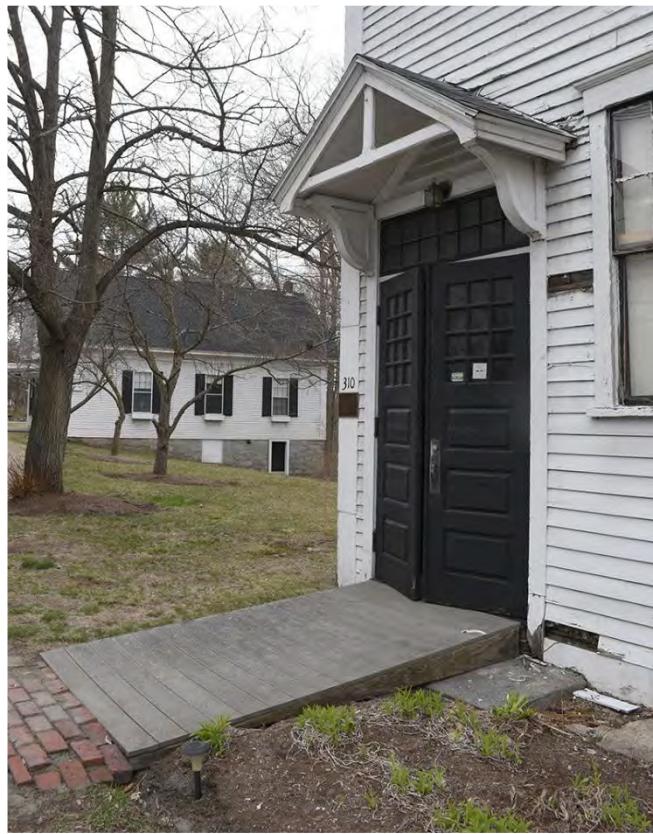
*Photo 35: Main entrance on the west façade. These doors date to the 1908 stairwell addition.*

The main entry doors on the west elevation were added in 1908 when the northern stair addition was constructed. These double doors are in good condition and still function as the main entrance to the building. The exterior of the doors is painted black, and the 12-light panel in the upper third of each door has small, square panes of glass that generally match the design of the Colonial Revival 16/16 sash windows of the second floor. Above the door, the 14-lite (2 x 7) transom window also has square panes of glass, though the transom is boarded up on the interior. A wood ramp provides accessible entry and sits directly upon a large stone step. The right-hand door has recent damage to the interior of the muntins in the upper panel of lights (Photo 36, Page 46 below). The damage should be repaired and the doors repainted.

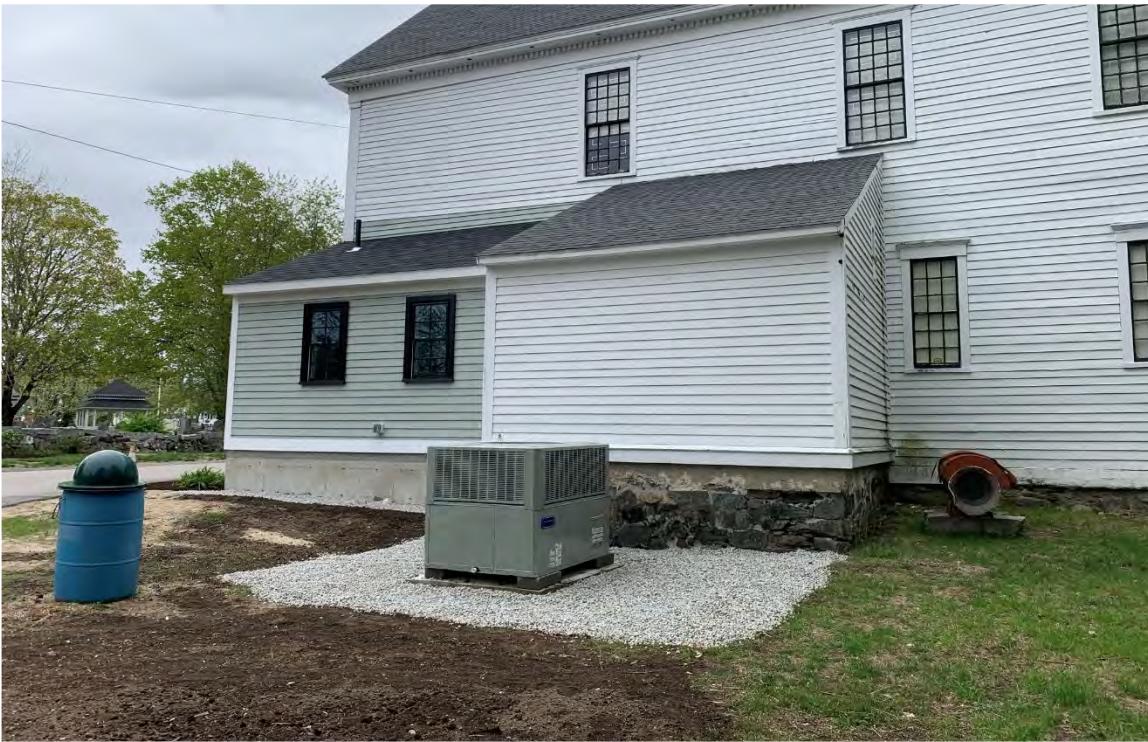
*Photo 43: Air conditioning unit newly installed on the east side of the building.*

A new HVAC compressor has recently been installed just behind the vault addition on a concrete pad surrounded by gravel (Photo 43 above). This should be screened with either a wood frame and lattice enclosure or with landscaping.

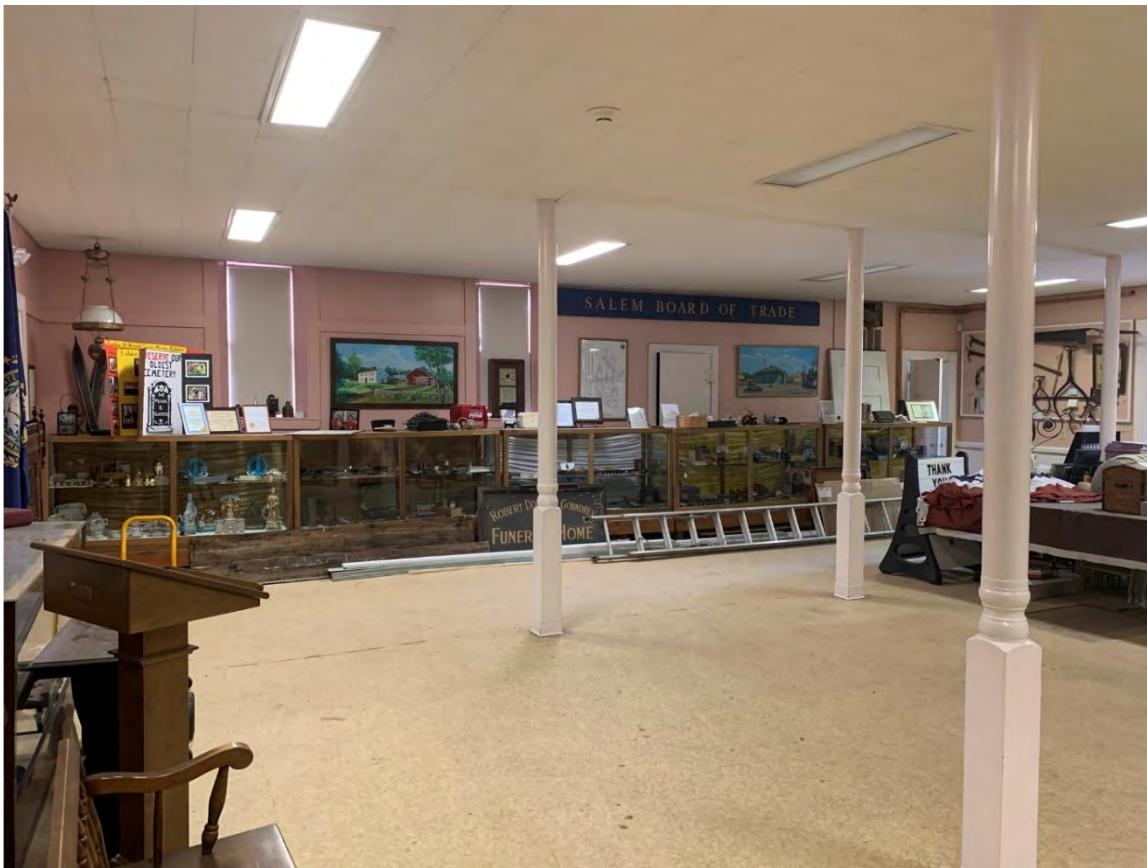
*Photo 44: First floor main room, former town hall space, with dropped ceilings and fiberboard covered walls, looking southeast.*

The first-floor main room has mid-twentieth century finishes, including a pressed-tile dropped ceiling, painted wall boards, and vinyl sheet flooring (Photo 44 above). The finishes are in moderate condition, with a few of the ceiling tile seams sagging, and only one area on the south wall missing a tile. A plaster ceiling is visible behind the tile at that location. The recessed fluorescent lighting is in good condition, though two light fixtures are not functional due to either old bulbs or electrical issues. The flooring is in good to poor condition, with areas of heavy wear and edges peeling or warping.

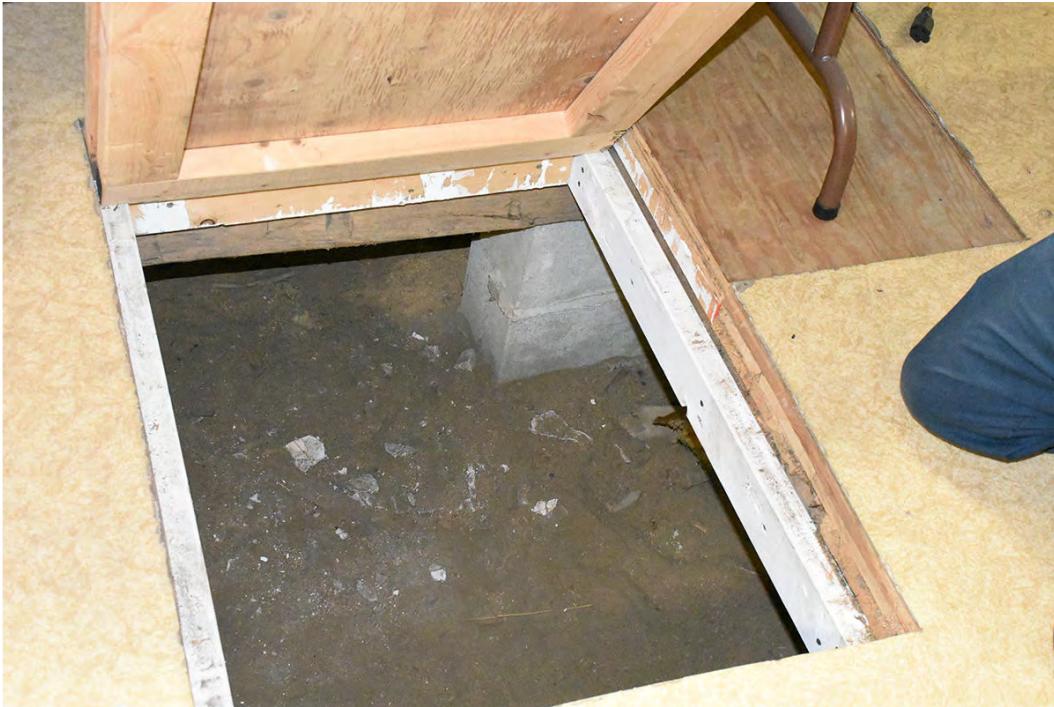
*Photo 45: Trap door in floor of the main room providing access to the crawlspace. Area is clean and dry, and CMU blocks supporting floor structure are visible.*

Access to the crawlspace beneath the building is in the center of the room. The crawlspace is dry and clear, showing CMU blocks providing support beneath floor joists and the interior columns (Photo 45 above).

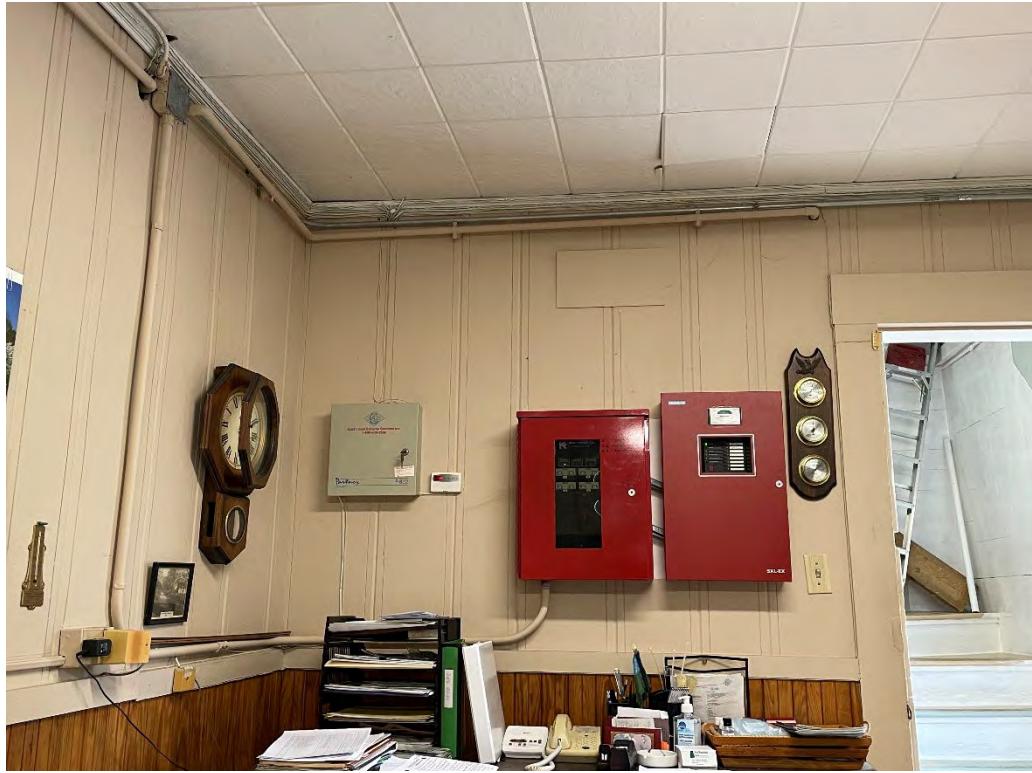
*Photo 46: Surface-mounted conduit and wires in the eastern corner of the office.*

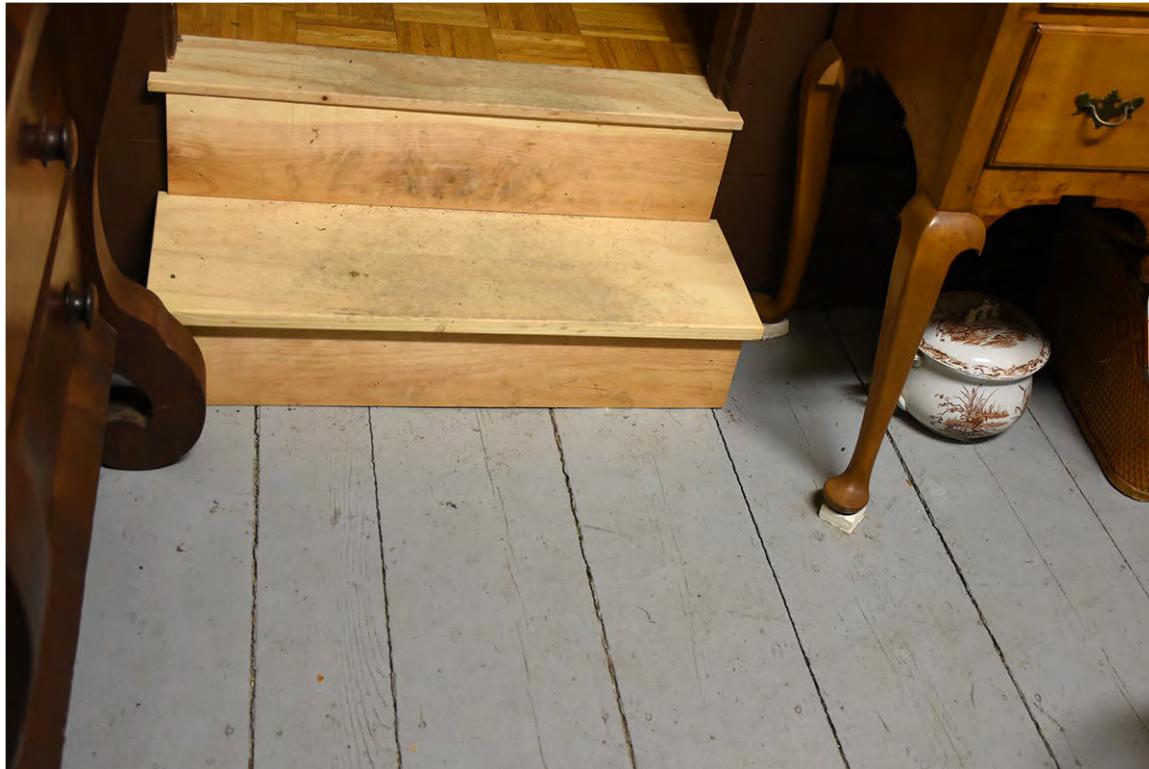
The museum rooms on the south side of the main space of the second floor have wider, painted pine floors in the “bedroom” in the southwest corner, which are in good condition. The parquet flooring on the central raised platform is in good condition. The platform area extending out into the main space is finished with black marbled linoleum tiles and aluminum edging. The linoleum is peeling in some corners, and the front shows wear and abrasion.

*Photo 52: Painted pine flooring in the “bedroom” and the modern, elevated parquet flooring into the “kitchen” room.*

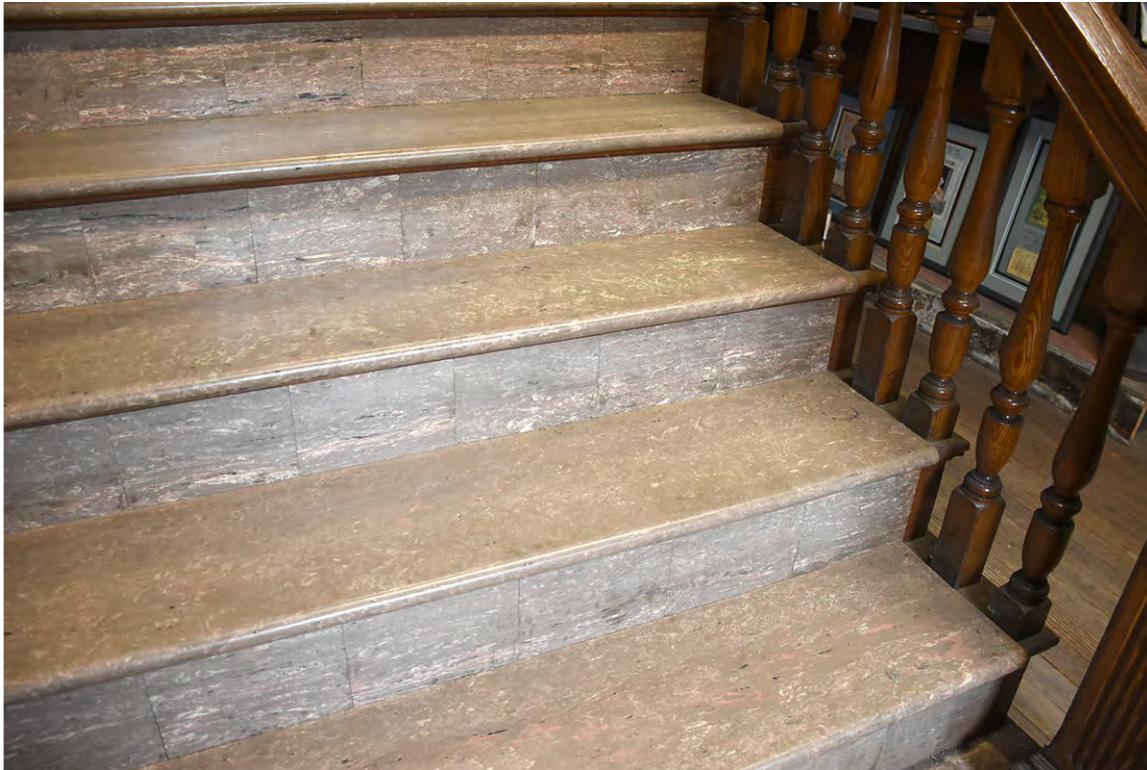
*Photo 53: Linoleum covering the treads and risers of the main staircase.*

The northern addition, containing the staircase, kitchen, and “Military Room,” is finished in varnished matchboard on the walls and ceiling. The staircase is in excellent condition, and the linoleum over the treads and risers is also in excellent condition (Photo 53 above). The horizontal beadboard panels and their finish are in excellent condition, with little evidence of staining or damage. The flooring is of wood boards and shows signs of surface wear and water damage from general use (Photo 54, Page 61 below). The floors in the stair hall and in the “Military Room” need refinishing. The floors should be lightly sanded and an oil-based polyurethane finish added to prevent further deterioration.

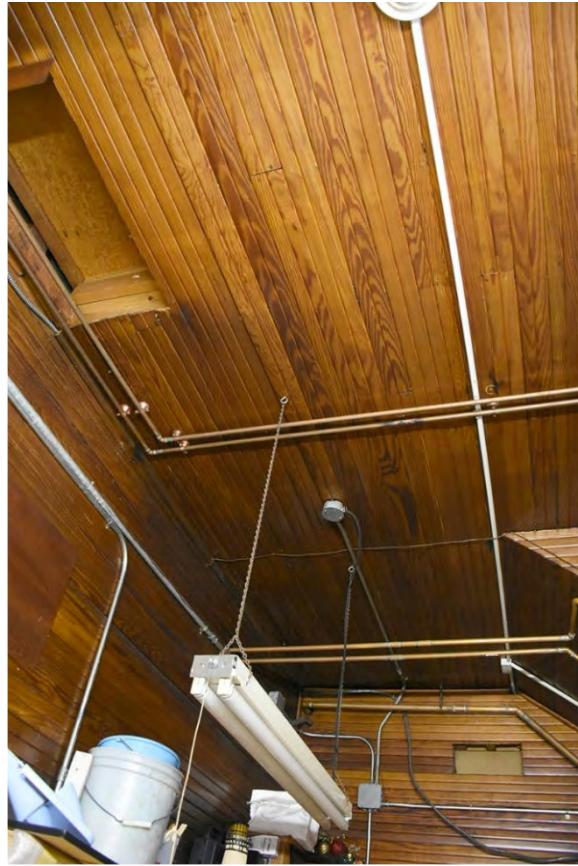
*Photo 55: Ceiling of the kitchen, looking west, with conduit and pipes mounted on the surface of the wood beadboard panels.*

The first-floor kitchen/mechanical room holds the boiler and oil tanks in a closet beneath the stairs. Again, the beadboard walls and ceiling are in excellent condition, but much of the surface is obscured by shelves and other storage. Many pipes and conduits are mounted to the surface of the ceilings and walls (Photo 55). Several cut-outs have been made in the ceilings and walls for air flow or mechanicals. The pine cabinets are 1970s additions and are mostly in good condition, but the cabinets nearest the sink show heavy surface wear (Photo 10, Page 22). The flooring is a vinyl laminate made to look like wood boards. It is generally in good condition but the vinyl on the trap door in the northeast corner is peeling off.

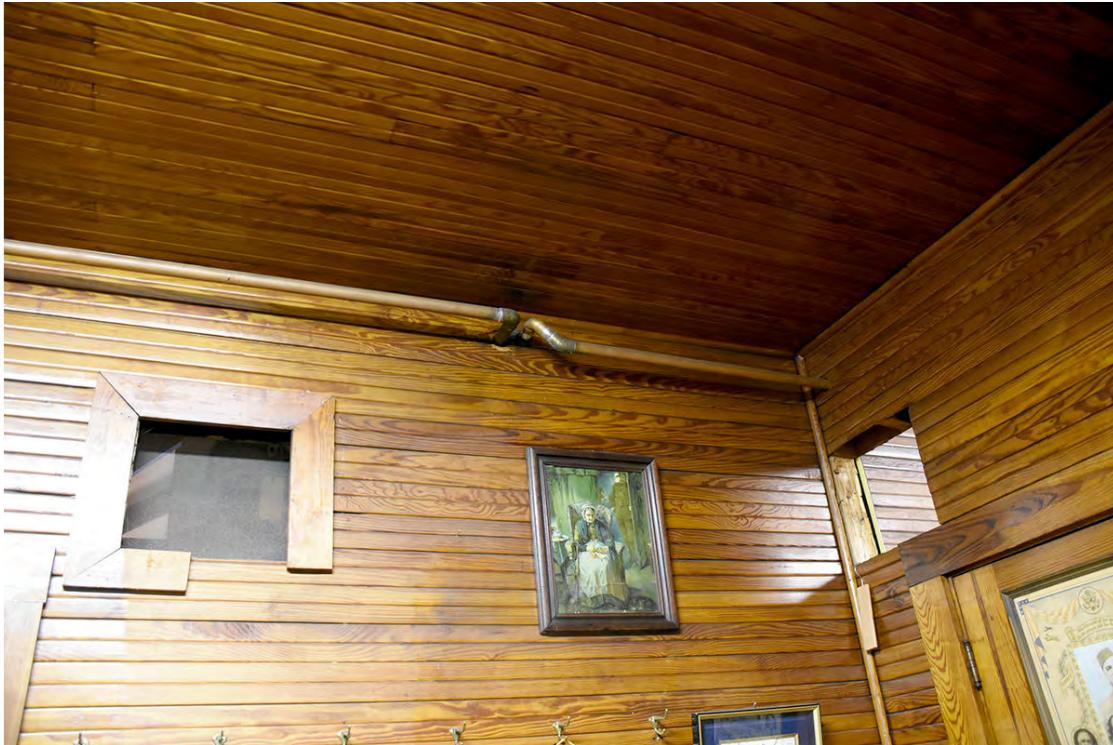
*Photo 56: Openings have been cut into the upper walls of the “Military Room” for ventilation.*

The finishes in the “Military Room” are in good condition. There have been alterations in the walls with holes cut for ventilation and pipes (Photo 56 above). The chimney has been encased in the same beadboard, and the edging is beginning to lift away from the walls at the top outside corner (Photo 57). The flooring is worn and stained through use, similar to the condition elsewhere in the north addition.

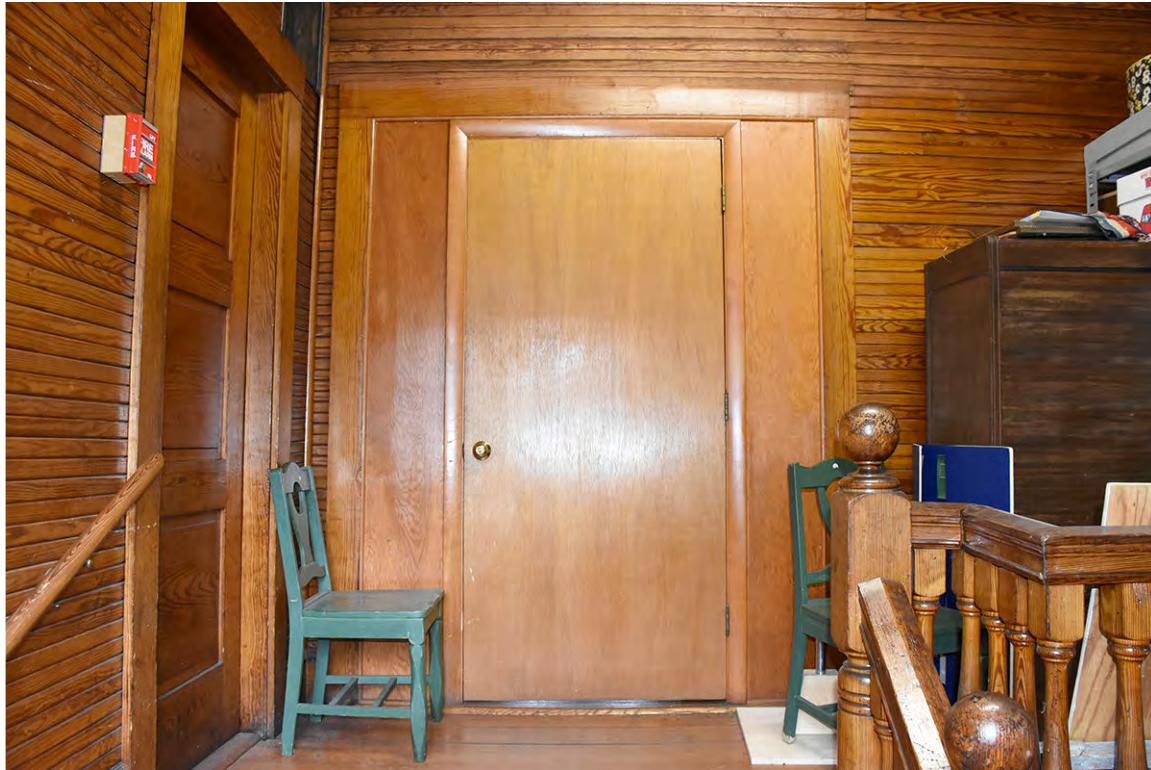
*Photo 66: Main doorway into the second-floor hall was infilled in the mid-twentieth century with a flat hollow-core door. A 1908 3-panel door into the Military Room space is at left.*

The main door from the stairs to the second-floor hall was likely originally a set of double doors, but the opening has been infilled to contain a single, flat hollow-core door (Photo 66 above). This modern door, though matching in color and wood tone, does not match the character of the surrounding finishes in the building.

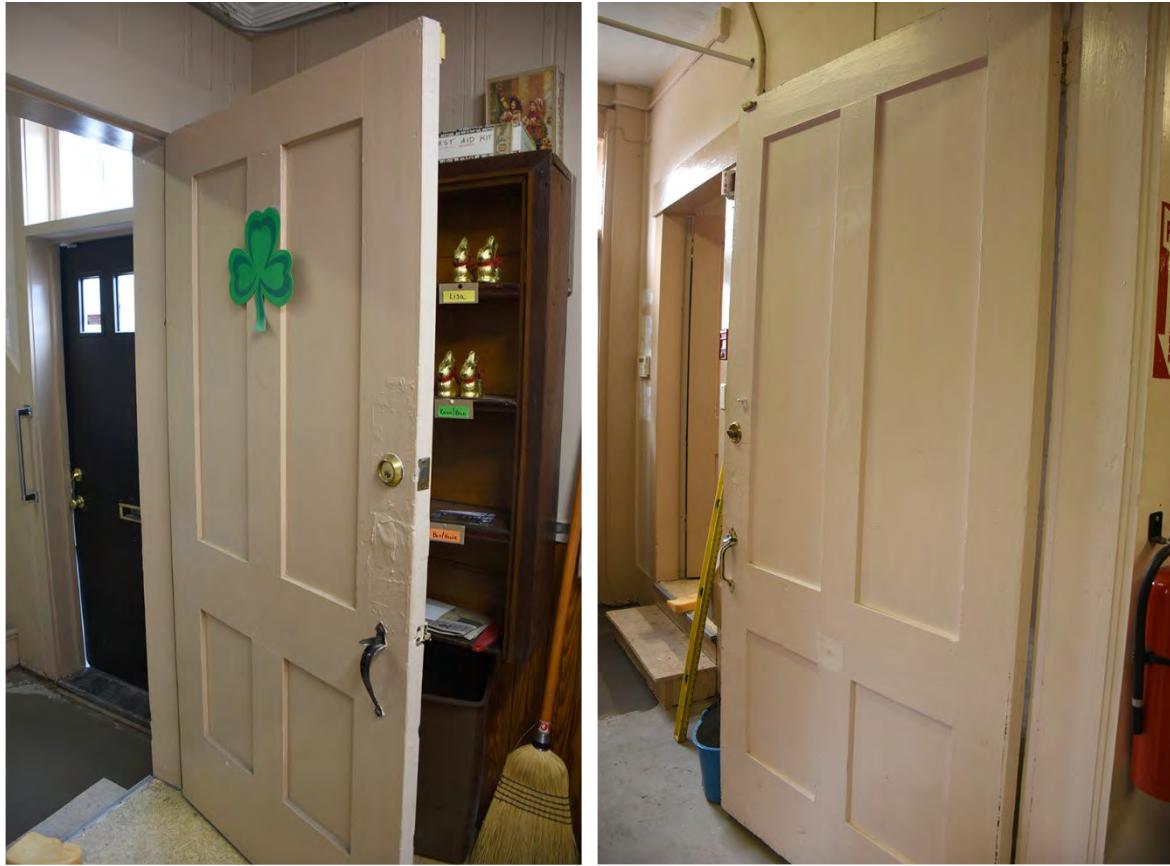
*Mid-nineteenth century doors.*

*Photo 67: (left) first-floor office door and*

The doors into the office on the first floor, the main room on the first floor, and the space beneath the balcony on the second floor, all accessed from the southeast stairhall, are mid-nineteenth century doors. All doors and their frames are in good condition. The first-floor office door has many patches where former hardware was located (Photo 67 above). These patches could be repaired and resurfaced to be smooth and less unsightly. The first-floor door into the former town hall room also has surface wear, but can be easily repaired with sanding and paint (Photo 68 above).

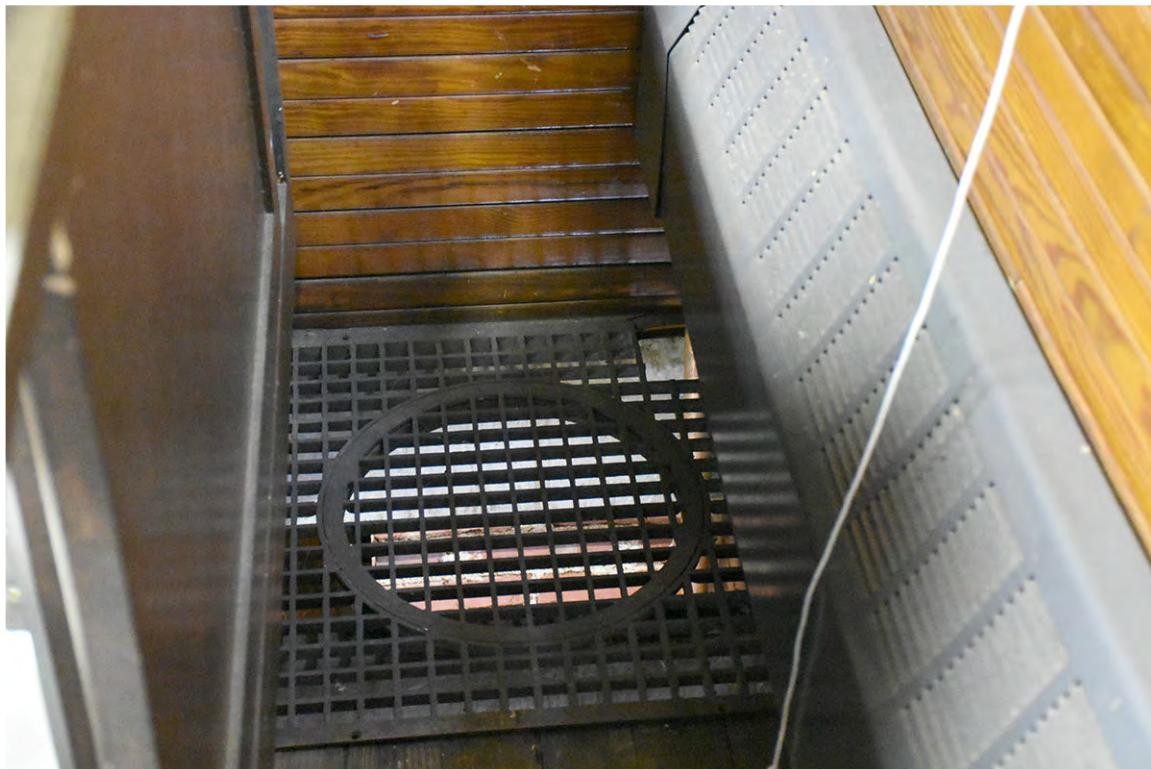
*Photo 69: Floor grate for heat and air exchange in the Military Room, north wall, with later radiator panel at right along wall.*

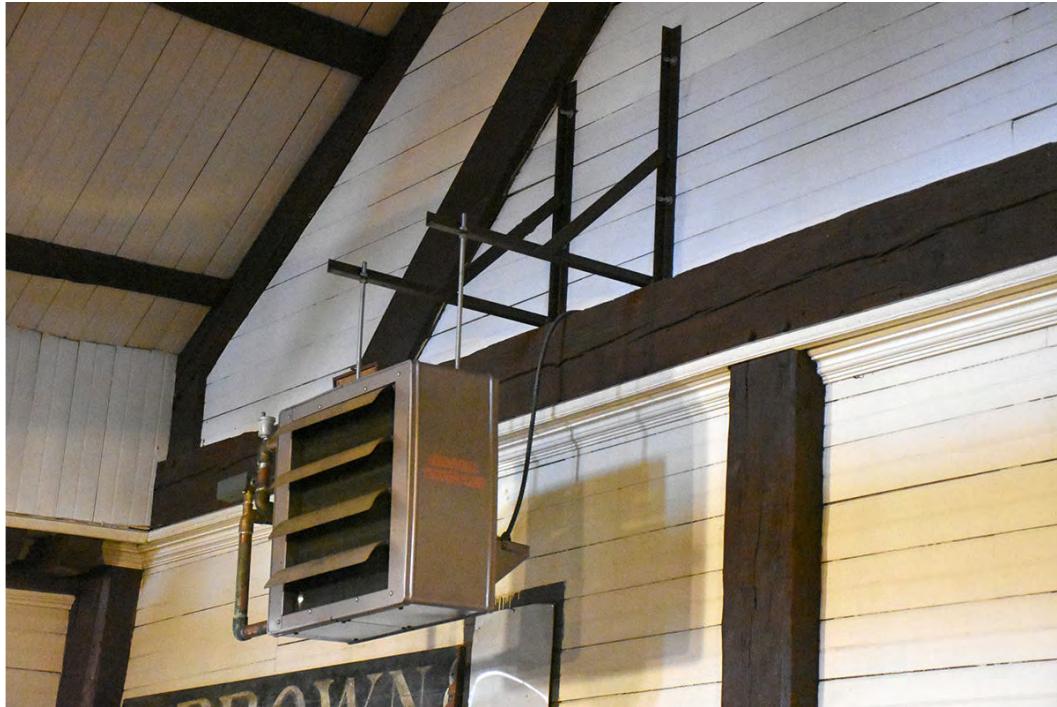
*Photo 70: One of two heating units mounted on the north wall of the second-floor hall.*

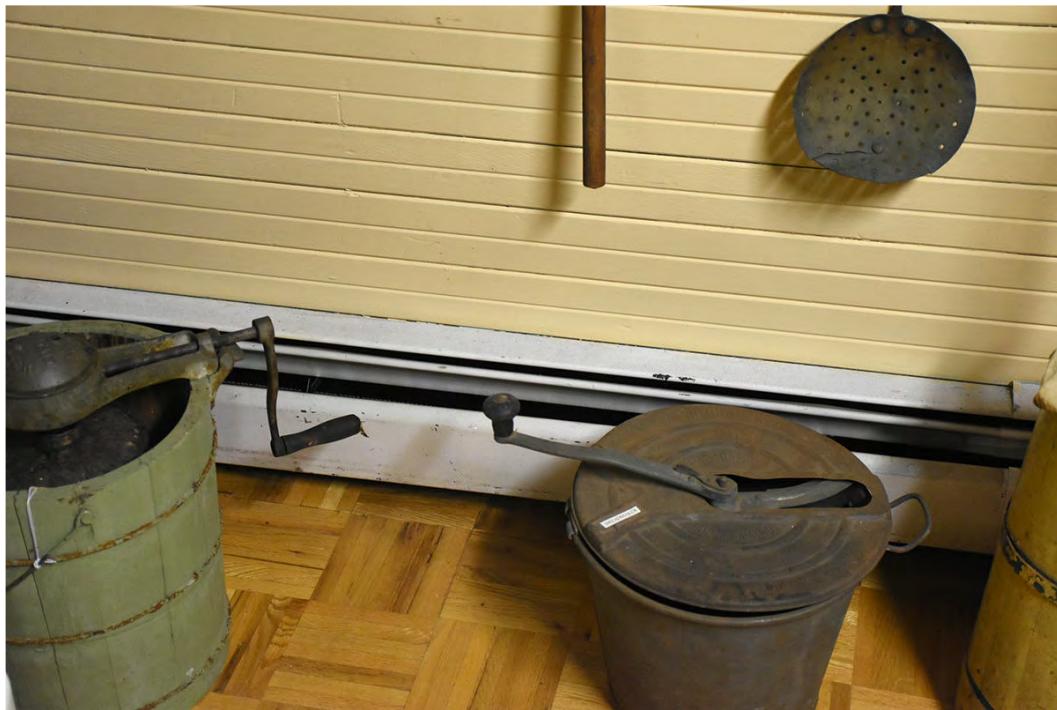
The south rooms on the second floor have a different heating system. Finned tube baseboard radiators line the west and south walls in the “bedroom” and central room (Photo 71 below).

*Photo 71: Finned tube baseboard radiators are installed in the second-floor rooms on the south side.*

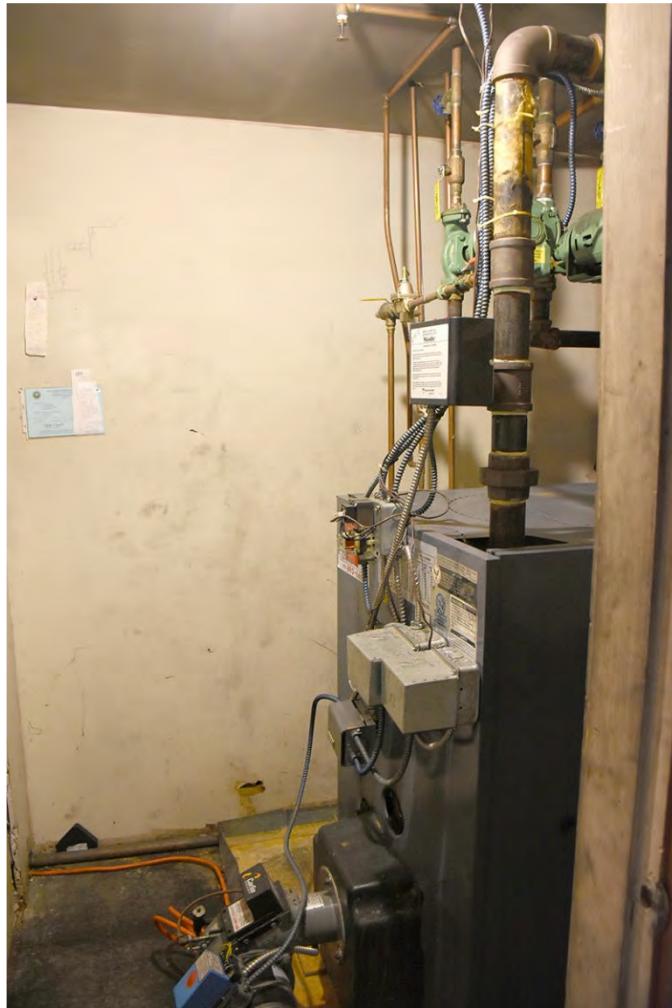
The boiler is in good condition and is serviced regularly (Photo 72 below). Fuel is stored in two small oil tanks beneath the stairs on the north side. As noted earlier, heating and pipes are surface mounted to walls and ceilings and are left generally exposed (except for rooms with drop ceilings). Any pipes that are no longer used or functional should be removed.

*Photo 72: Boiler located beneath the north stairs*

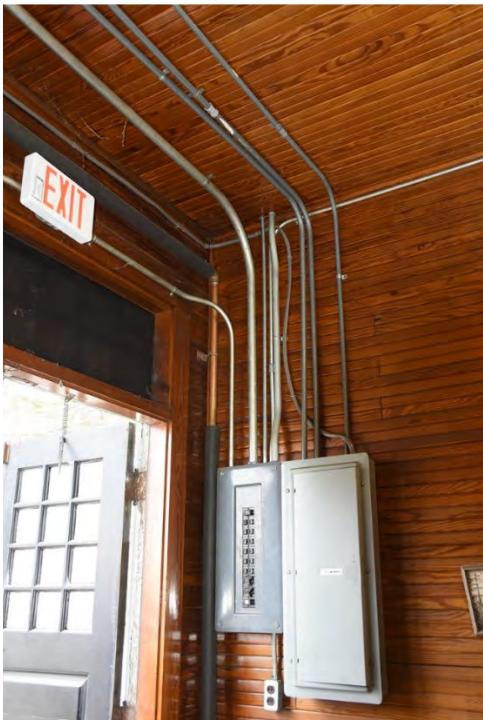
The main electrical panel is located just inside the main doors on the north wall (Photo 73 below). The panels are out of date and need to be replaced to upgrade the entire system. Many of the outlets and light switches are also old and need to be replaced. Much of the electrical wiring is taken through the building via conduit, which is surface mounted to the ceilings and walls (Photo 73 and Photo 74 below). Any extraneous and disused wiring, including telephone wires, that are surface-mounted should be removed from the interior walls. New wiring should be surface mounted or installed with the least impact on the building as possible. Light bulbs should be replaced with LED bulbs in a warm tone where appropriate to reduce energy consumption.

*Photo 73: (left) Electrical panel just inside the main doors, and*

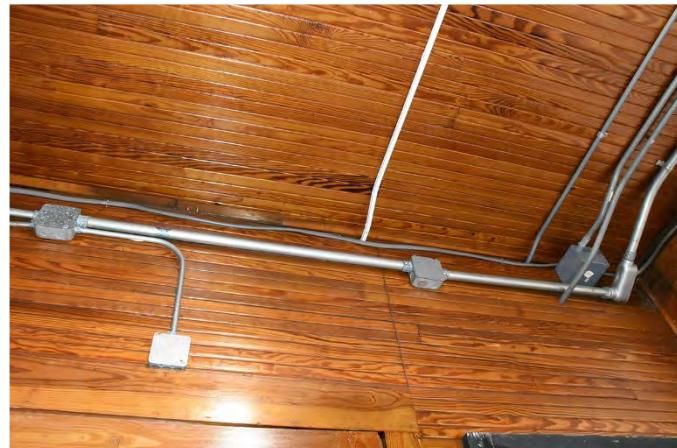
*Photo 74: (right) Electrical conduit surface-mounted to walls and ceilings.*
