# NEW ENGLAND CONSTRUCTION

# GAINING HIGHER STATUS

Arlington, Massachusetts, Adopts Pavement Preservation Methods Such as Asphalt-Rubber Chip Seal to Boost Rating of Town's Road Network

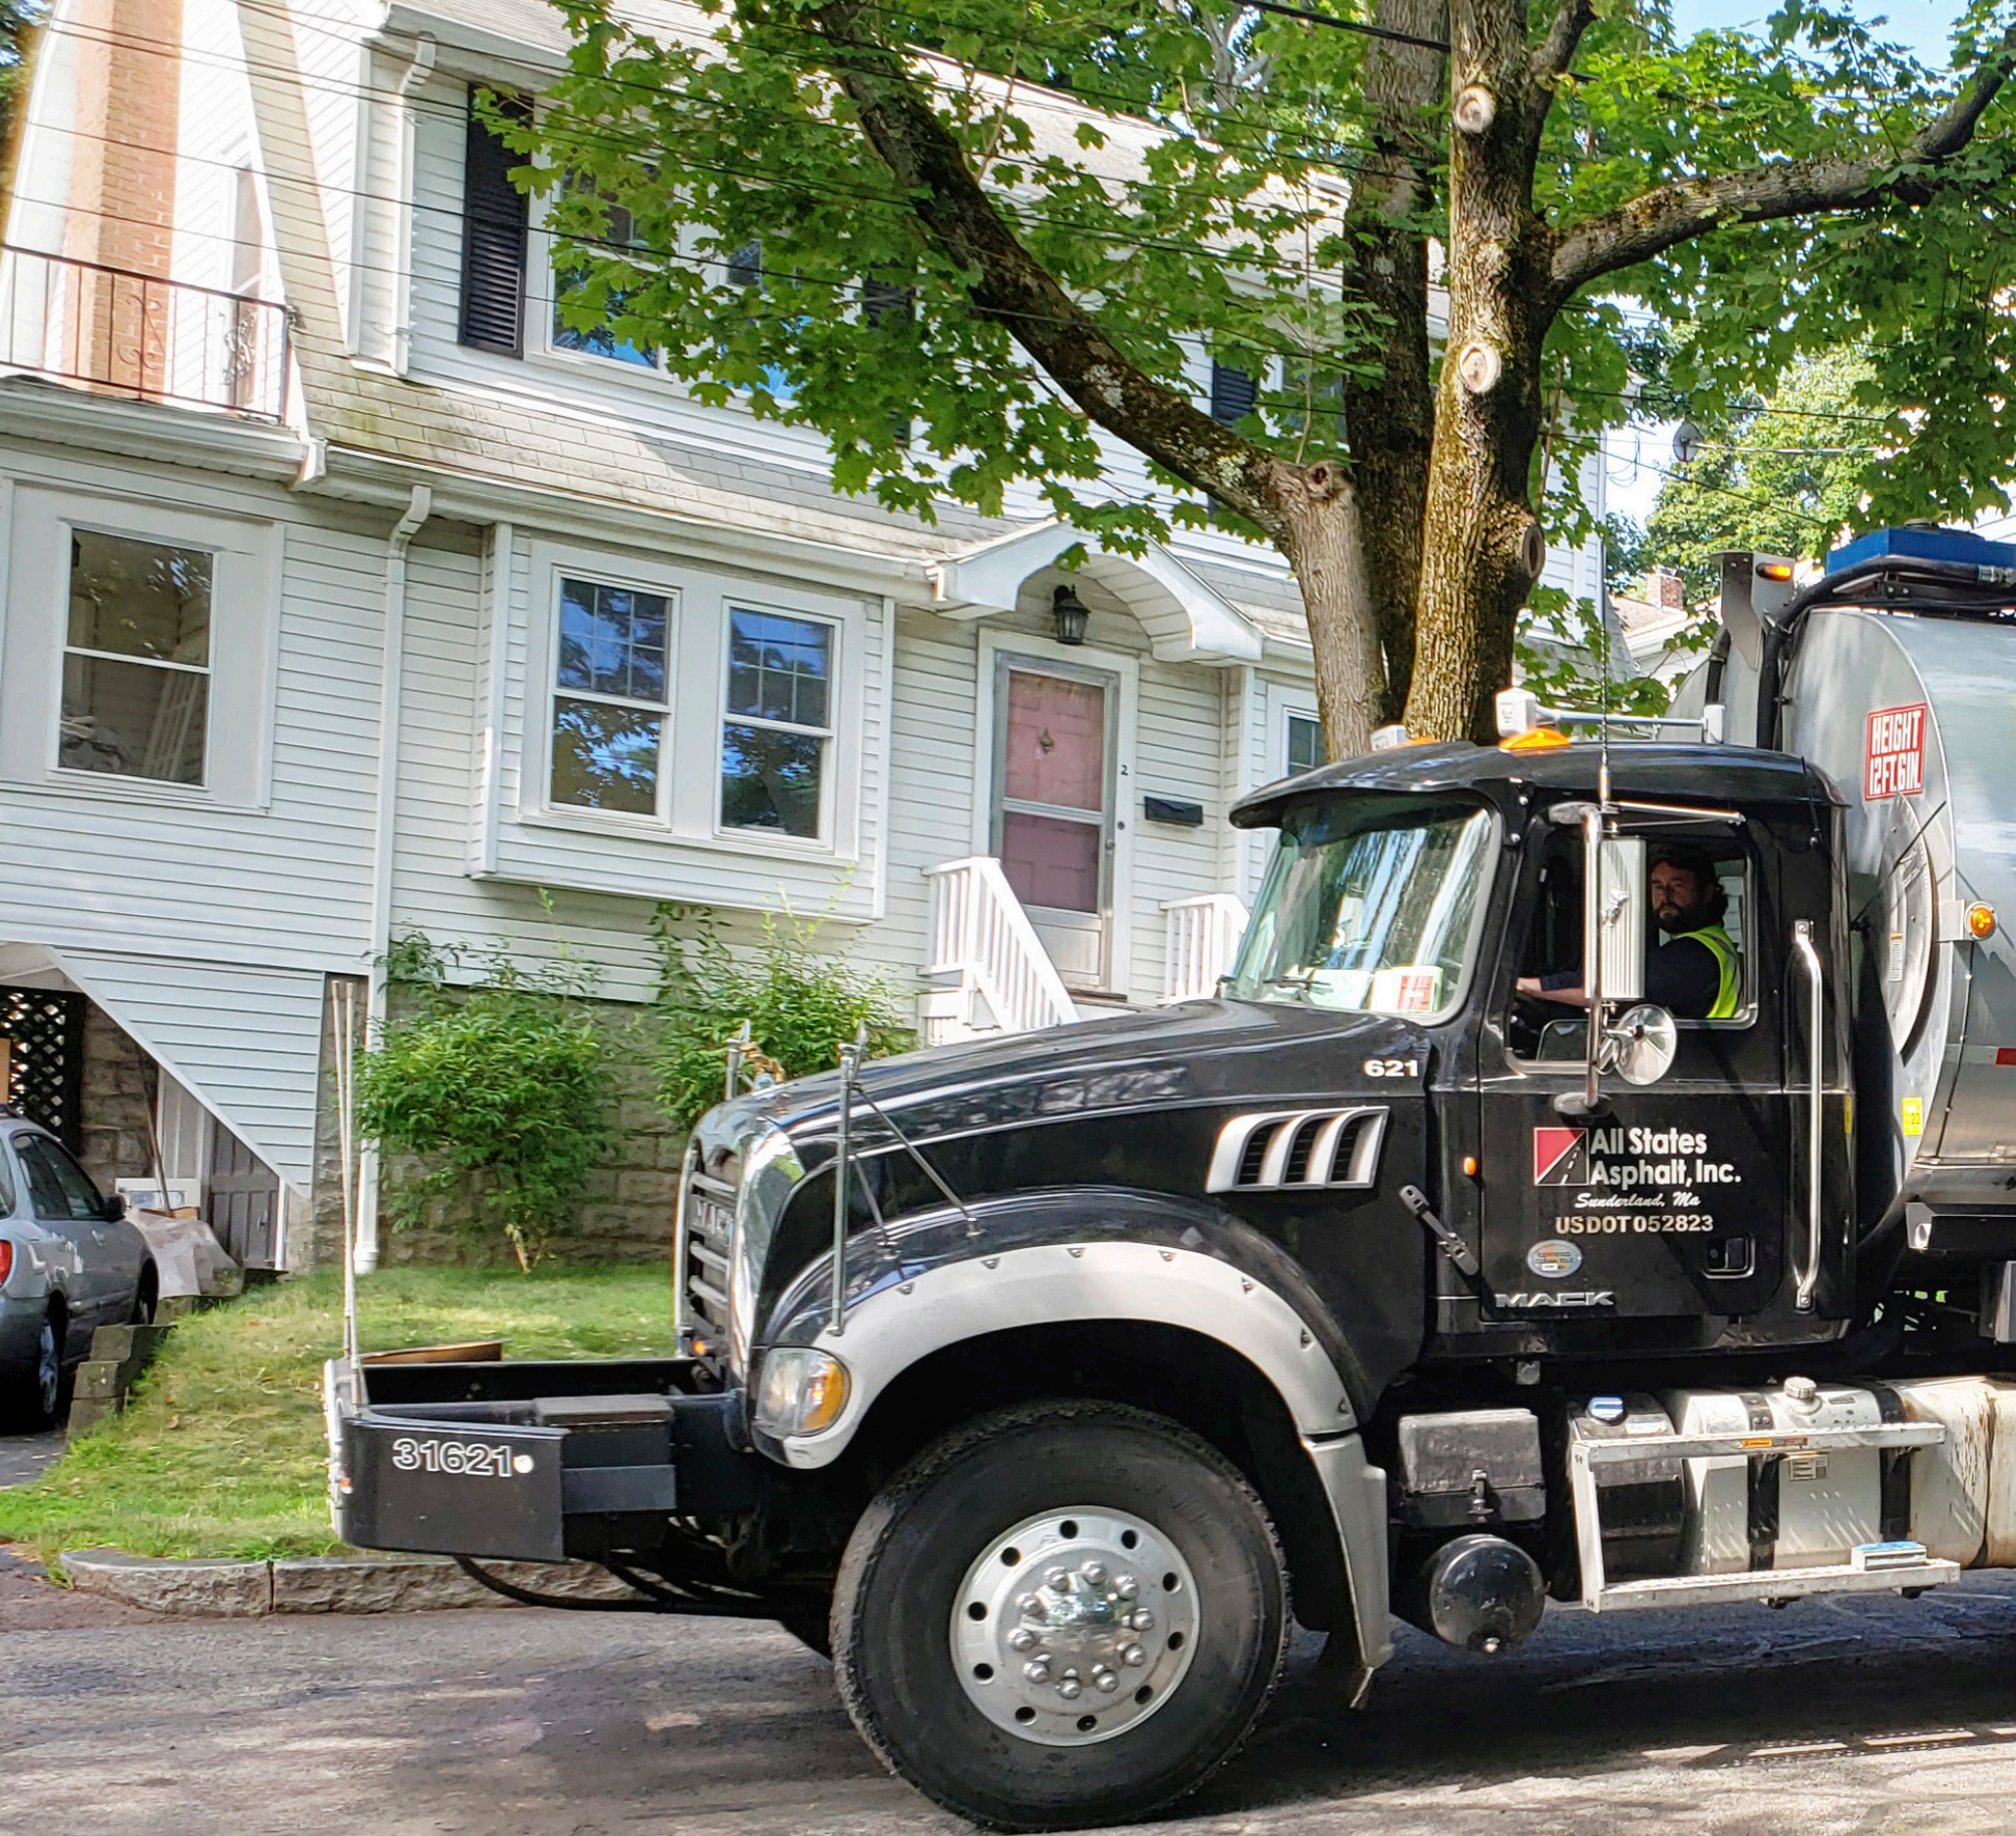
A Bearcat distributor mounted on a Mack truck hot-sprays liquid asphalt rubber on the street and is followed immediately by the chip spreader for the asphalt rubber chip seal treatment.

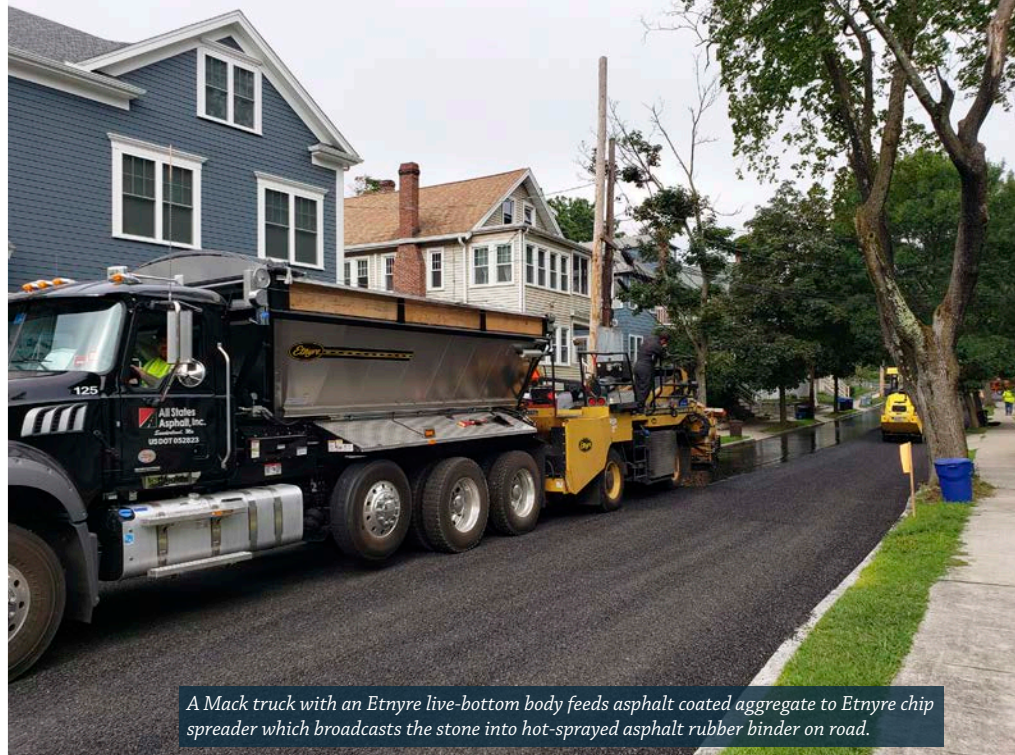
A Mack truck with an Etnyre live-bottom body feeds asphalt coated aggregate to Etnyre chip spreader which broadcasts the stone into hot-sprayed asphalt rubber binder on road.

A chip spreader distributes the coated stone over the hot-sprayed asphalt rubber binder at the rate of approximately 35 pounds per square yard, then rollers embed the stone into the asphalt rubber binder. The final step is sweeping away any loose cover aggregate. This is followed by the return to normal traffic.

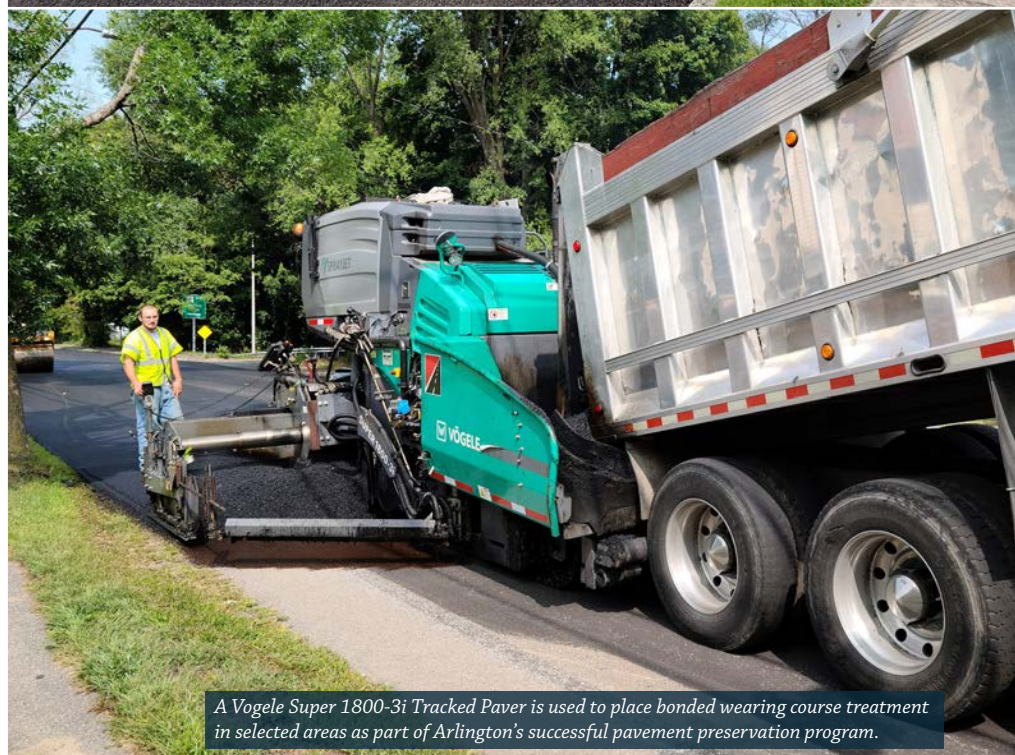
A Vogele Super 1800-3i Tracked Paver is used to place bonded wearing course treatment in selected areas as part of Arlington's successful pavement preservation program.

The other principal pavement preservation treatment provided by ASMG, the BWC, is being used in selected areas of town. This thin asphalt overlay is employed to restore ride quality while sealing and protecting the underlying pavement. It can also be used to mitigate shallow rutting and can help retard fatigue cracking. BWC is a non-structural layer, typically only 0.75-inches thick, which incorporates a gap-graded aggregate and polymer-modified asphalt.

In this process, an emulsion layer is applied to the existing pavement surface immediately in front of the paving screed using a self-priming paver. The emulsion serves as a tack coat and helps to seal the underlying pavement surface while also immediately bonding it to the new asphalt surface placed by the paver.

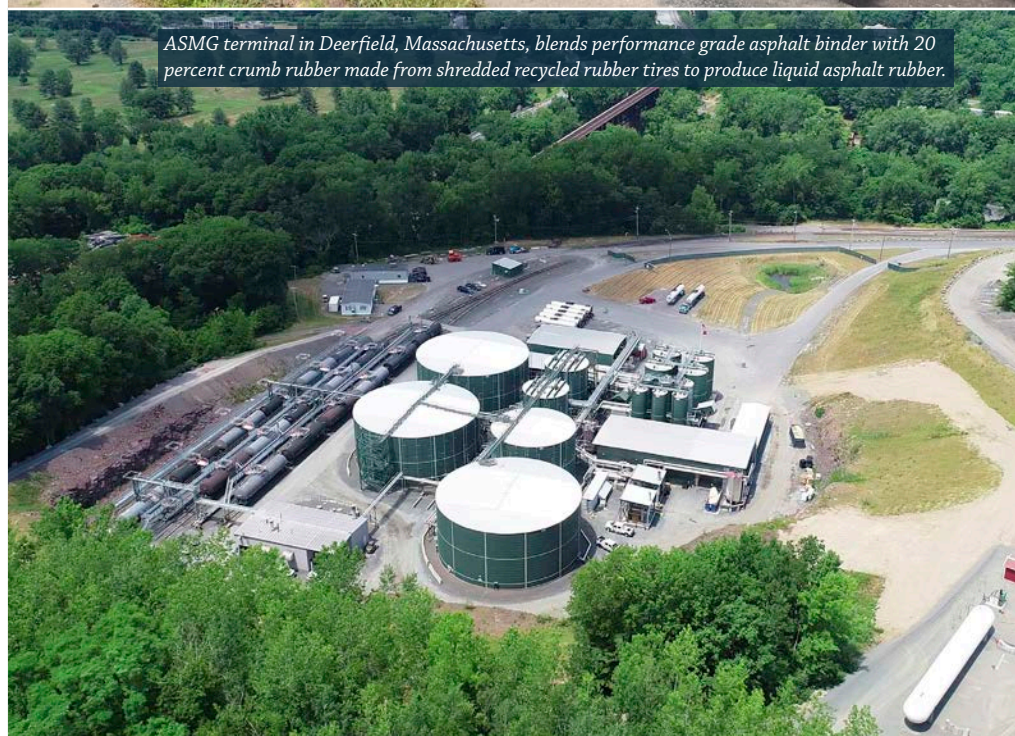
ASMG terminal in Deerfield, Massachusetts, blends performance grade asphalt binder with 20 percent crumb rubber made from shredded recycled rubber tires to produce liquid asphalt rubber.

In ASMG’s asphalt rubber chip seal process, the road surface first receives a thorough cleaning immediately before application, then a distributor hot sprays approximately 0.60 gallons per square yard of crumb rubber modified asphalt over the road. Betsold said the asphalt rubber is made in their terminal where performance grade liquid asphalt binder is blended with 20 percent crumb rubber formed from shredded recycled tires. This modified asphalt rubber is said to provide a flexible, durable seal. The aggregate, or chips, are 7/16-inch single sized stone that is run through a hot mix plant to be heated and lightly coated with asphalt to assure it is clean and dry.

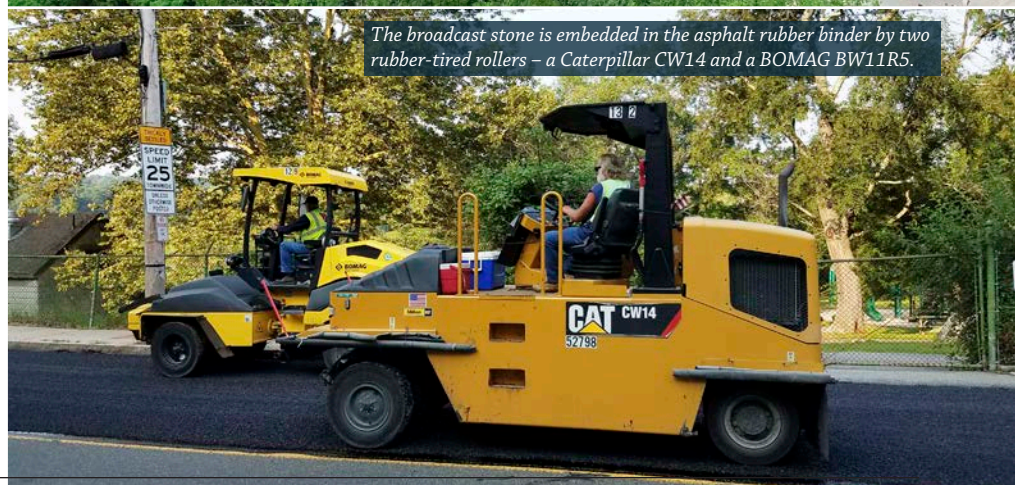
The broadcast stone is embedded in the asphalt rubber binder by two rubber-tired rollers – a Caterpillar CW14 and a BOMAG BW11R5.
