EVALUATION AND ASSESSMENT  
SALEM TOWN OFFICES  
33 GEREMONTY DRIVE  
SALEM, NEW HAMPSHIRE

OCTOBER 11, 2017

The H.L. Turner Group Inc.

Facility Assessment Report  
Salem Town Office Building

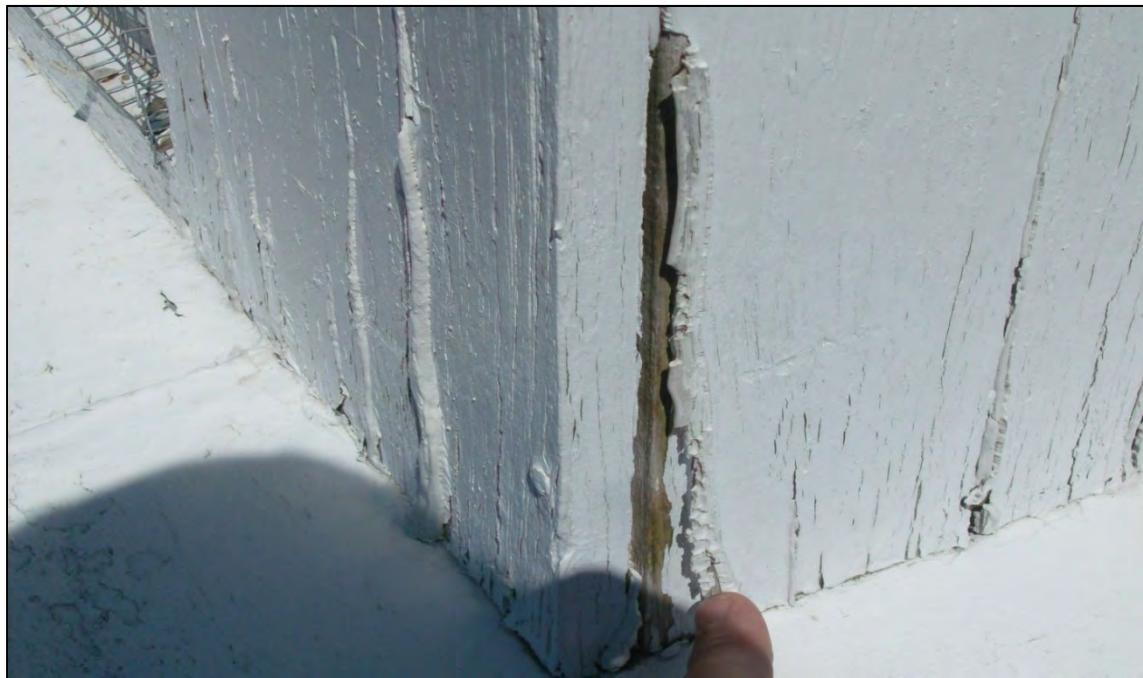
The cupola has some rotted sections of wood trim, and in general, the entire cupola needs scraping and painting. The brick chimney which extends up through the roof has loose mortar joints and needs repointing in several areas.

Peeling paint on cupola.

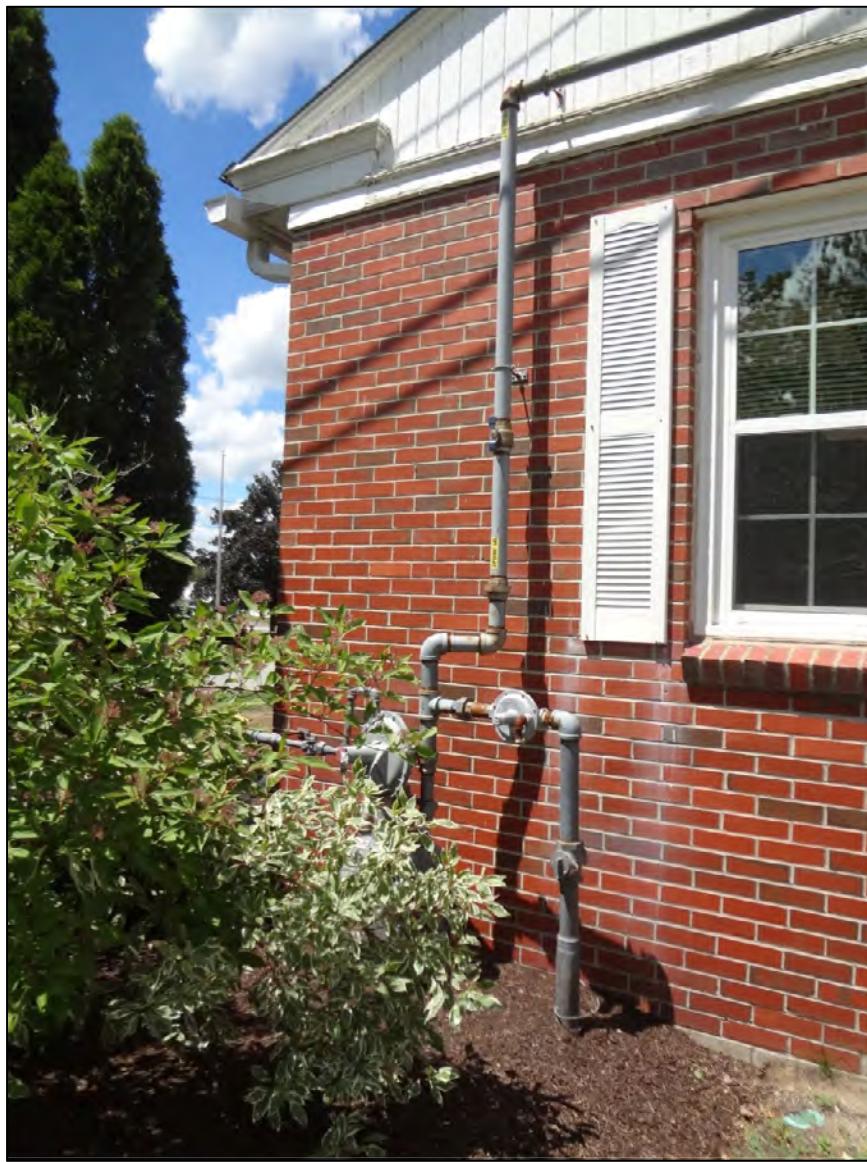
Gas regulator close to window.

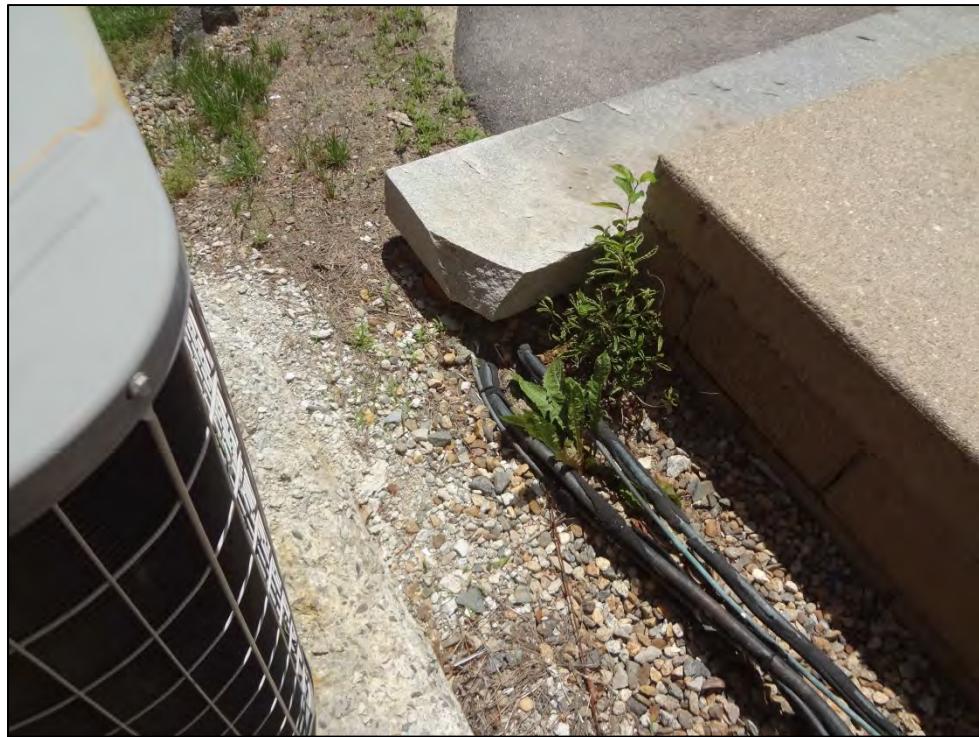
Refrigerant piping under stair and bad insulation.

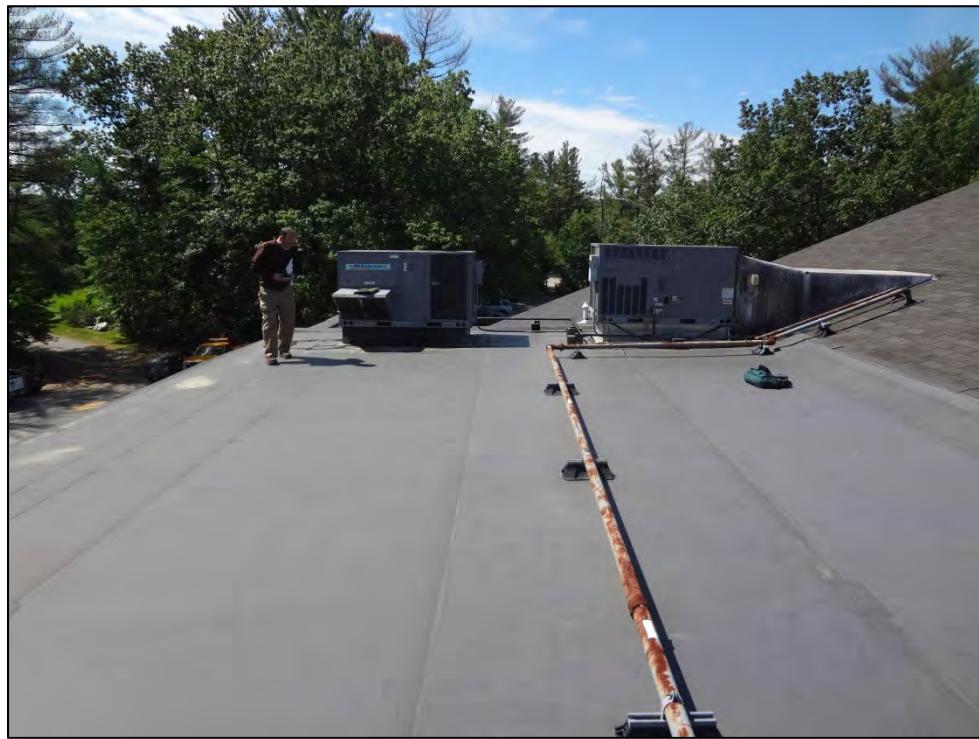
RTUs need safety protection.

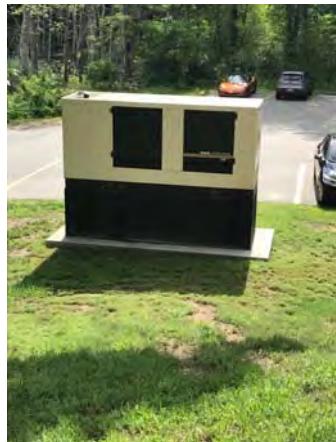
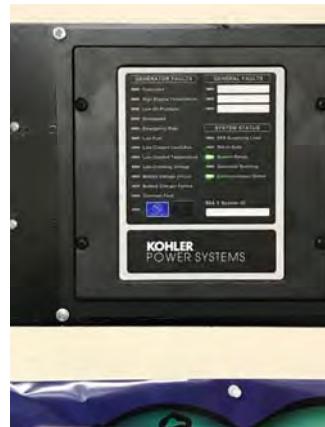
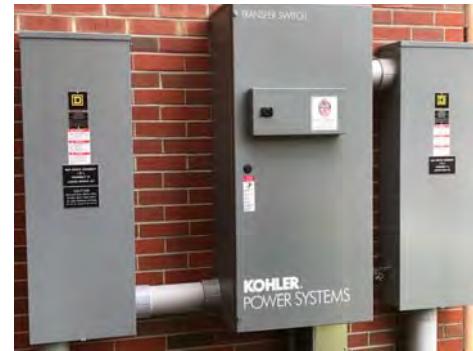
The building's entire services is backed up by an exterior 125 KW Kohler diesel generator. The generator is enclosed in a weatherproof enclosure. There is a 400 amp Kohler automatic transfer switch located on the building exterior. There is also a Kohler remote generator annunciator in the building. All of the associated generator equipment appear to be in excellent working condition.

Continue to test the generator monthly, as is required by code, and provide typical maintenance such as oil changes, lubrication.

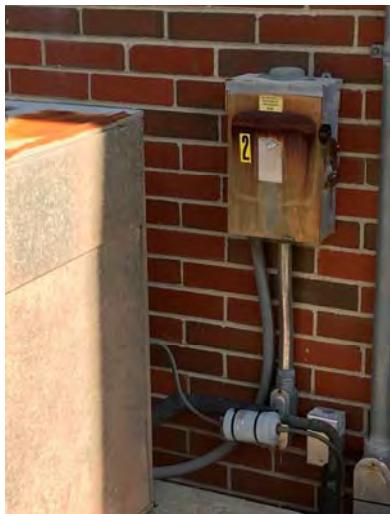
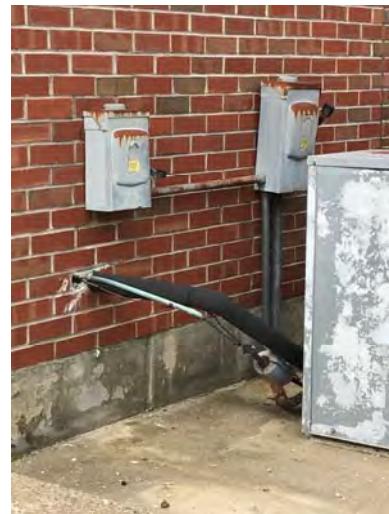
There are (3) exterior disconnects serving HVAC equipment that are showing signs of deterioration/rusting.

Replace these disconnects, in kind, immediately.

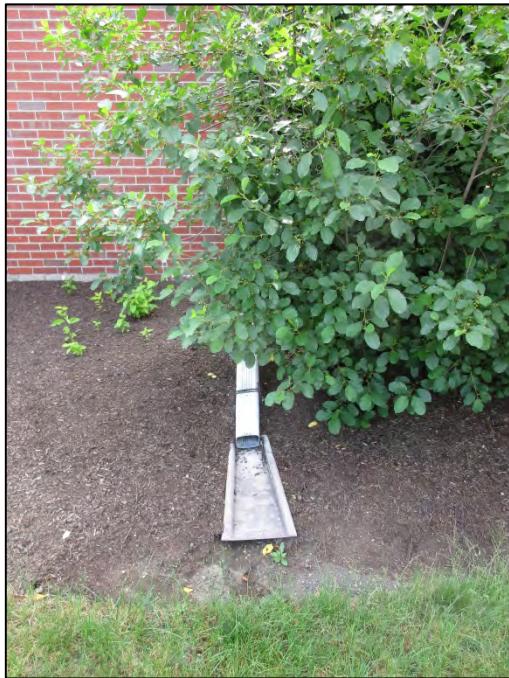
Gutter outlet at southwest corner of building.  
Tie into an underground piping system to eliminate  
direct discharge.

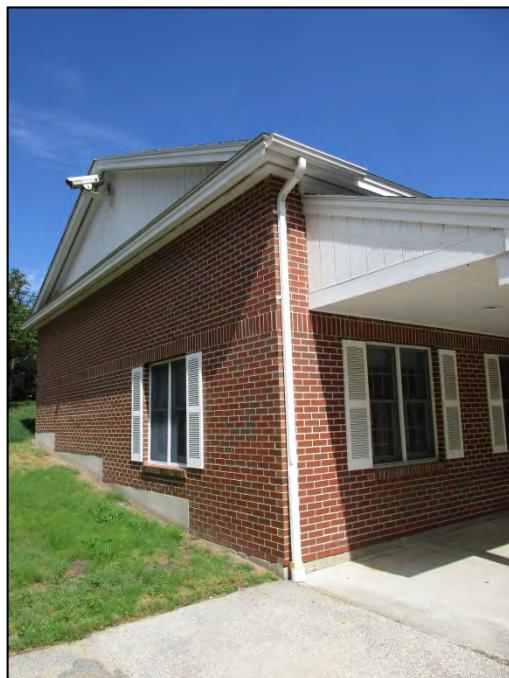
Roof gutter on the south side of the building connected  
to an underground system. Underground system likely  
crosses east parking lot and discharges in wooded  
swale on east side of property.

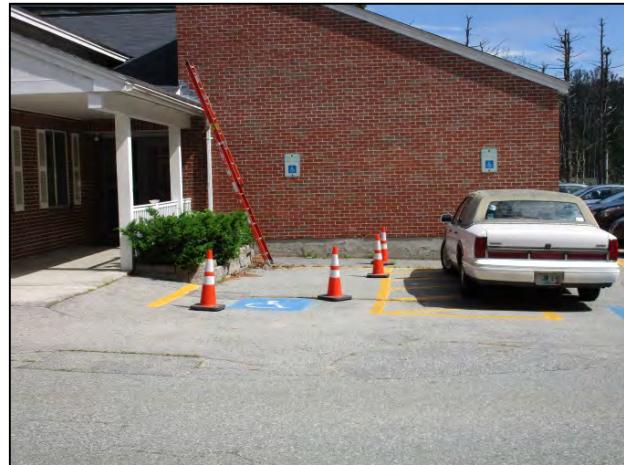
Accessible spaces adjacent to south side of Town Hall. No 'Van Accessible' signage and the slope up to the concrete sidewalk is excessive.

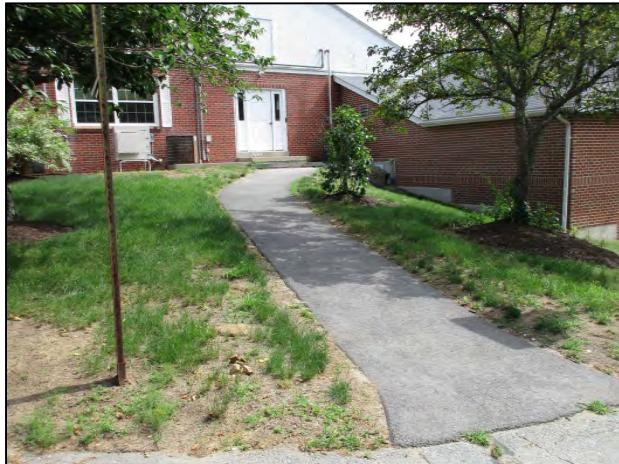
Sidewalk with 10% slope; no railings or landings.

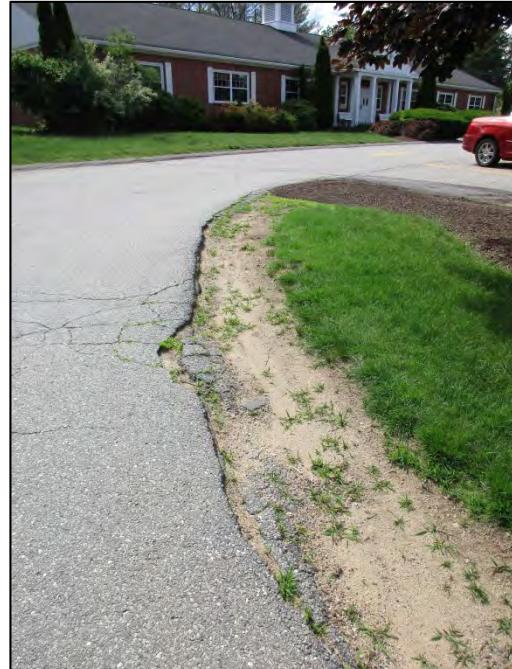
Poor grass cover and erosion along edge of pavement.

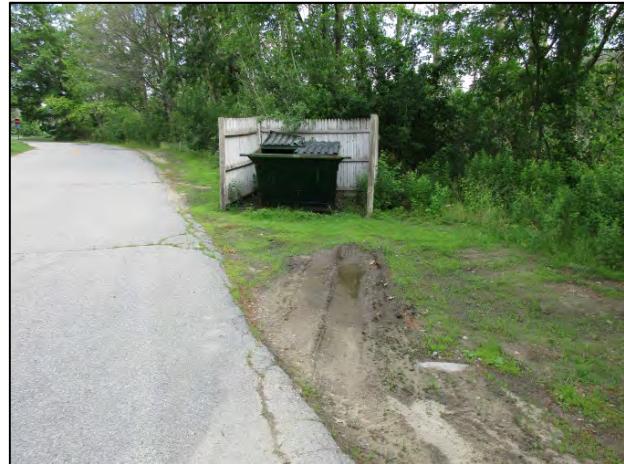
Vehicle approach to dumpster. Gravel surface susceptible to rutting. Note gravel surface beneath dumpster.
