**Owner's Project Manager
Request for Qualifications (RFQ 2021-011)
Town of Salem**

RFQ 2021-011 OWNER'S PROJECT MANAGER

On Wednesday, June 21, 2017, The H.L. Turner Group Inc. (TTG) visited the site of the Salem Town Offices at 33 Geremonty Drive in Salem, NH, to perform a facility assessment of the building and surrounding site. The purpose of this assessment was to identify any existing deficiencies in the building or site that the Town should plan to address. The report is divided into four main sections. The first section gives an overview of the architectural features of the building including the exterior façade, roof, and interior finishes. The second and third sections address the major electrical and mechanical equipment, and associated deficiencies respectively. The final section is an in-depth discussion of the surrounding site, including drainage issues.

PROJECT NO. 4529 ~ SALEM TOWN OFFICE BUILDING - FACILITY ASSESSMENT

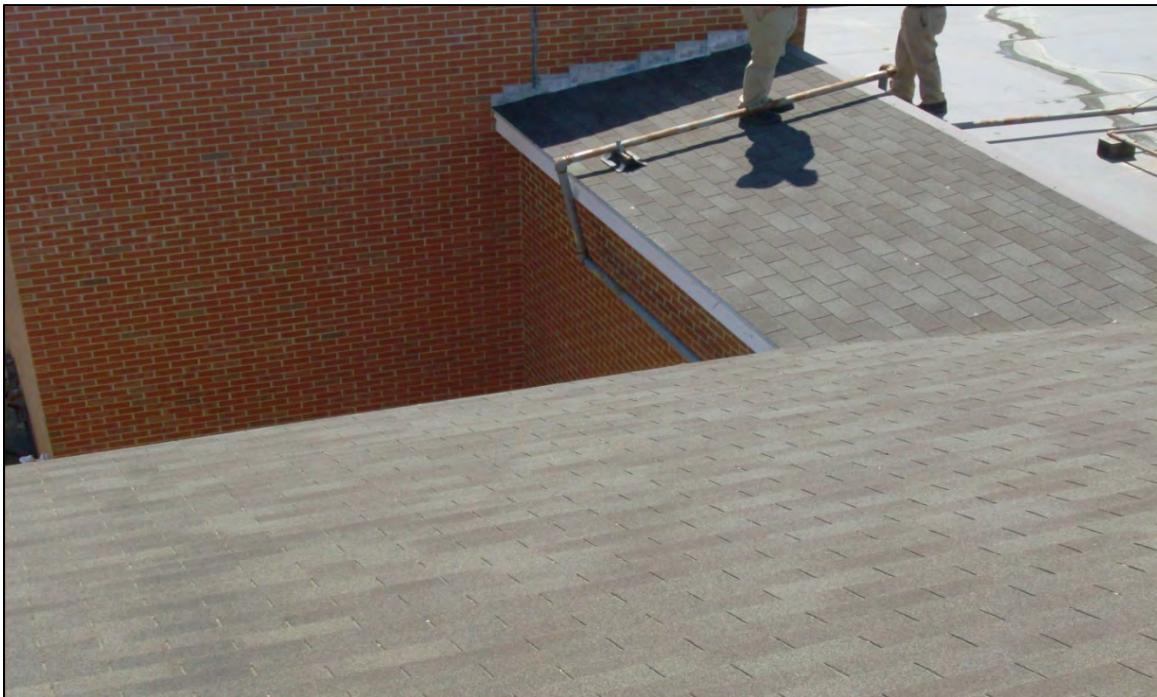
Ice dams at the northeast side of the building in the back, over the boiler room, and over the area where the main transformer is located, are particularly bad. It is not unusual that crews are called in every winter to chop ice to break-up the ice dams. The natural gas pipe that feeds the boiler room runs across the roof and down the wall in this same area. Reportedly the pipe often gets encased in ice as well. This is a definite safety issue and should be of highest priority to rectify this situation since the pipe could become broken and/or dislodged due to ice encasing it, or from ice chunks breaking loose and falling against the gas line.

Exposed gas line to boiler room runs over roof and across north wall.

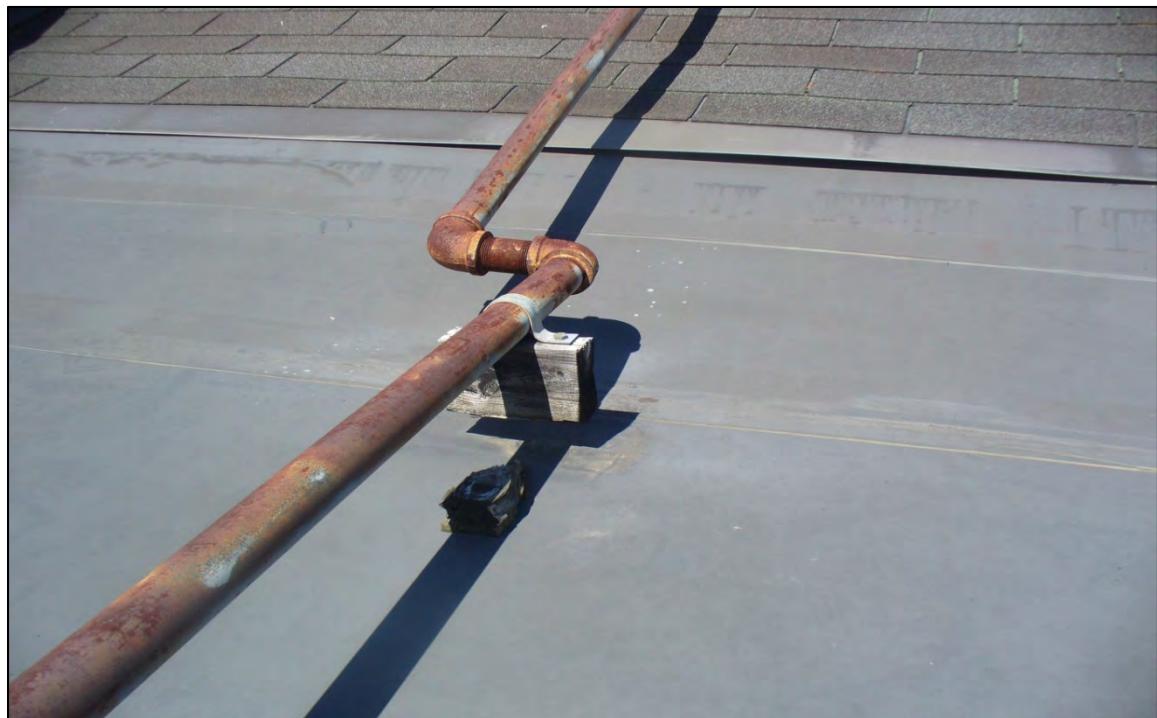
Gas line runs from attic space to mechanical units on roof and over to boiler room.

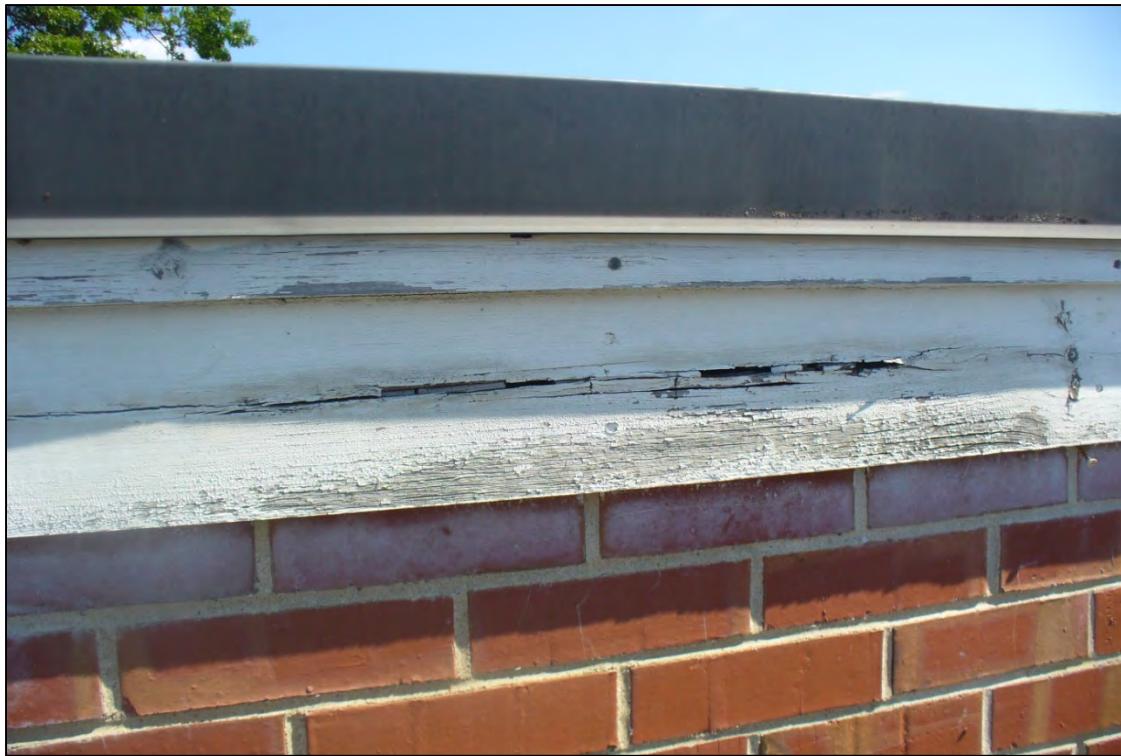
The wood fascia, rake board, cornice, trim, soffit, and frieze board are peeling and require scraping and painting. Some wood repairs may be needed due to rot and decay. One section of rake board and trim were replaced, but never received any paint. Heat tape is installed along the lower edge of the west side of the roof to help minimize the formation of ice dams. We observed that many of the ceiling spaces have minimal insulation. In some areas it is only 3-½ inches thick. In other areas the insulation has been pushed aside for mechanical work and it was never put back in place. This has led to ice dams along the eaves and in the valleys, which has led to roof leaks. In the original 1967 section of the building, the roof framing consists of site built wood trusses spaced at 24 inches on center. The Kraft paper-faced insulation, although it is mostly 12 inches thick in this area, some of it was installed with the Kraft paper side facing up away from the heated space, as opposed to against the heated space. Much of the insulation has been moved around and displaced when mechanical work was done. The insulation is stuffed into the eaves thus preventing any air to move up through the eave vents into the attic space. Furthermore there is no ridge vent, only a small gable end vent on one side

Rotted fascia on high roof over stairwell.

- Scrape and paint the wood fascia, rake board, cornice, trim and soffits. Replace wood that has rotted.
- Remove the old abandoned air handling units in the attic space. Properly insulate the area occupied by the units.

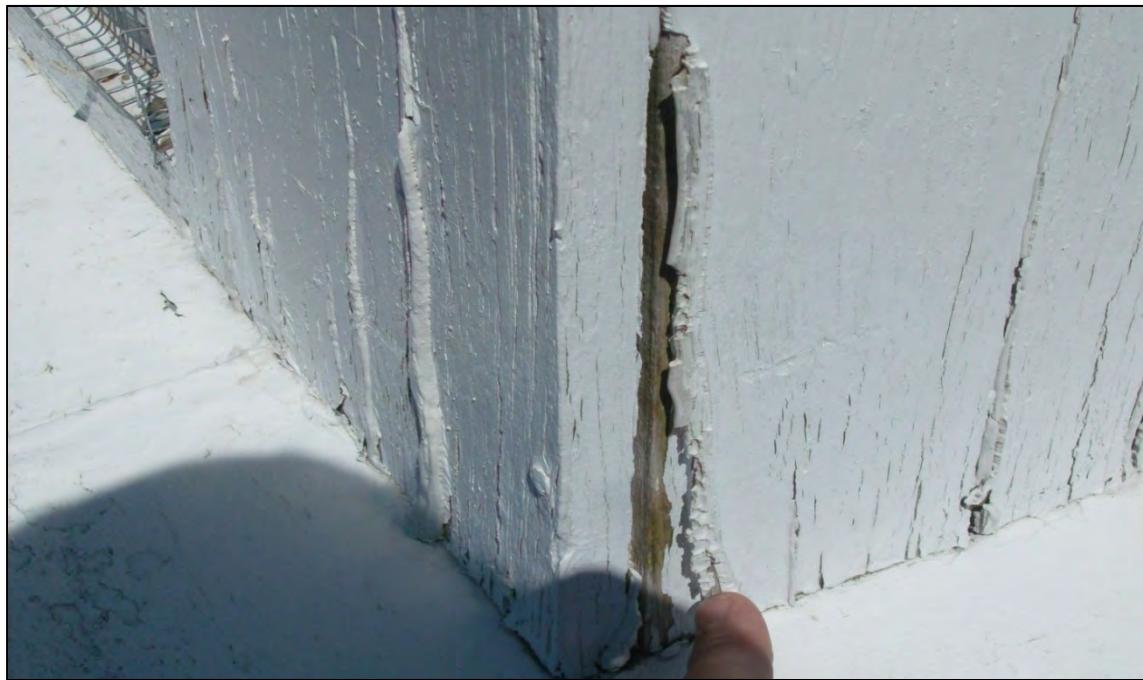
The cupola has some rotted sections of wood trim, and in general, the entire cupola needs scraping and painting. The brick chimney which extends up through the roof has loose mortar joints and needs repointing in several areas.

Peeling paint on cupola.

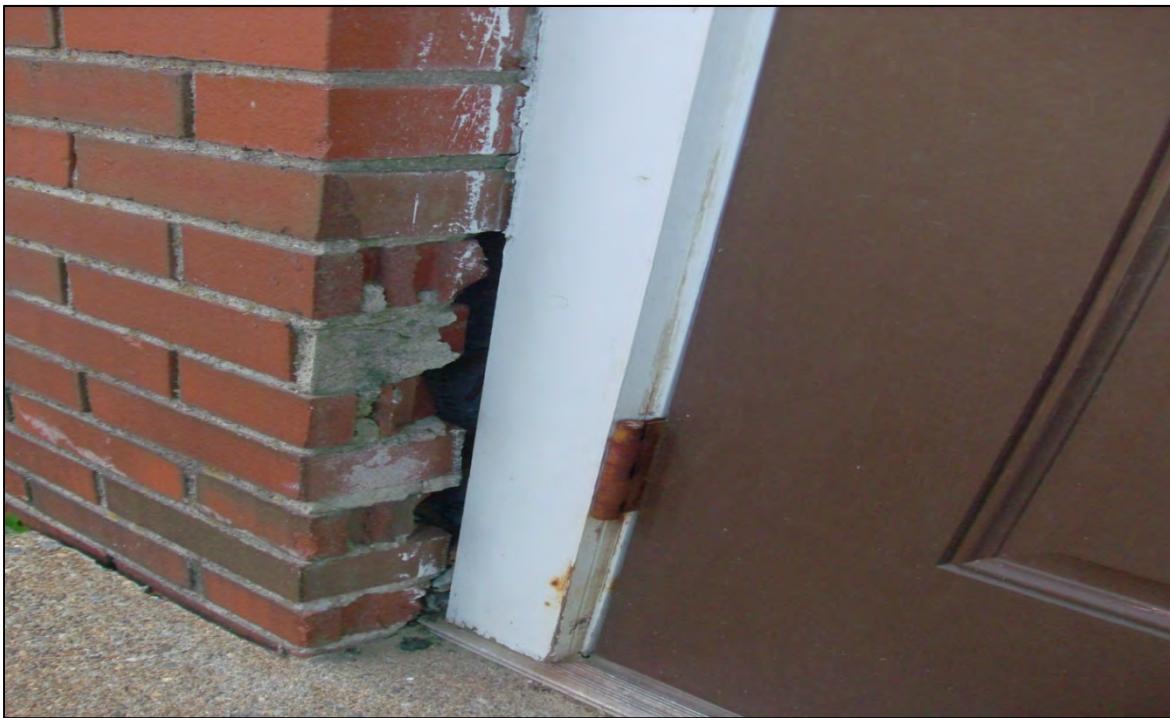
Large gaps left behind brick façade when door frame was cut in and installed.

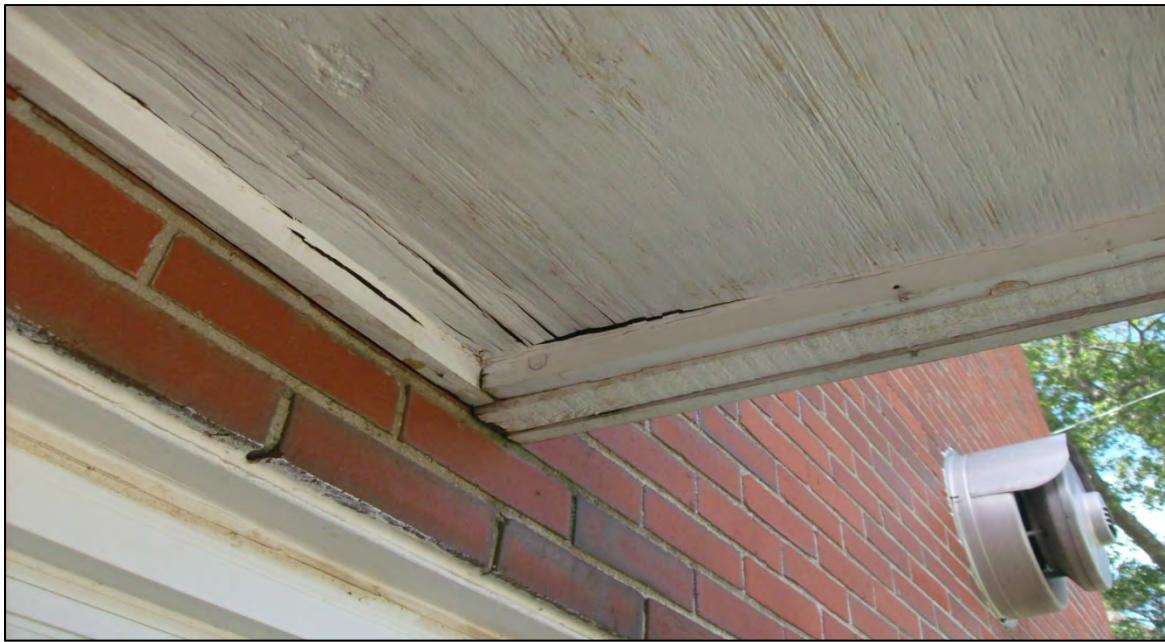
Rotted ceiling board under canopy at finance department entry door.

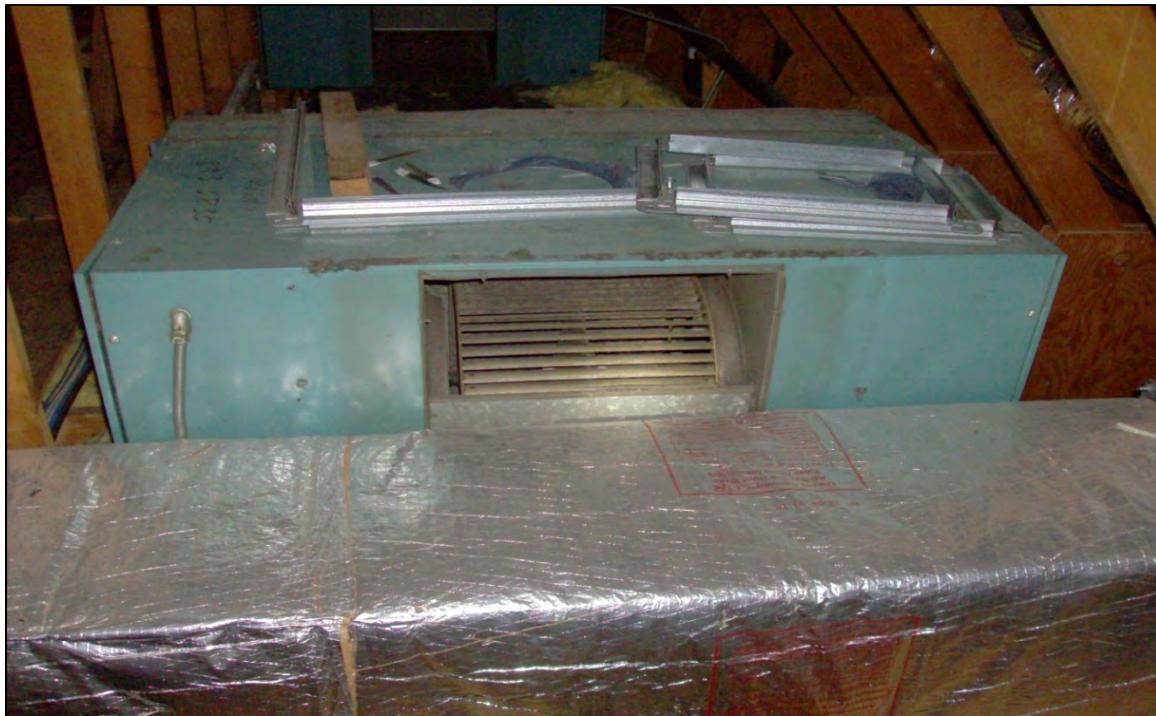
of the building. We also observed some old mechanical units in the original 1967 attic section that have been abandoned in place. These old units should be removed and the area they occupied properly insulated.

Old abandoned air handling unit in attic above.

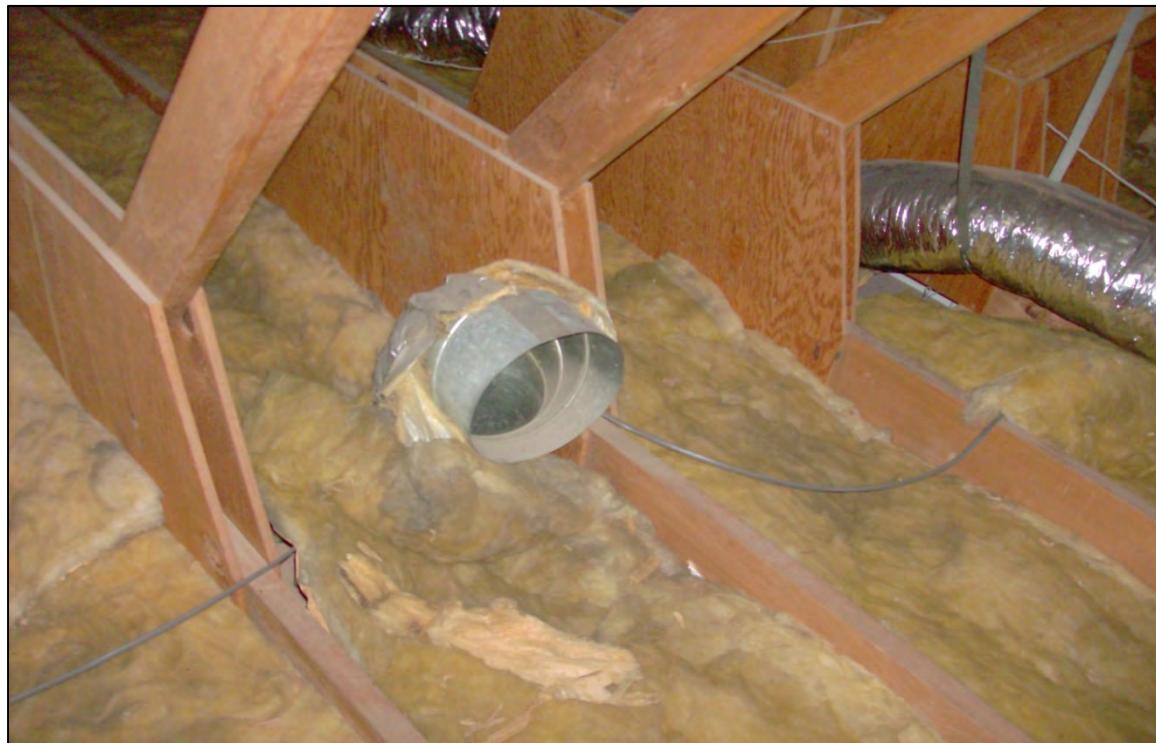
Insulation in attic space over original building, plus old abandoned ductwork open to the space.

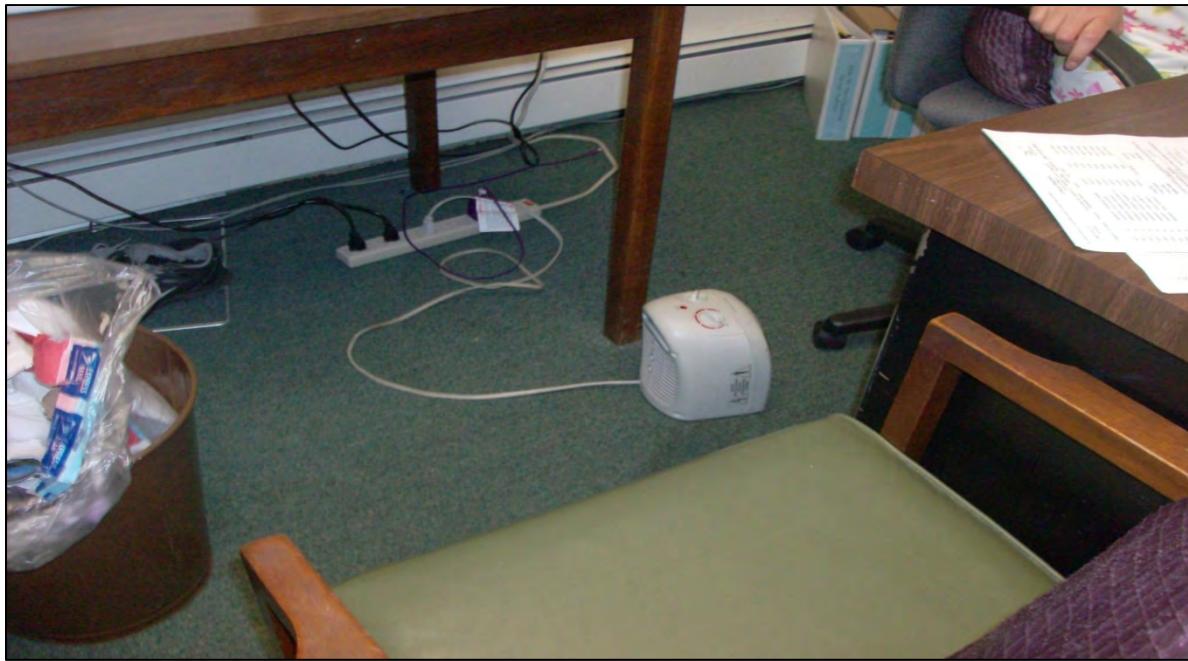
Lack of enough receptacles results in power strips and circuit overloads.

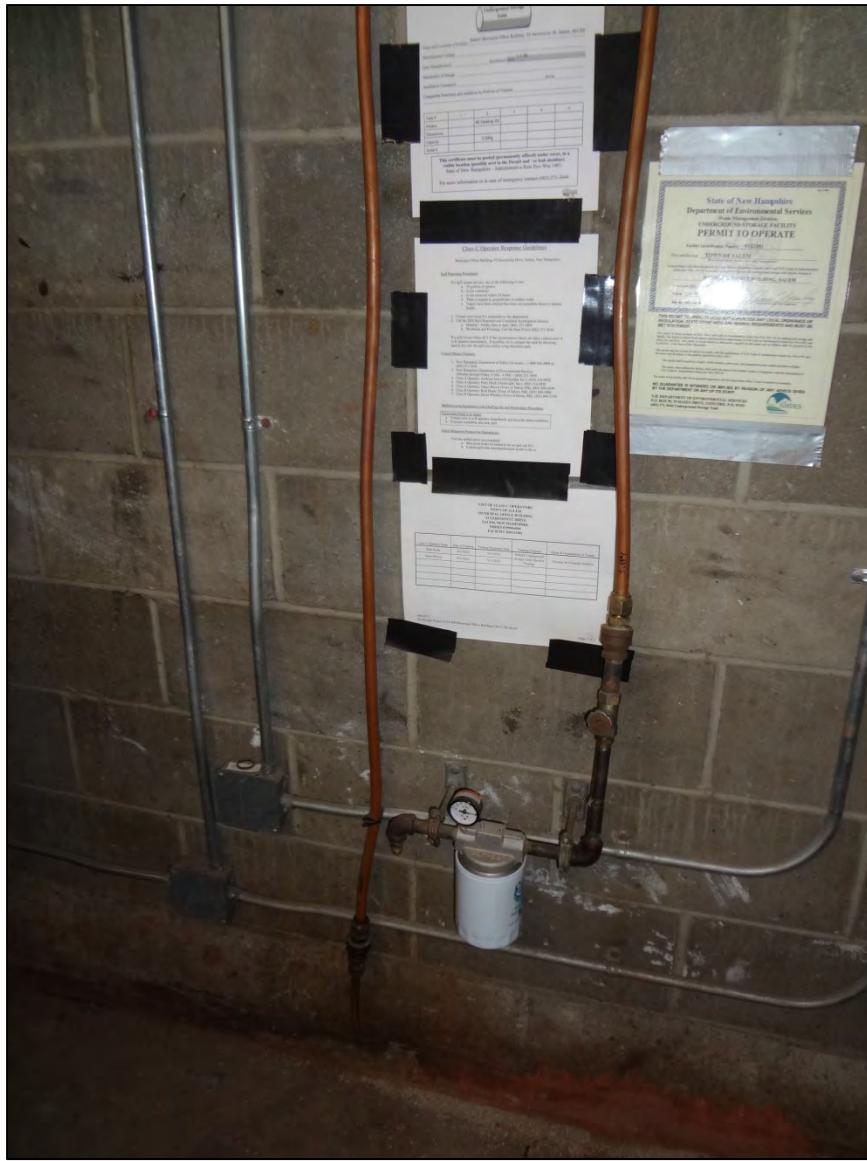
Abandoned oil piping and signs to remove.

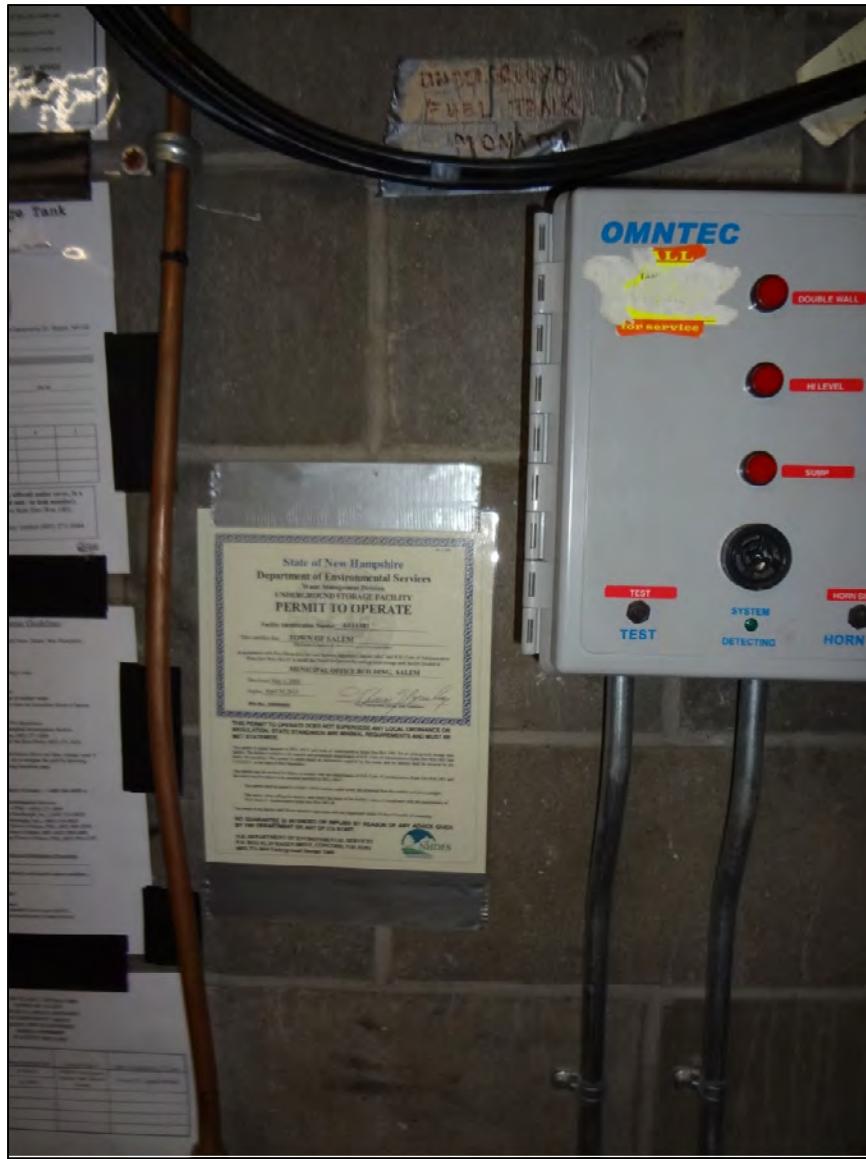
Abandoned oil tank alarm to remove.

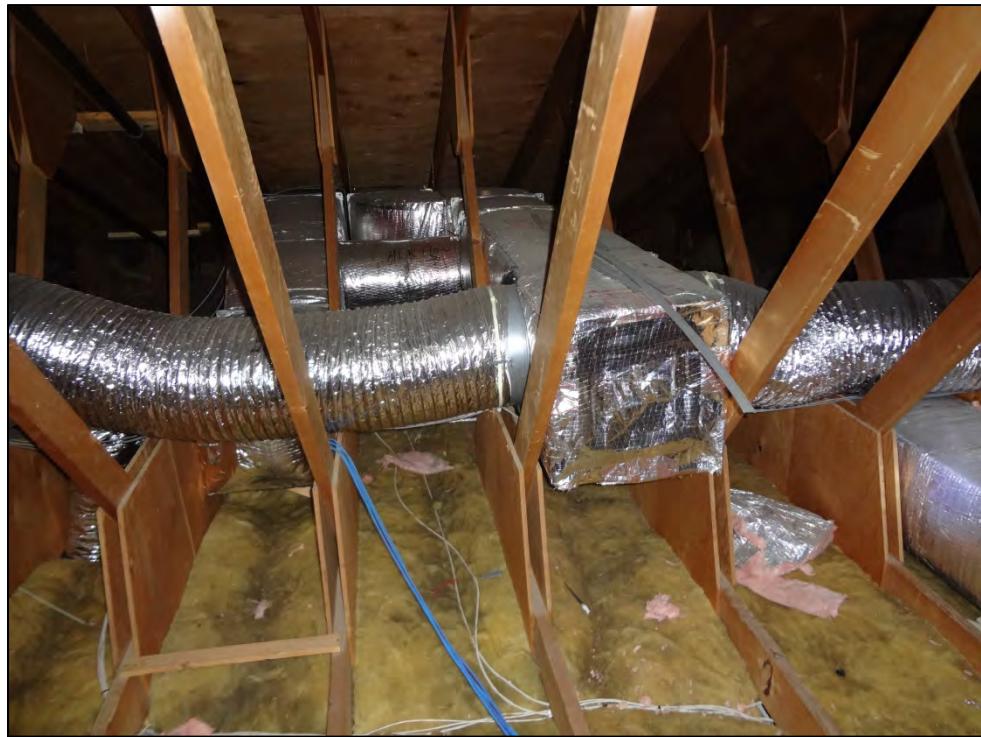
Attic ducts excess flex and poor insulation.

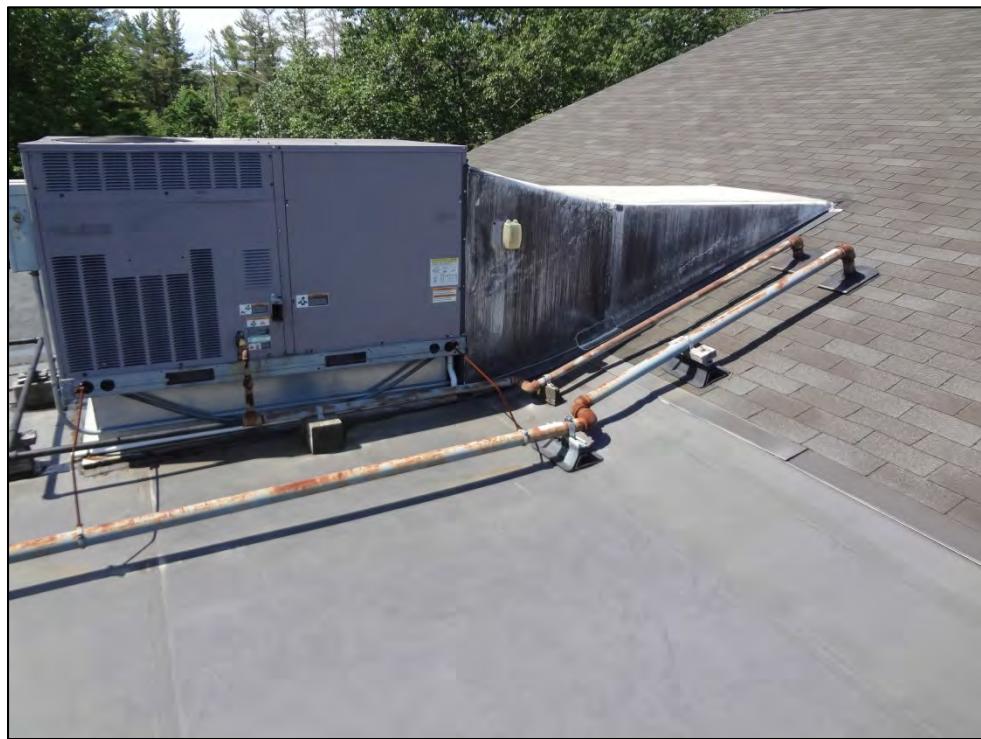
Gas piping needs repainting and supports.

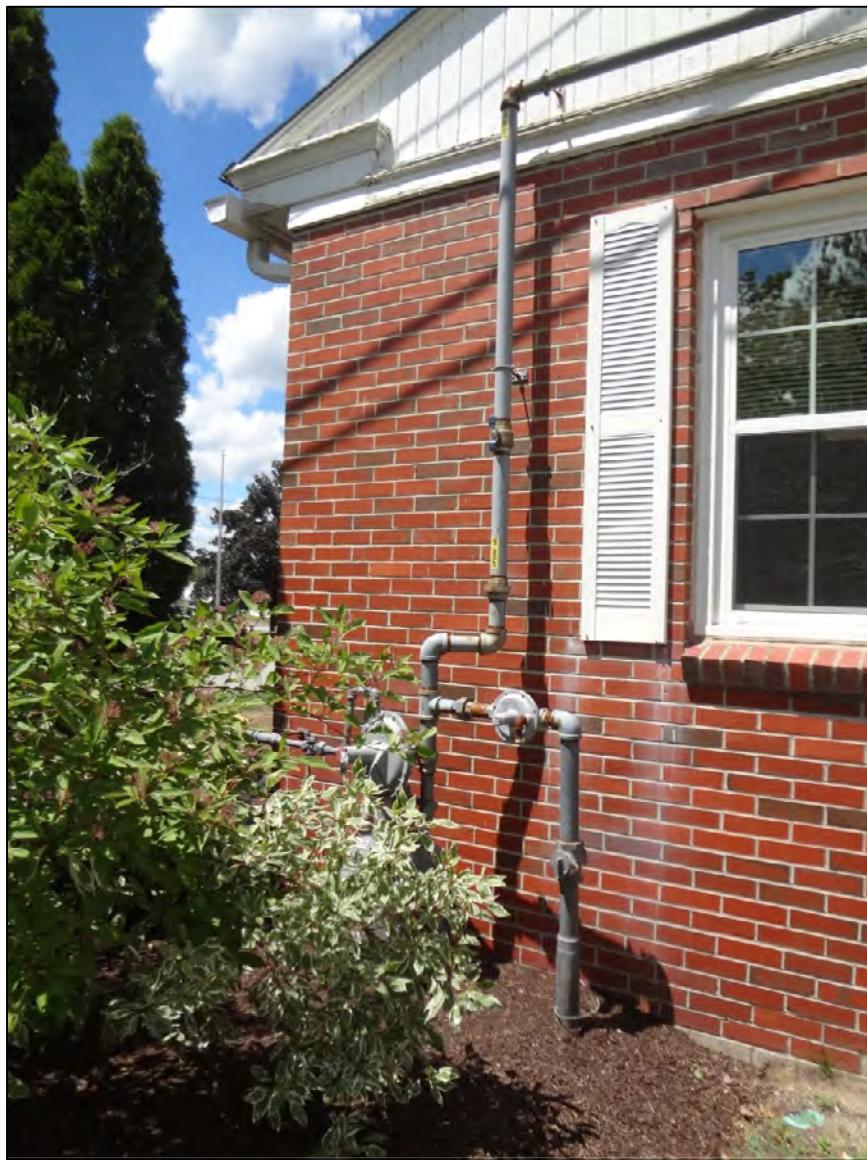
Gas regulator close to window.

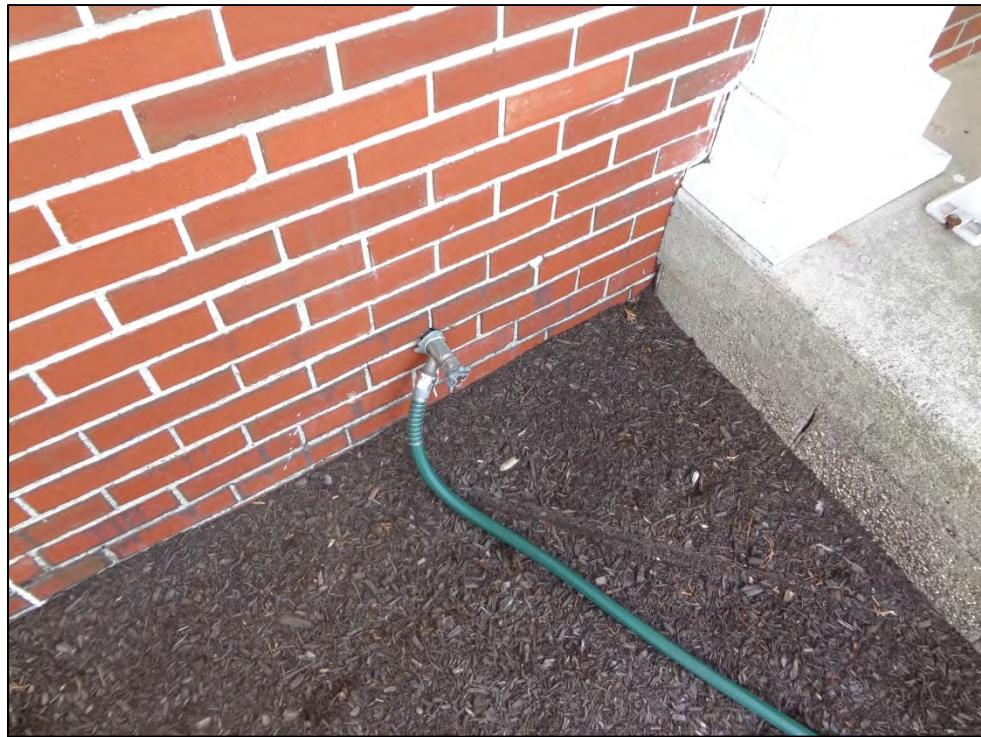
Hose bibb lacks vacuum breaker.

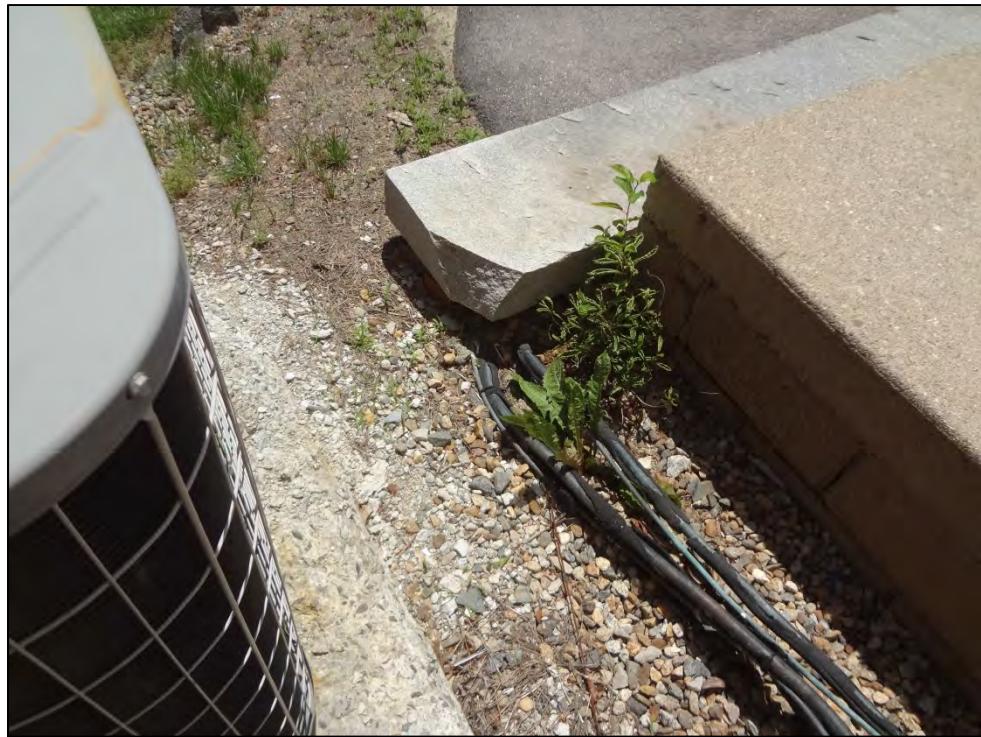
Refrigerant piping under stair and bad insulation.

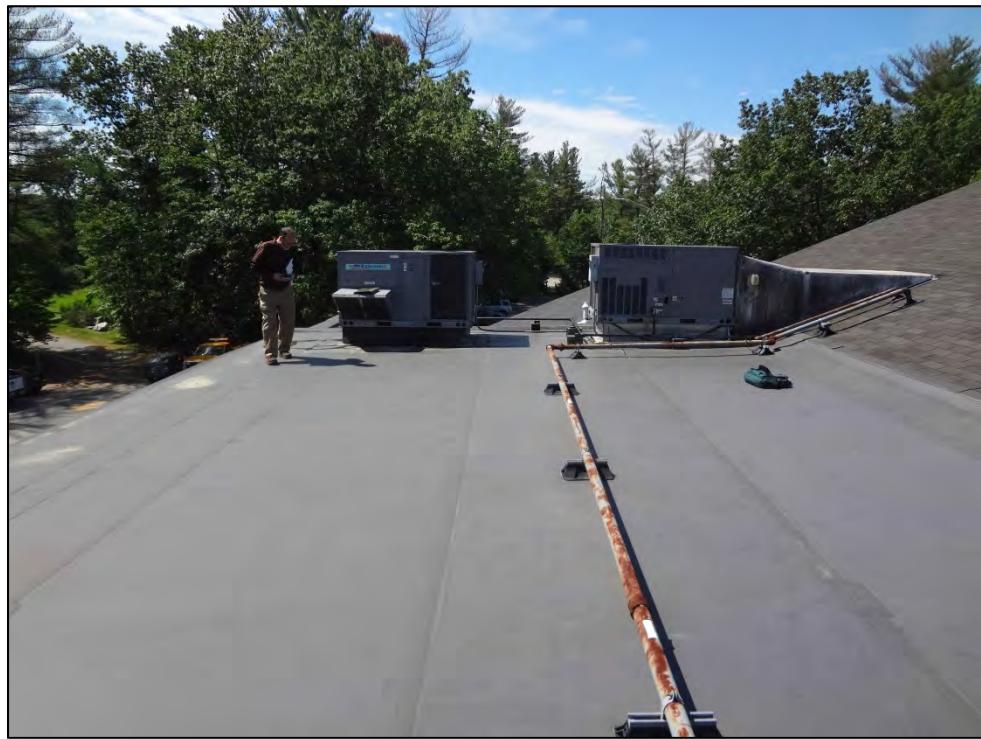
RTUs need safety protection.

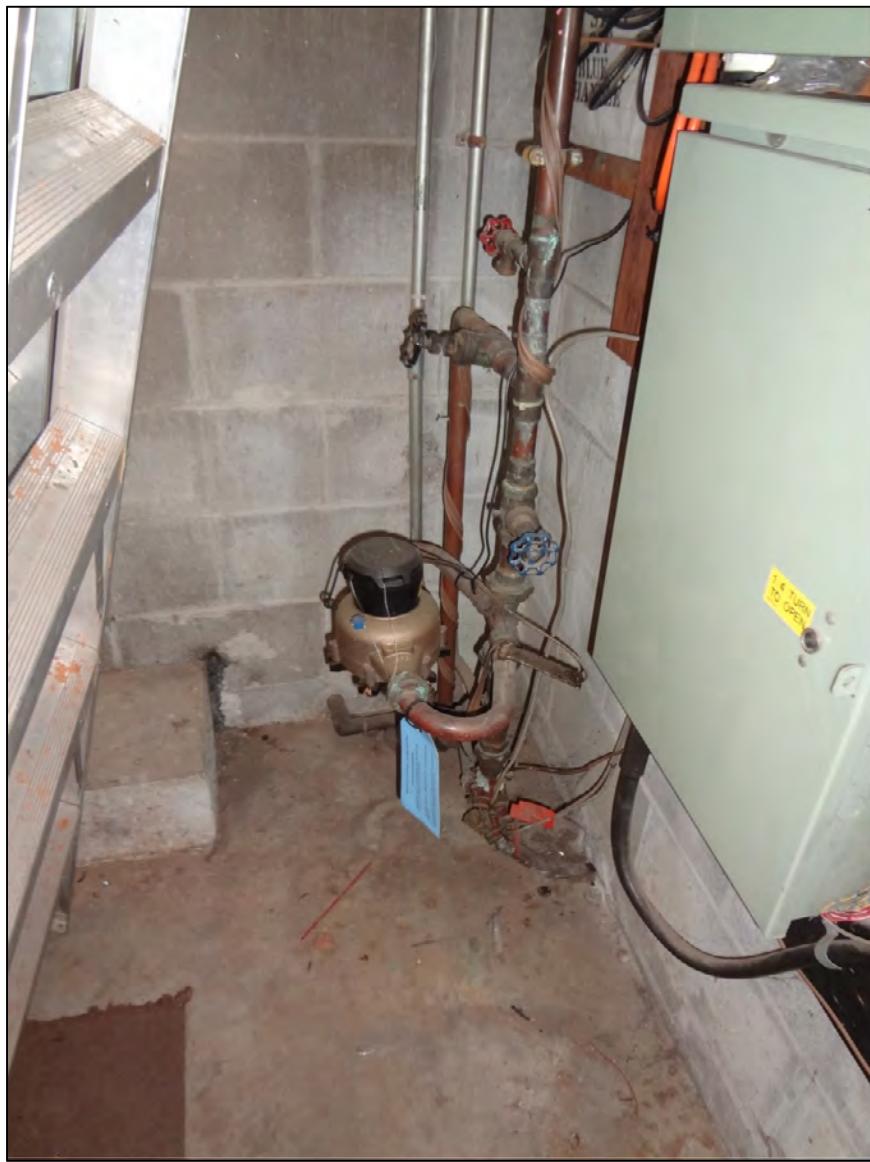
Water entrance small and lacks features.

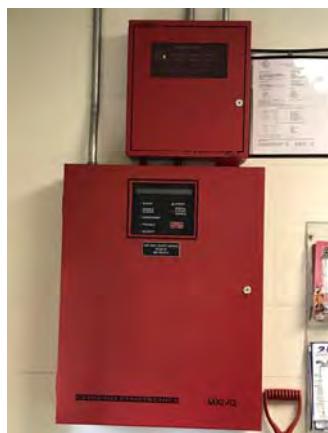
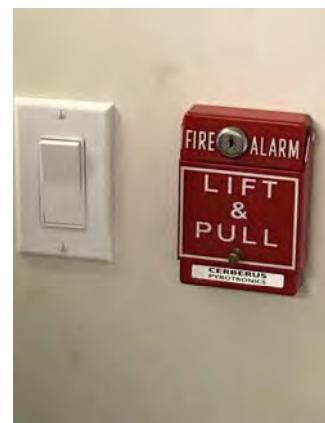
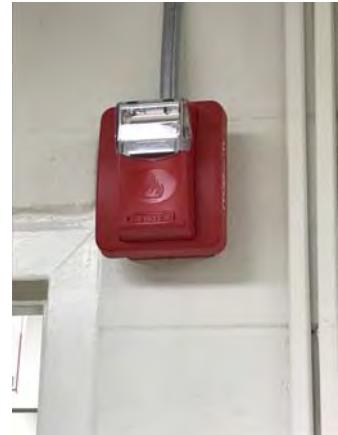
The panel has been tested yearly, as is evidenced by the yearly report mounted adjacent to the FACP. Although the coverage was adequate, the devices are approaching their useful life expectancy, as well as the FACP, therefore, it is recommended that the entire system be replaced with a new addressable Fire Alarm system to meet the 2012 IBC, ADA and 2015 International Fire Code.
